PHOTOGRAPHIC
EVALUATION REPORT
MISSION 1026-1
28 OCTOBER -
2 NOVEMBER 1965
MISSION 1026-2
3-7 NOVEMBER 1965

NATIONAL PHOTOGRAPHIC INTERPRETATION CENTER

SYNOPSIS

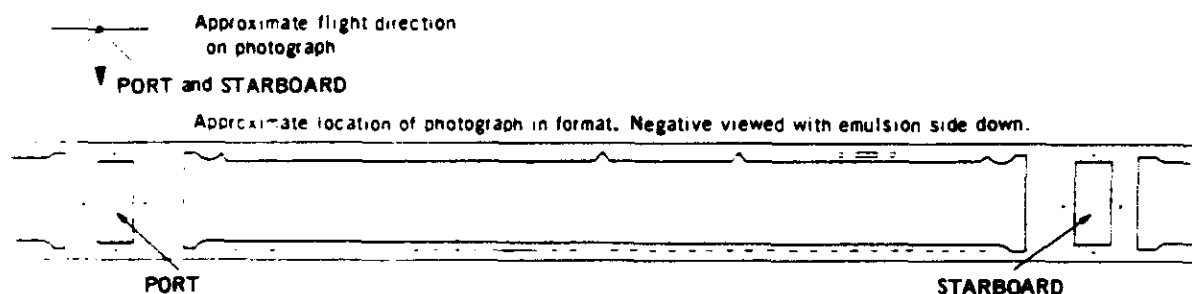
FIGURE 6

Both master horizon cameras were operational throughout the mission. In the first pass (1D), the starboard horizon imagery is normal. From the second operational pass (3D) through pass 14D the imagery of this camera appears to be out-of-focus. When studied under magnification, the photography was discovered to display a sharp (in-focus) but veiled condition. The cause of this phenomenon, which has occurred on previous missions, is unknown. Most starboard horizons in part 2 of the mission are slightly to grossly overexposed. This heavy exposure is believed to be a combination of lock angle and high reflectivity due to considerable cloud cover. An area of fog enters each starboard horizon format at the frequency-mark/supply corner. The level of fog is commensurate with the density of the horizon imagery. This area may result from a reflection on an external surface. The port horizon imagery is of good quality and the exposure is normal. Both horizons contain small traces of dendritic static. These occur intermittently along the frequency-mark edge of the format and affect neither the imagery nor the horizon arcs.

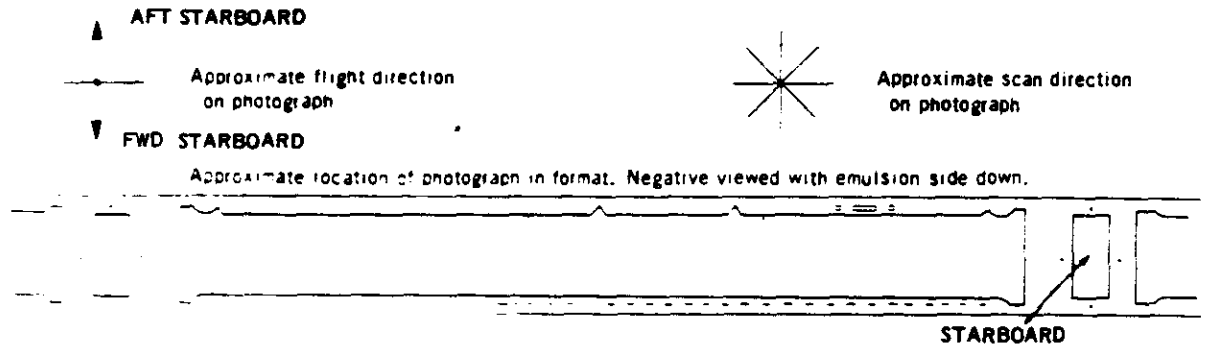
FIGURE 3

Both slave horizon cameras were operational throughout the mission. The starboard horizon displayed a veiled condition on all passes from 1D through 116D. Veiling was so severe on the first half of the mission that it could not be determined whether the imagery was veiled or out-of-focus. This condition continued into the second half of the mission, where veiling gradually became less severe and cleared up by pass 117D.
