CORONA J  
PERFORMANCE EVALUATION REPORT  
MISSION 1104-1 and 1104-2  
FTV 1644, CR-4

SUBJECT: MISSION 1104 FINAL REPORT (CR-4)

This document is the final payload test and performance evaluation report for Missions 1104-1 and 1104-2 which were launched on 7 August 1968.

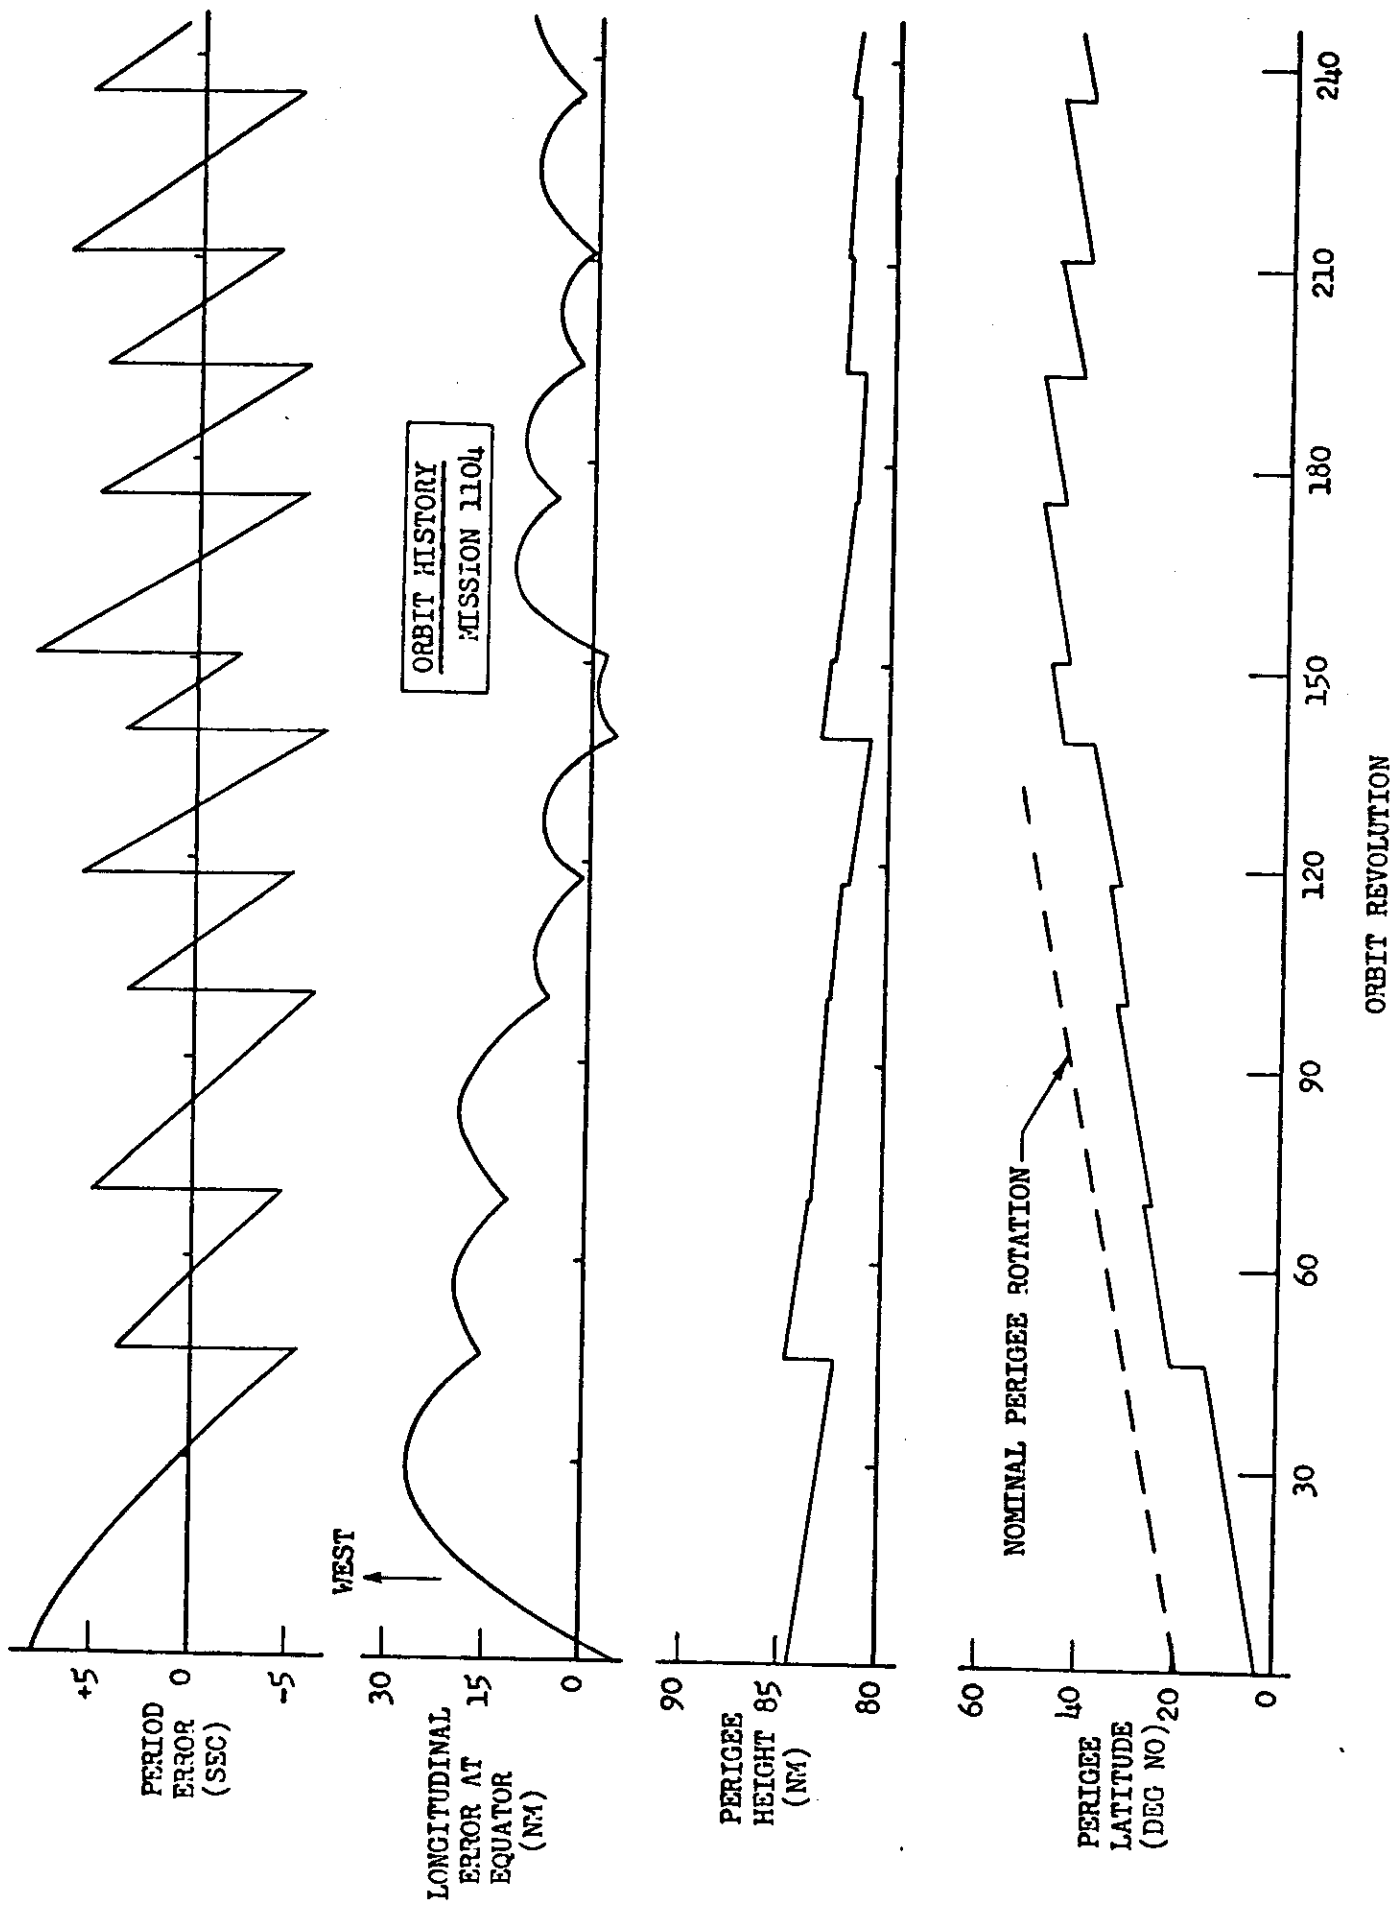
FIGURE 3-1

Figures 3-1 and 3-2 are plots of orbit history and operation distribution data.

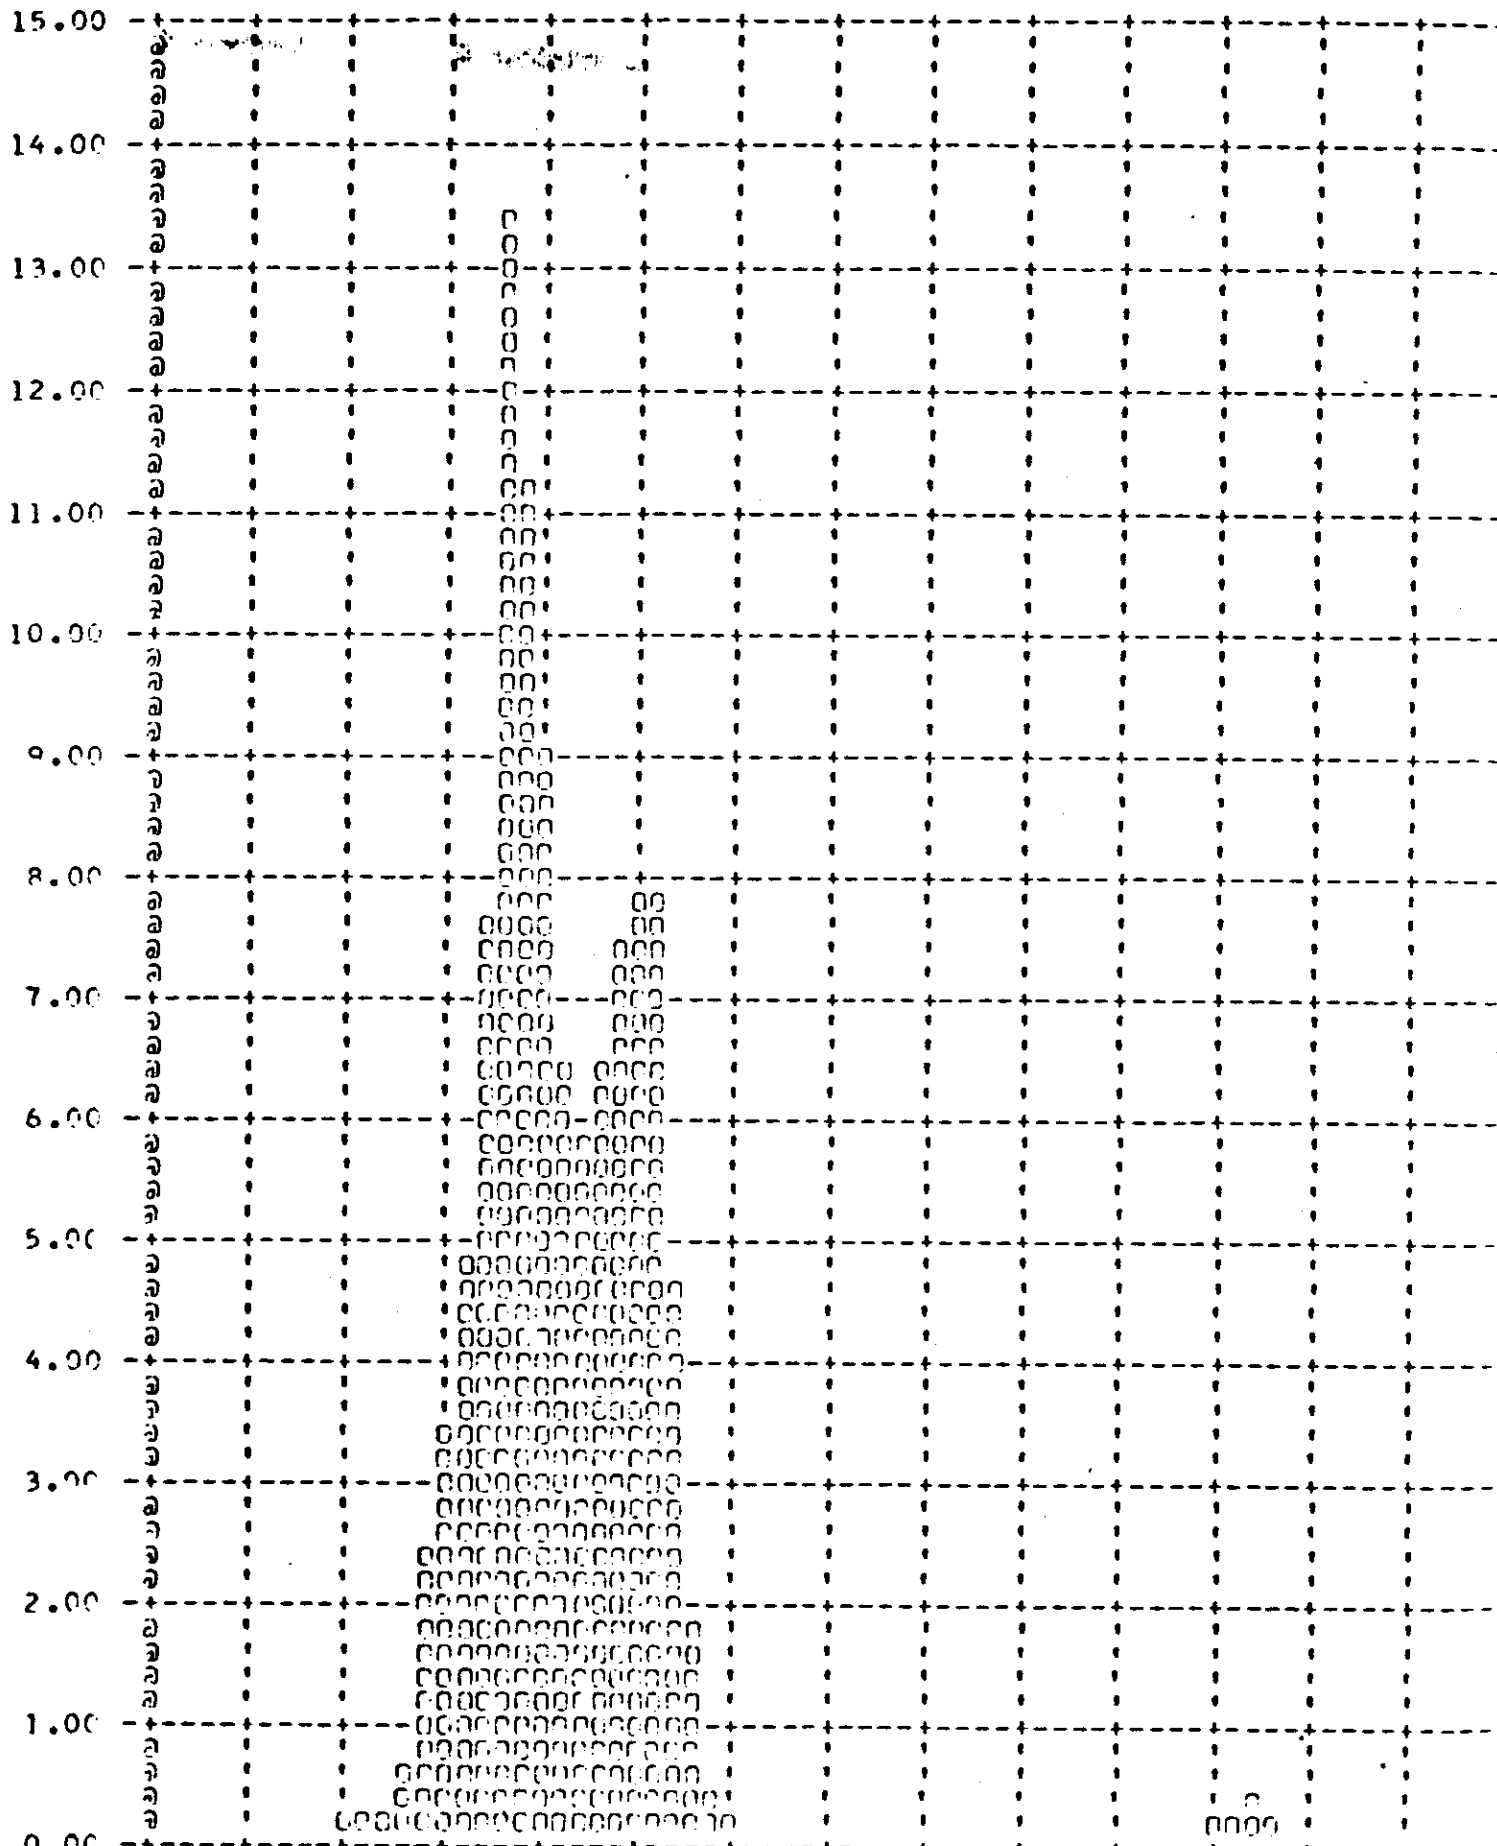
FIGURE 3-3

A satisfactory ramp to orbit match was maintained throughout the entire mission, 90% photography being exposed at less than 1.25% error. The V/h match performance is statistically summarized in Figures 3-3 through 3-6.

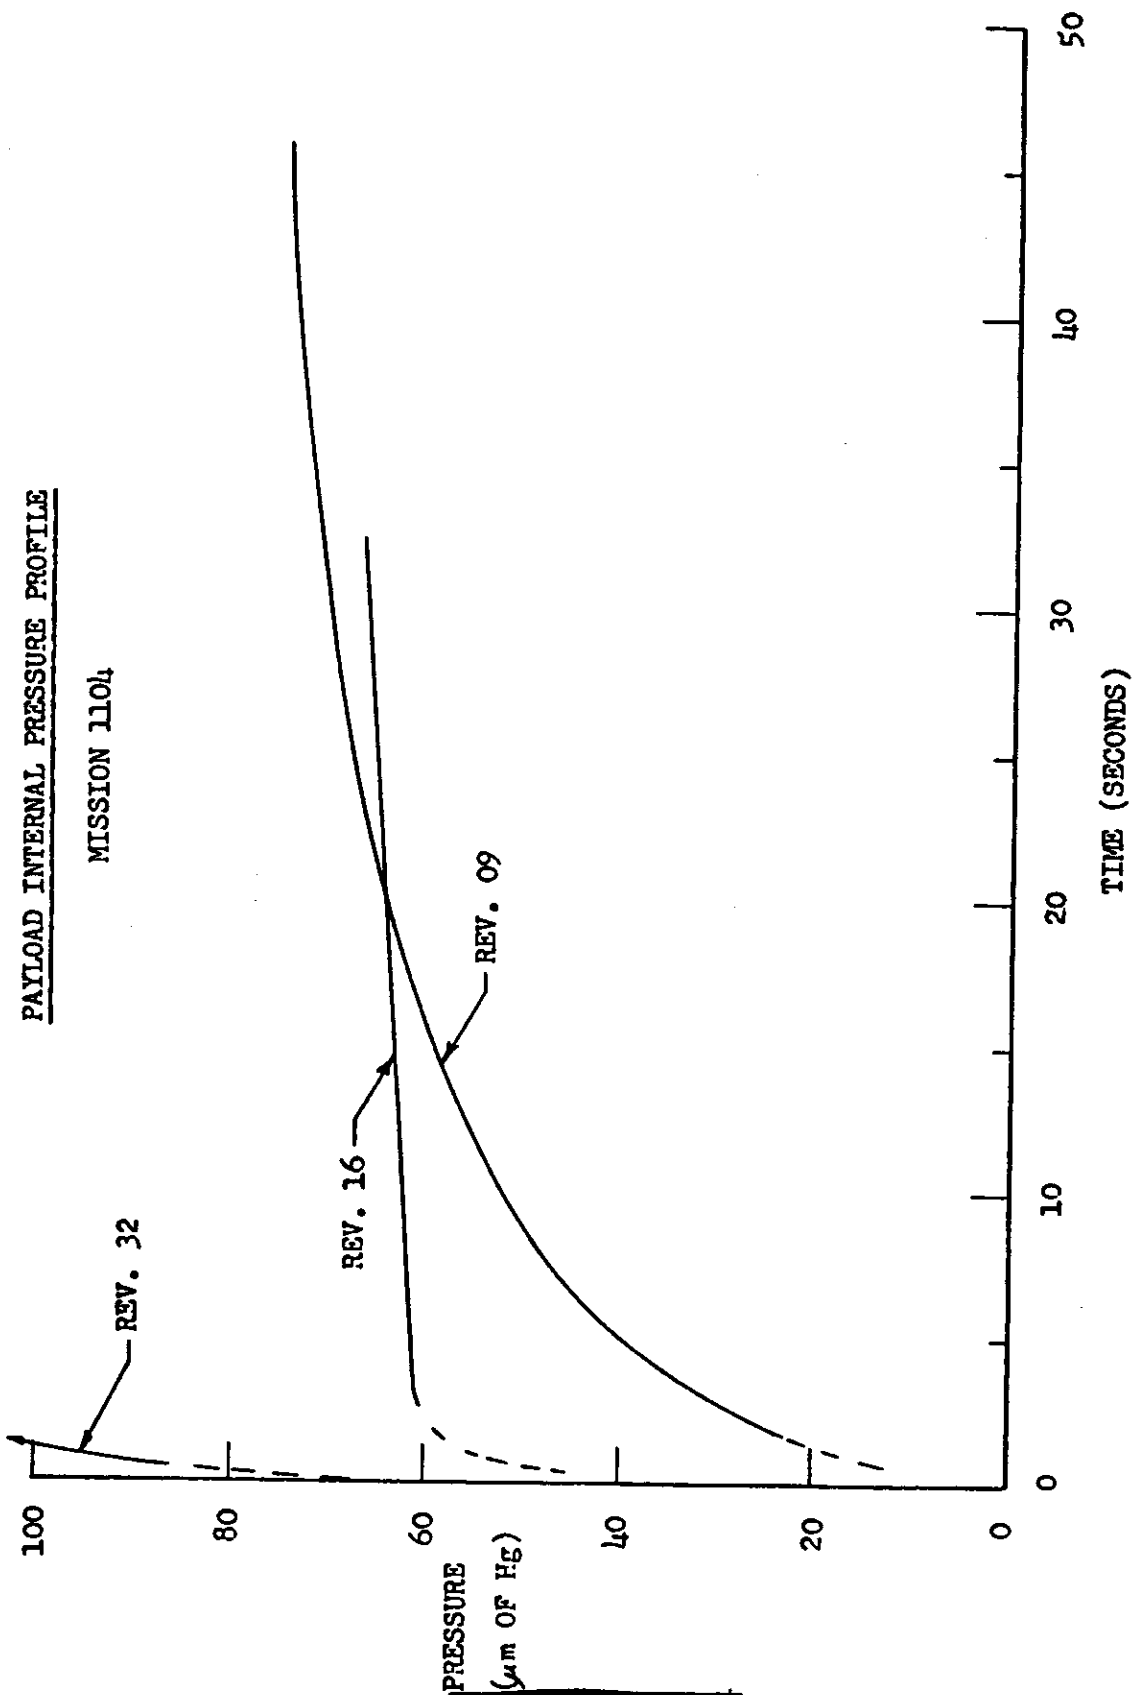
FIGURE 3-7

1. Stabilized pressures of 56 microns, 69 microns, and greater than 100 microns were observed during some operates, even when the lower range (16 micron) control was supposed to be in effect. Refer to Figure 3-7.
2. Supply pressure dropped 160 psi and 575 psi on two (2) operates and 100 to 150 psi per operate on several other instrument operates. Refer to Figure 3-9.
3. Pressure buildup, on occasion, exceeded 100 microns (gage limit) within 2 seconds. Refer to Figure 3-8.
4. Internal pressure fluctuated during instrument operation. During one such operate the pressure went to 66 microns, decreased to 62 microns, then increased to 70 microns at the "OFF" command.

The problem was attributed to a faulty high pressure regulator. The PMU was disabled during Rev. 124, after 130 minutes of operate time, with a pressure of 350 psi remaining. The system was re-enabled during Rev. 200 and remained on for the balance of the flight, with the exception of Rev. 211. The supply pressure remaining at the end of the mission was 200 psi. Refer to Figure 3-9. The system apparently did not perform as desired for the SO-180 film employed in Instrument 309 at the end of Mission 1104-2. This condition was evidenced by the predominance of corona discharge marking recorded on this special material.

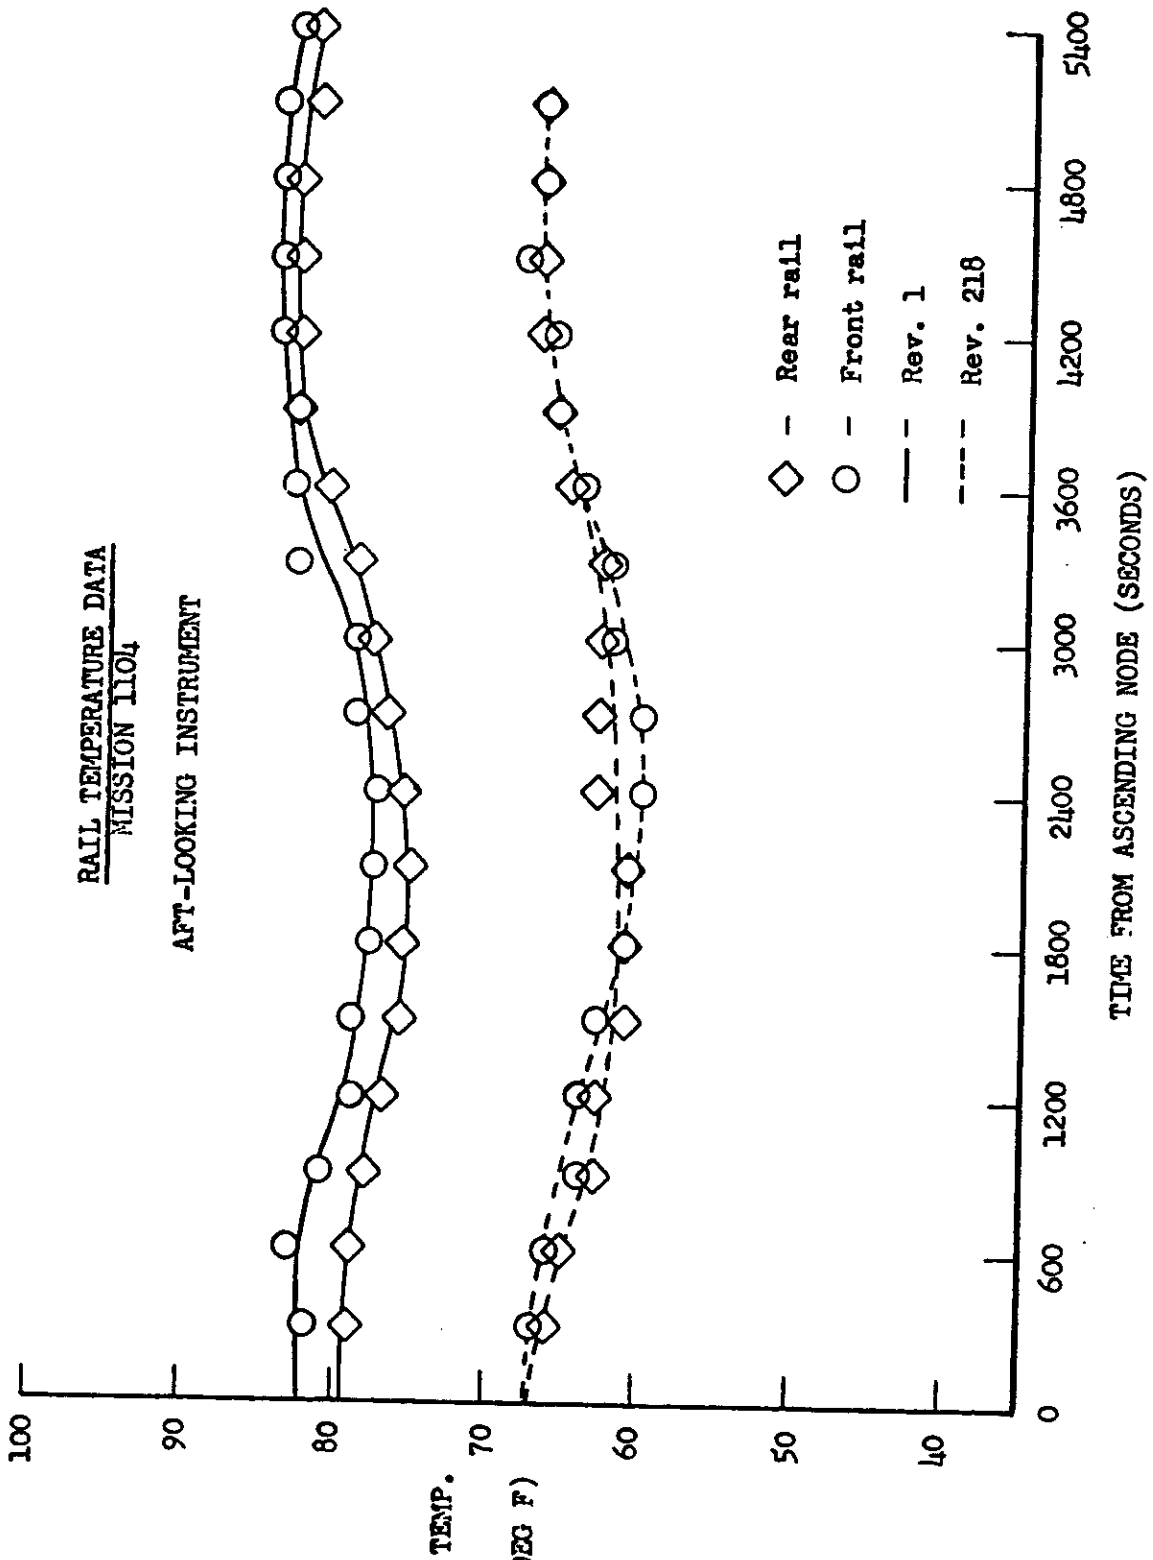
FIGURE 3-13

Thermal data obtained from the Agena tape recorder were analyzed to provide an estimate of Panoramic camera rail temperatures during any camera operation. The temperature data presented in Figures 3-13 and 3-14 were obtained at five (5) minute intervals during selected revs and is plotted versus vehicle orbital position (quadrant-latitude). The rail temperatures for any camera operation can be interpolated from these figures.
