CORONA J
PERFORMANCE EVALUATION REPORT
MISSION 1107-1 and 1107-2
FTV 1652, CR-7

This document constitutes the final payload test and performance evaluation report for Mission 1107 which was launched on 24 July 1969.

This report presents the final performance evaluation of Corona Mission 1107. The purpose of the report is to define the performance characteristics of the CR-7 payload system and to evaluate the technical aspects of the Mission, including analysis of in-flight anomalies.

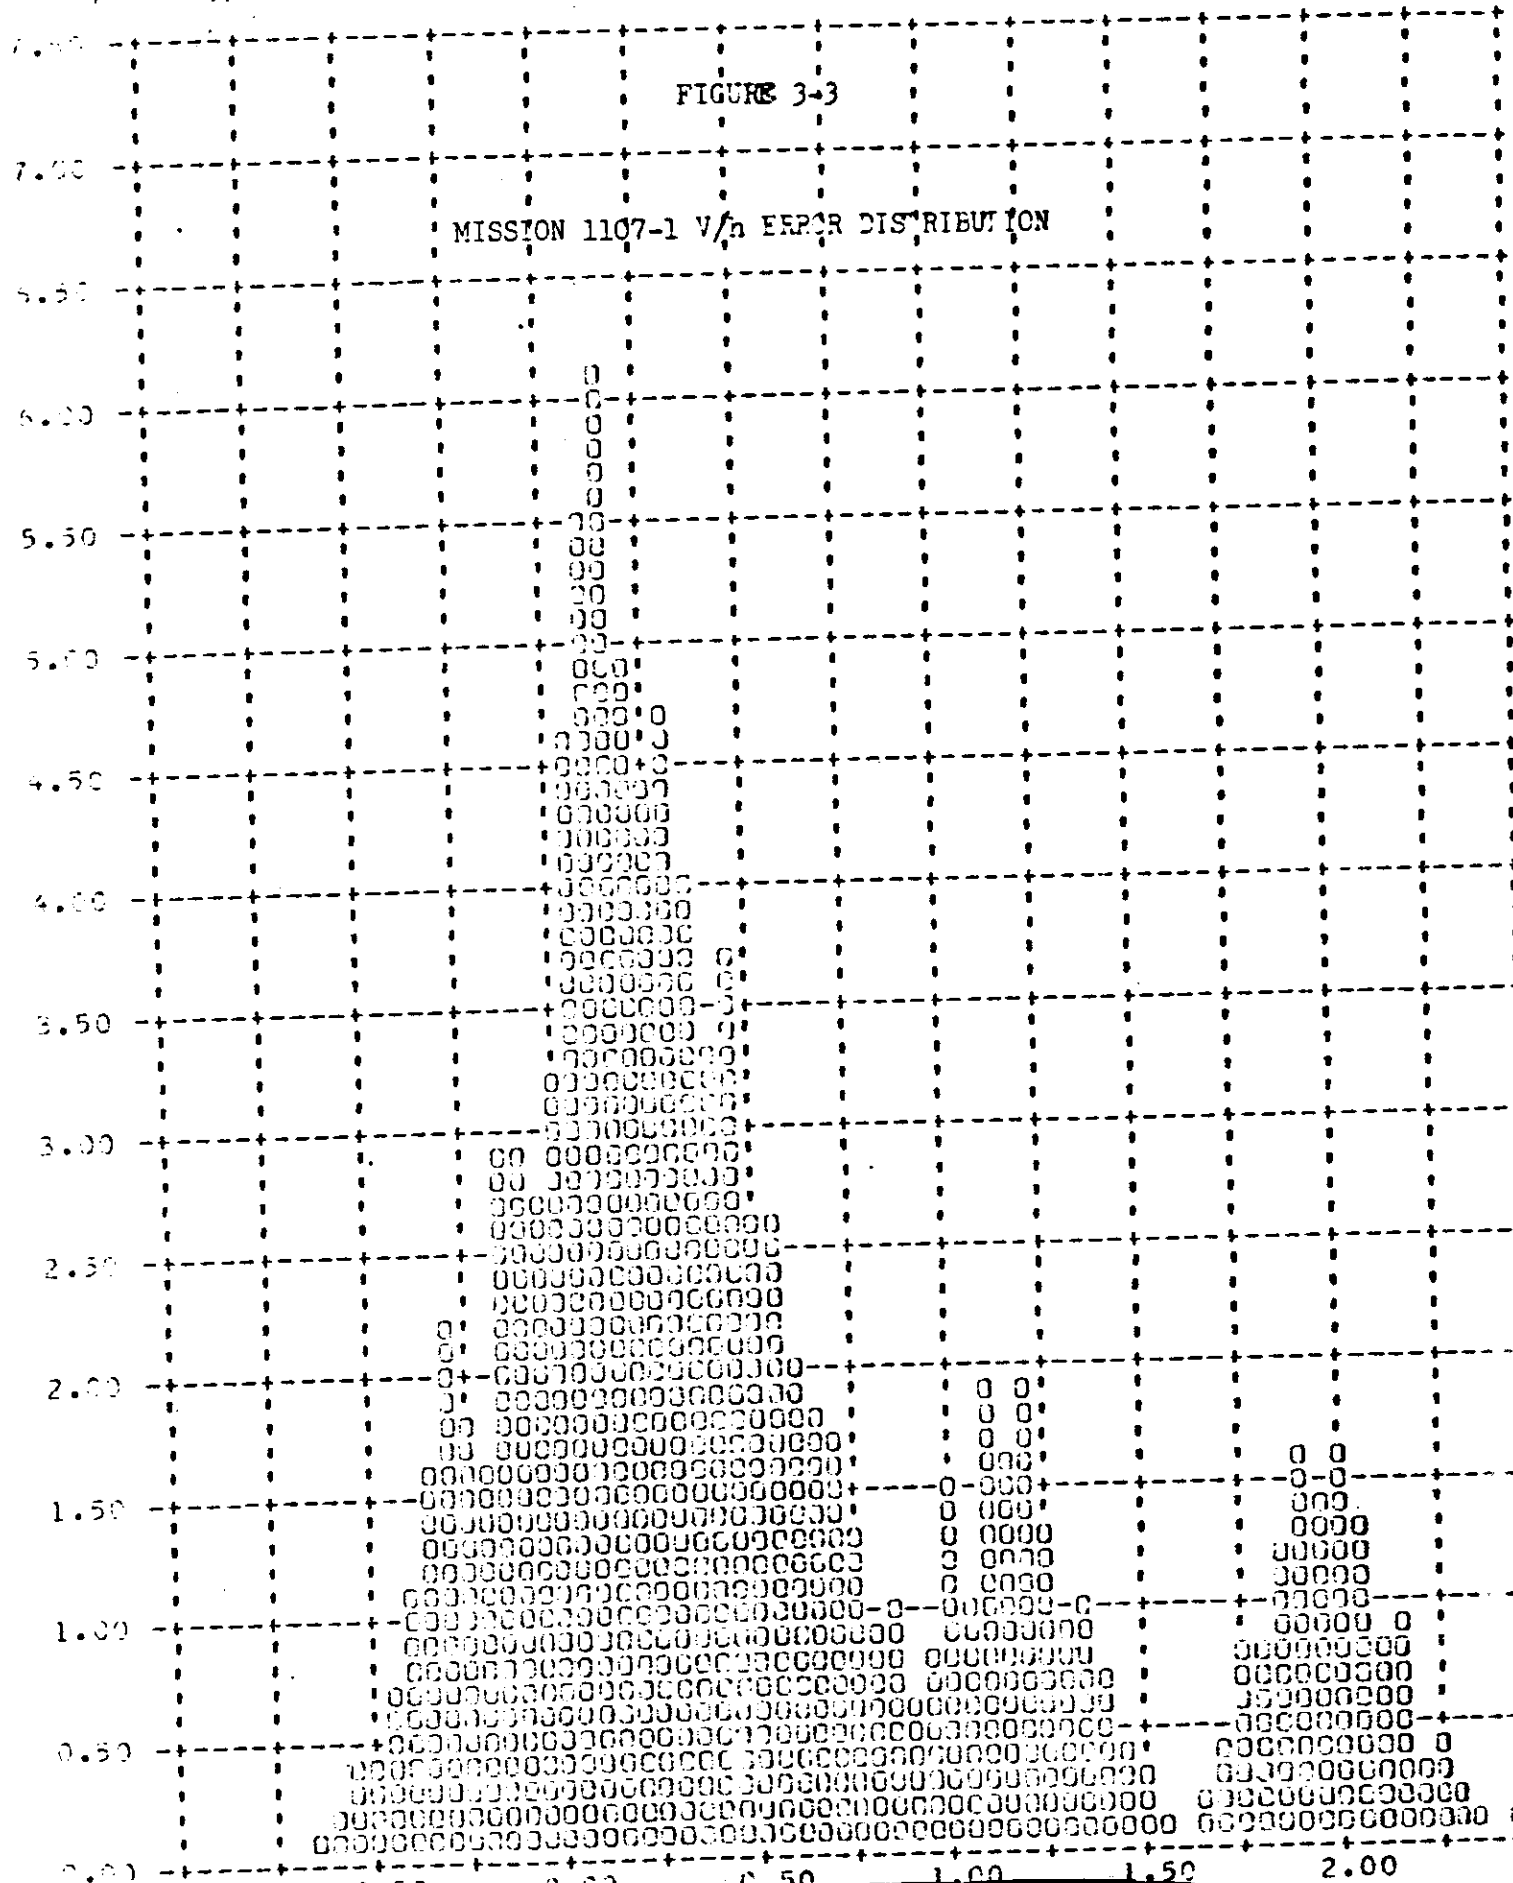
FIGURE 3-3

A satisfactory ramp-to-orbit match was maintained during both missions of the flight. Except for Revs. 1-8 and 23-25, the V/h mismatch was kept within plus or minus one percent for 95 percent of the frames taken. The ramp-to-orbit match is maintained by selecting the best combinations of start, half-cycle, and delay positions. The exceptions to accurate orbit matching mentioned above were due to use of incorrect orbit data. The V/h match performance is shown in Figures 3-3 and 3-4.

MISSION 1107-1 V/h ERROR DISTRIBUTION

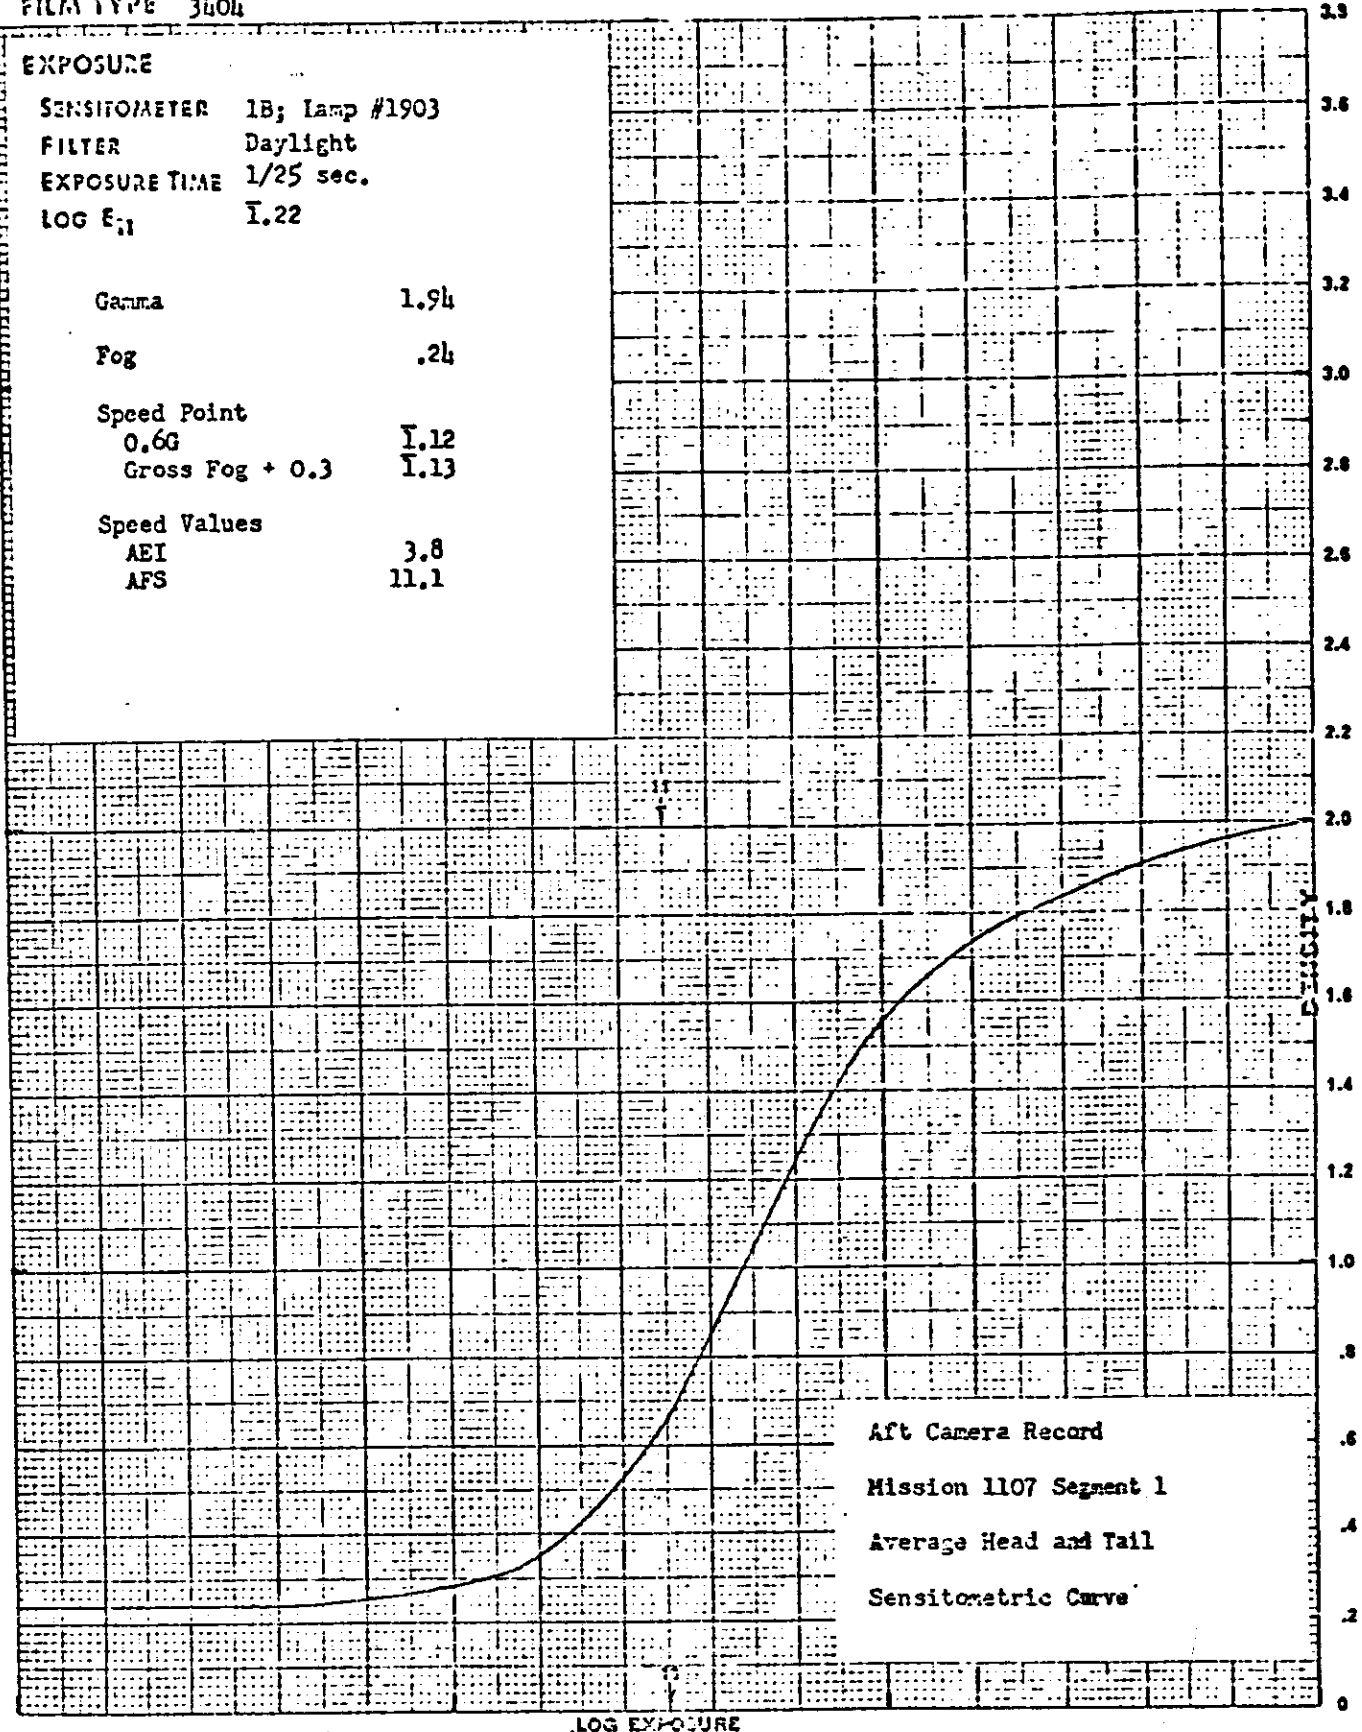
FIGURE 5-3: AFT CAMERA FILM, 1107-1, SENSITOMETRIC CURVE

removed before the flight, controlled exposures were added to the head and tail of each camera film and processed with it. The averaged results for both mission segments of the aft pan camera film are shown in Figures 5-3 and 5-4. These Characteristic Curves show that film processing results were very close to system standards. The only notable deviation was indicated by SPPF density data which showed the base plus fog values to range from 0.23 to 0.30, with the average of 0.25. A base plus fog value 0.20 is nominal.

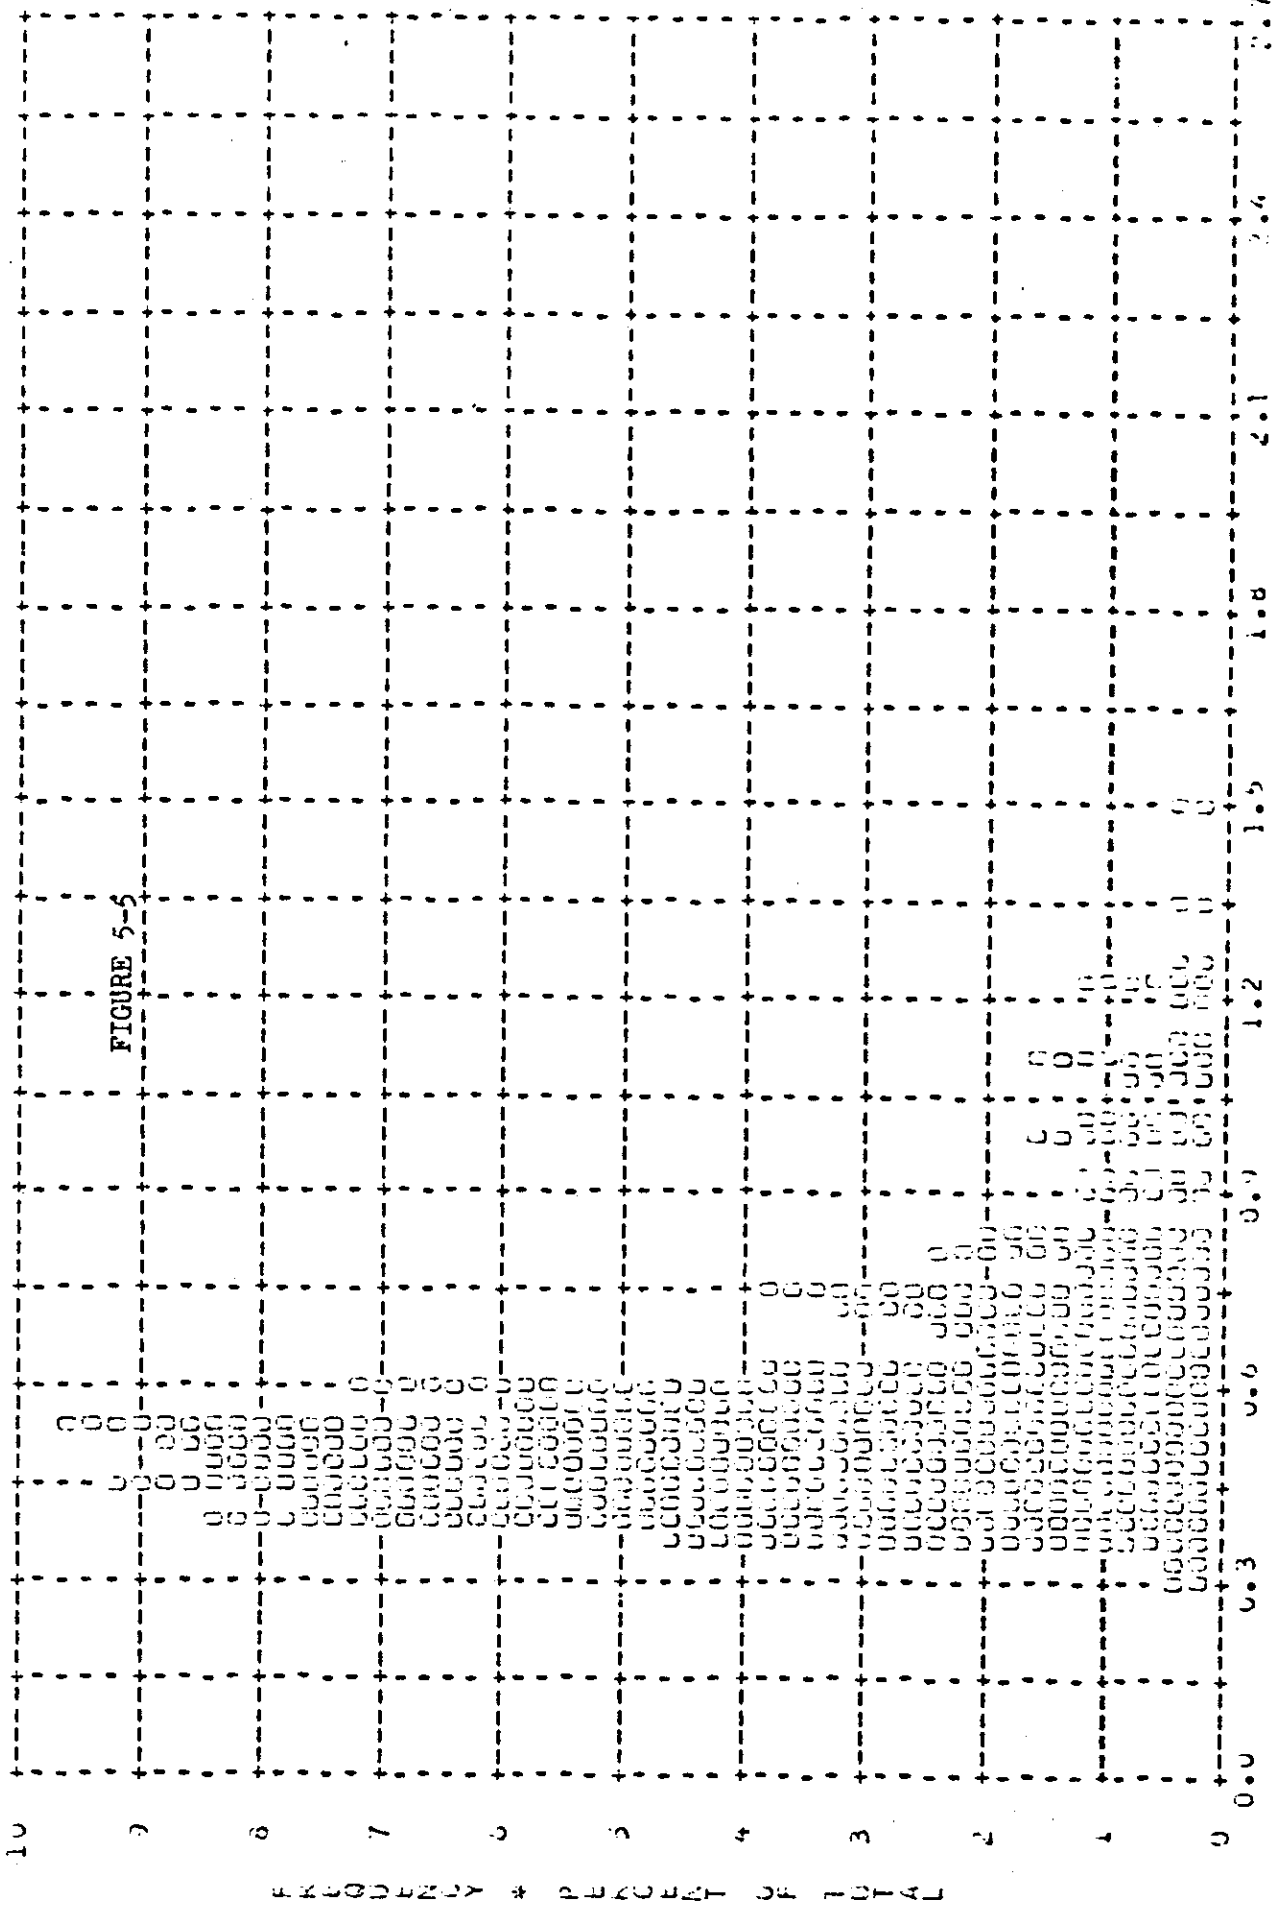
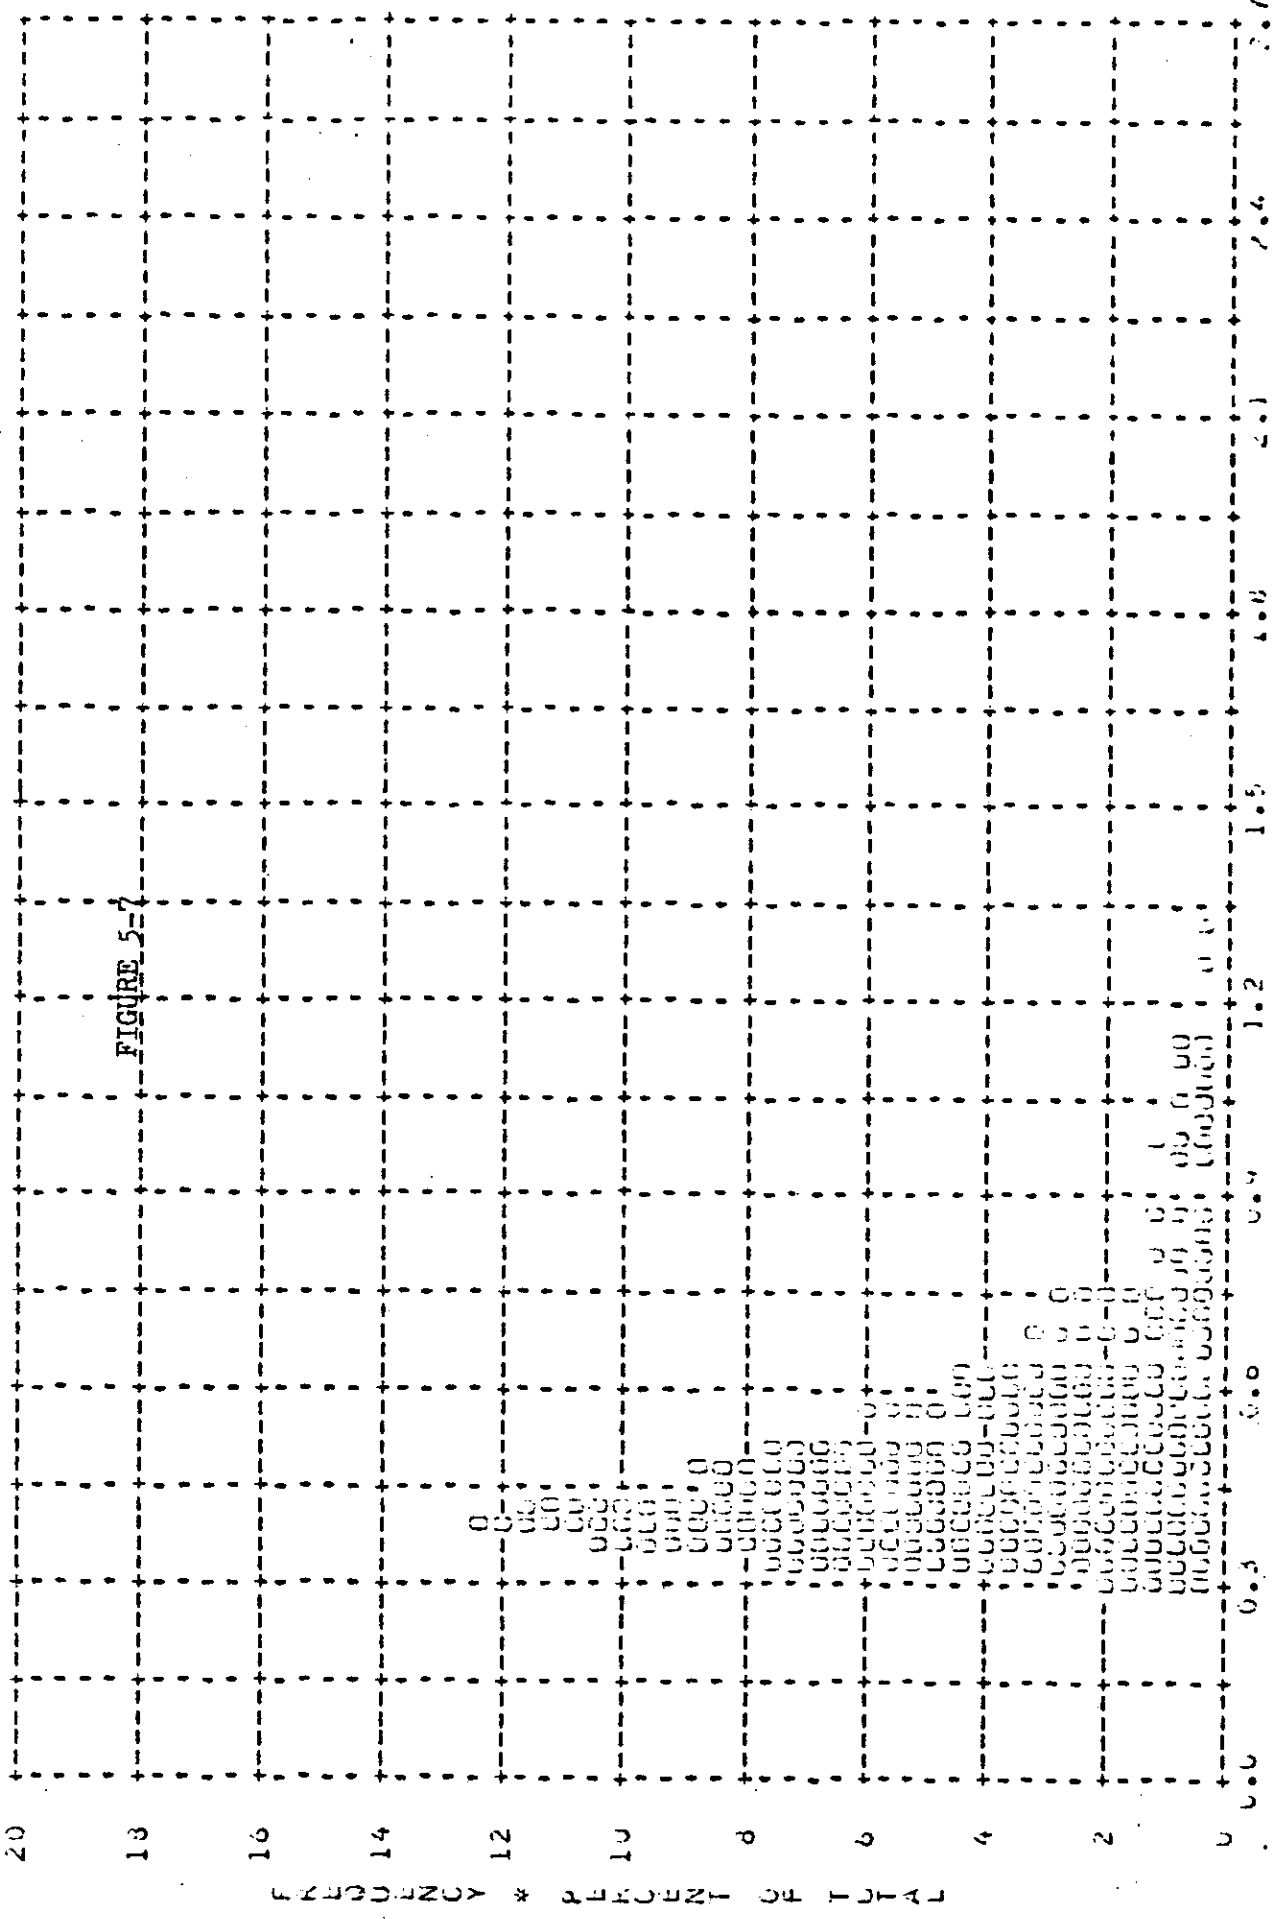
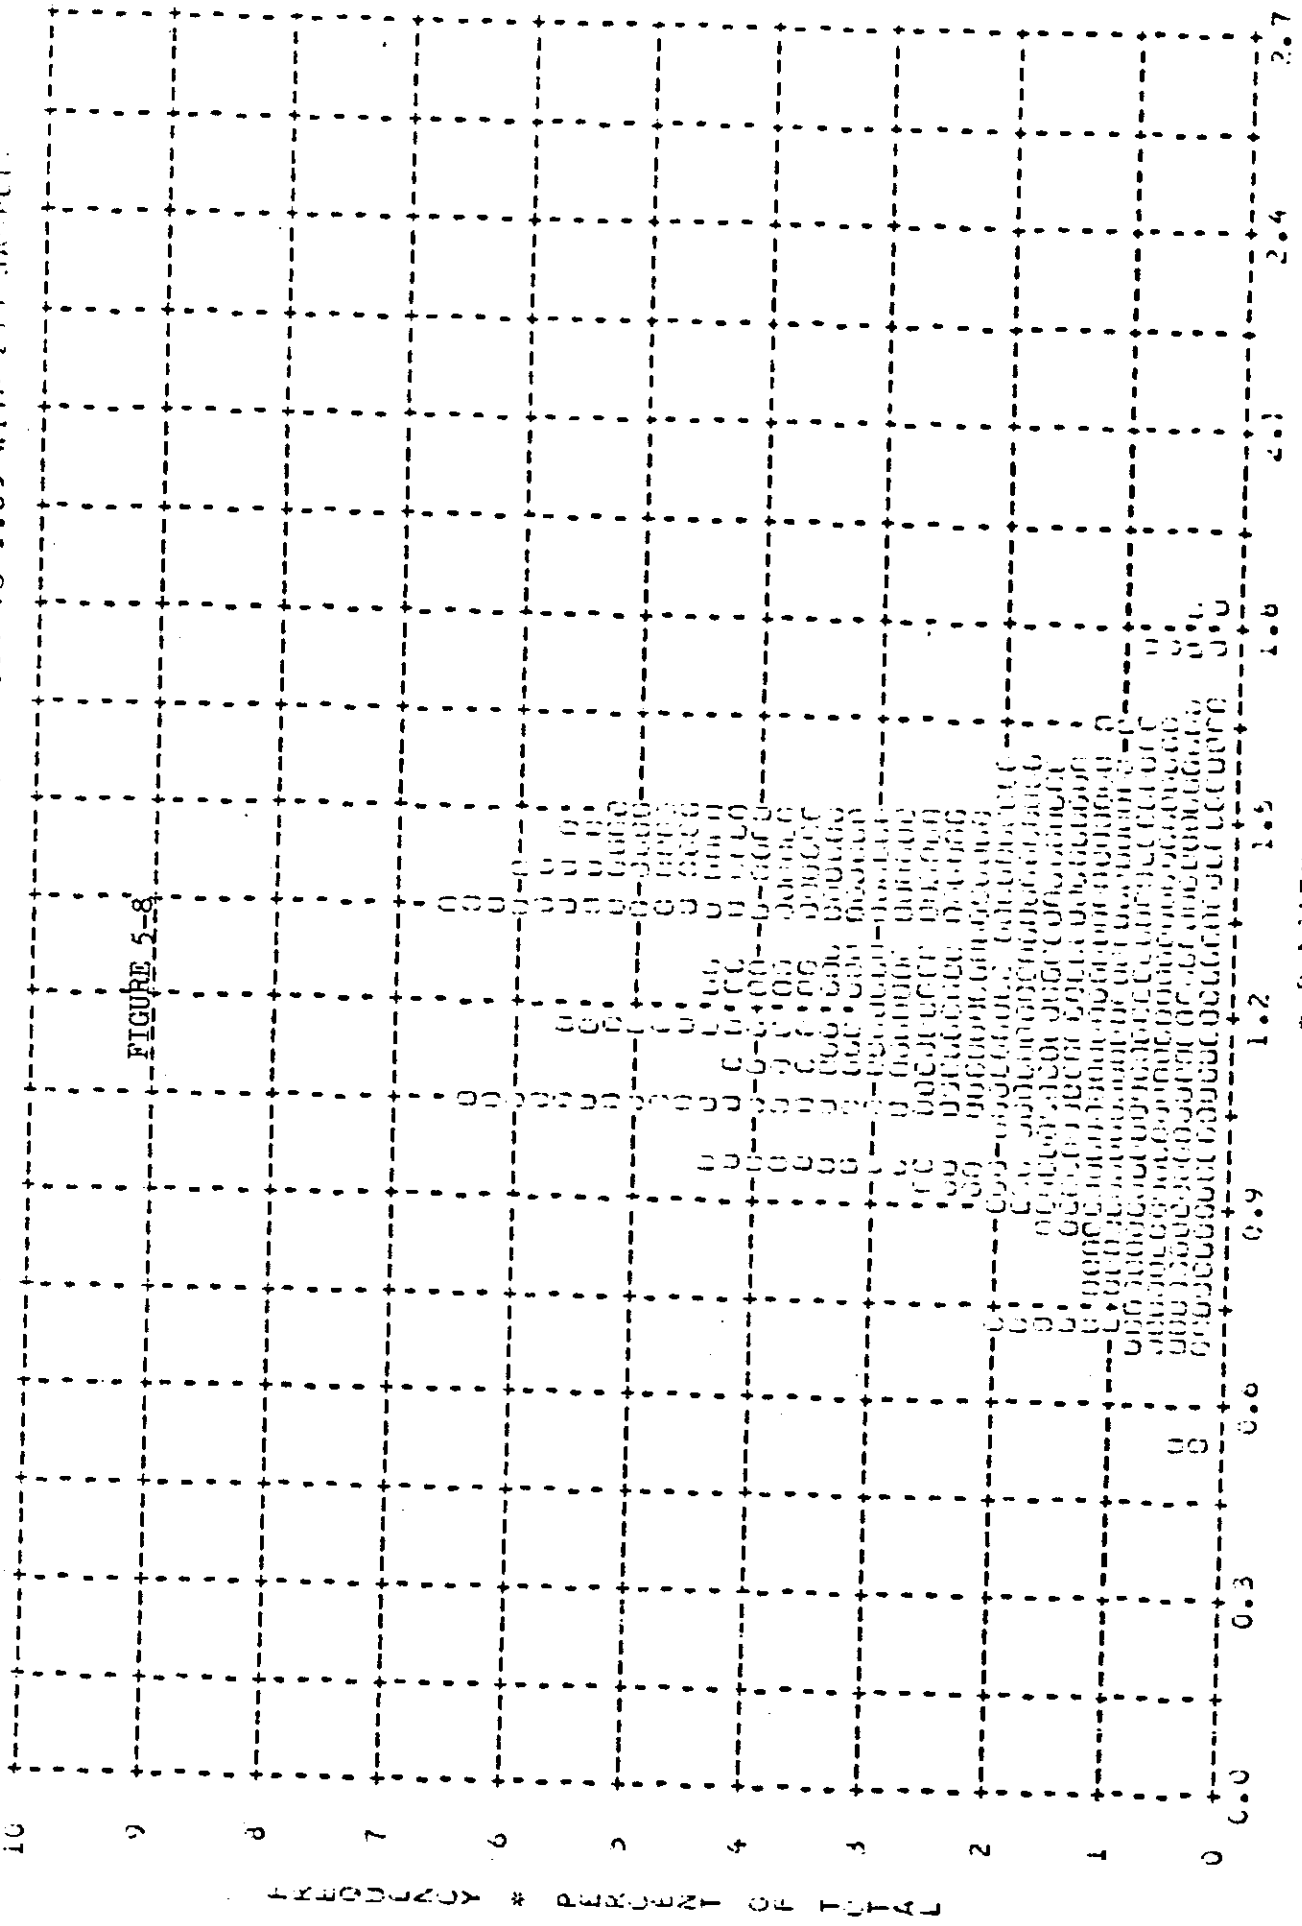
The distributions of terrain minimum and maximum densities are shown in Figures 5-5 through 5-8. Using the SPPF tabulated density data, every sample with a D-min less than 0.4 or D-max greater than 0.9 was examined to determine the cause of density variation. This included 121 frames with D-min less than 0.4 and 39 frames with D-max over 0.9. In almost all cases, the condition could be attributed to scene luminance conditions. In a few cases, desert or semi-desert areas were listed as snow covered. This is a fairly common error in interpretation of negatives when location information is not used. No cases were found where either exposure criteria or system control were clearly in error.
