CORONA J

PERFORMANCE EVALUATION REPORT

MISSION 1106-1 and 1106-2

FTV 1630, CR-6

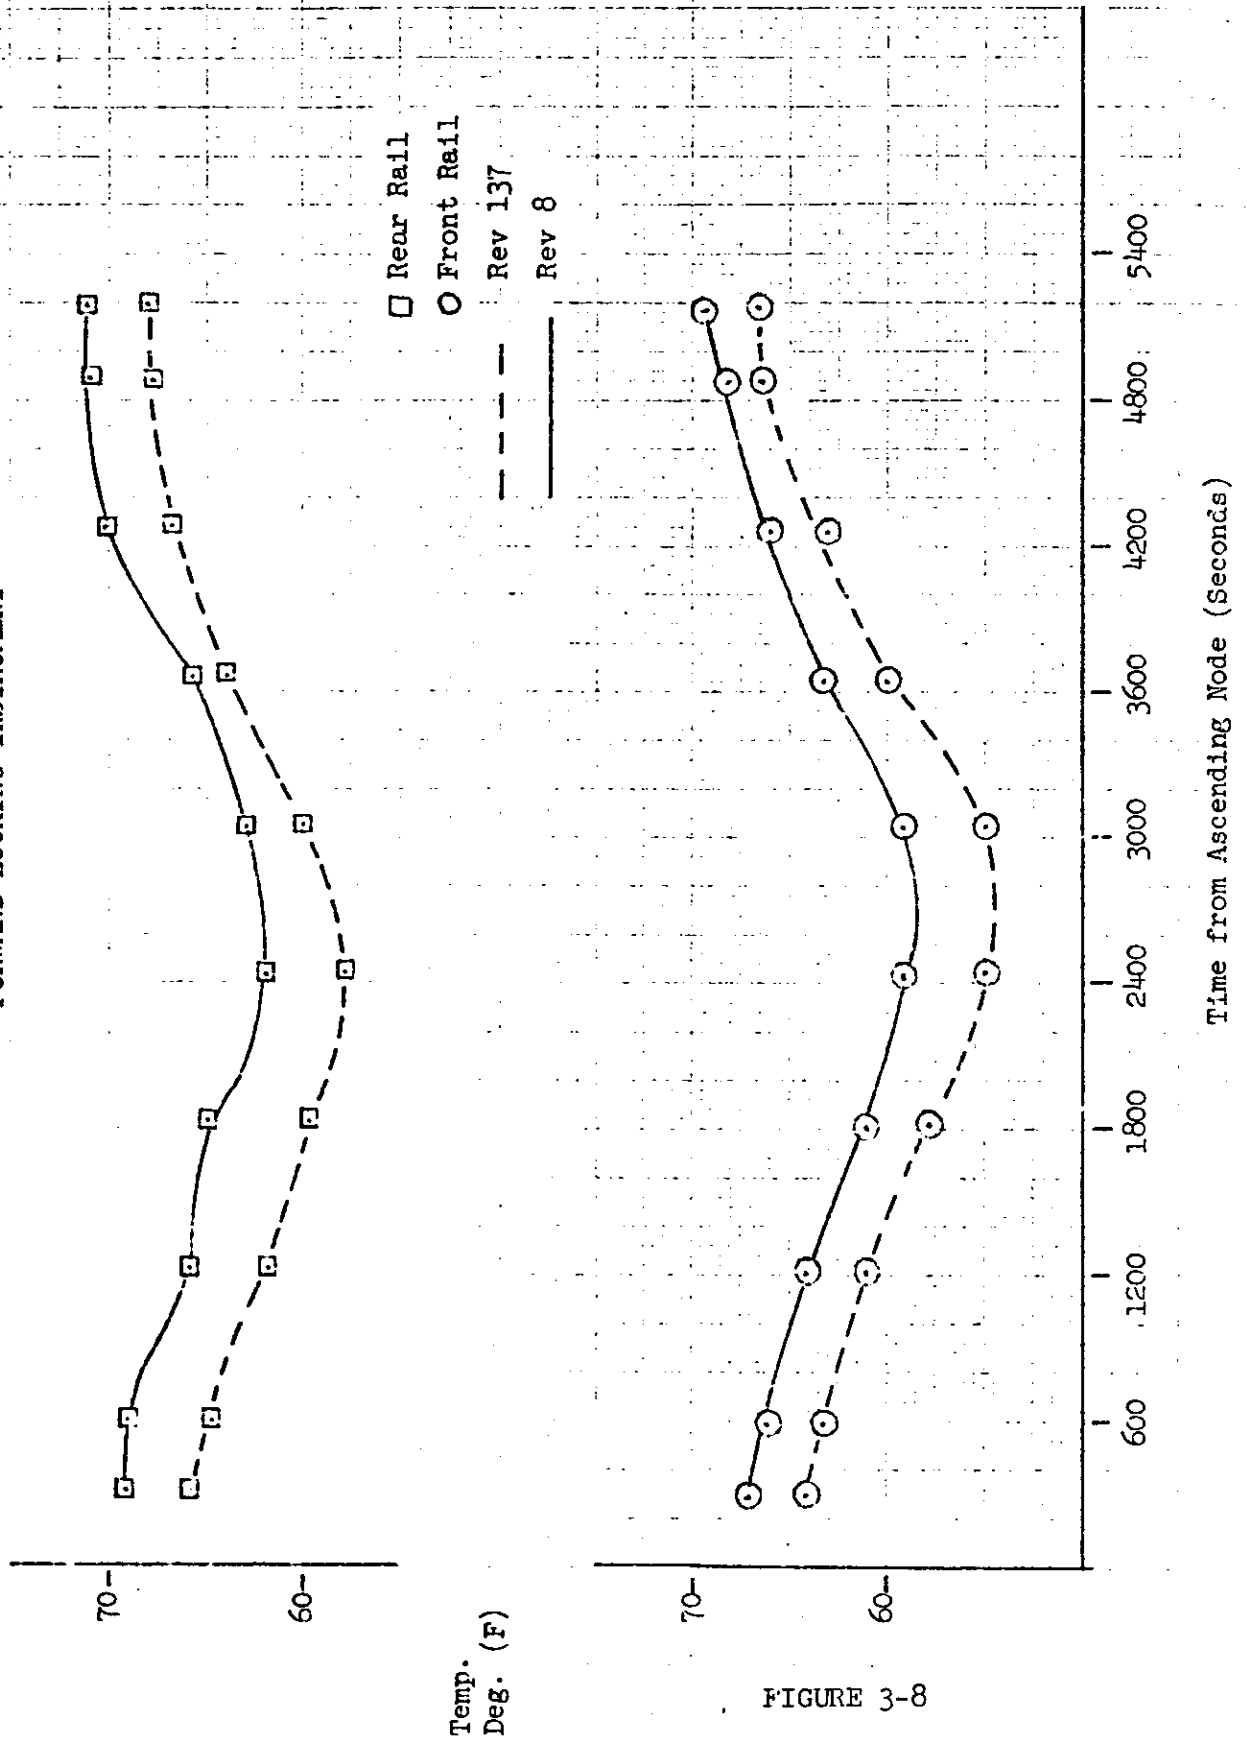
FIGURE 3-8

Temperature data acquired by the [REDACTED] tracking station show that panoramic camera temperatures were within the specified envelope. A modified paint pattern and increased lens insulation were utilized on this mission. The resulting thermal environment was the best ever obtained. The forward looking instrument had an average instrument temperature of 63 plus or minus 3 degrees F throughout both missions. The thermal gradient on the lens cell was approximately 4 degrees F and transients were plus or minus 1 degree F. The aft looking instrument had an average instrument temperature of 64 plus or minus 5 degrees F throughout both missions. The thermal gradient on the lens cell was approximately 2 degrees F and transients were plus or minus one degree. Figures 3-8 and 3-9 show each instrument's rail temperature for rev 8 and rev 137. Figure 3-7 shows a graphical plot of the actual average camera temperatures versus the predicted temperature as a function of the beta angle in degrees.

RAIL TEMPERATURE DATA

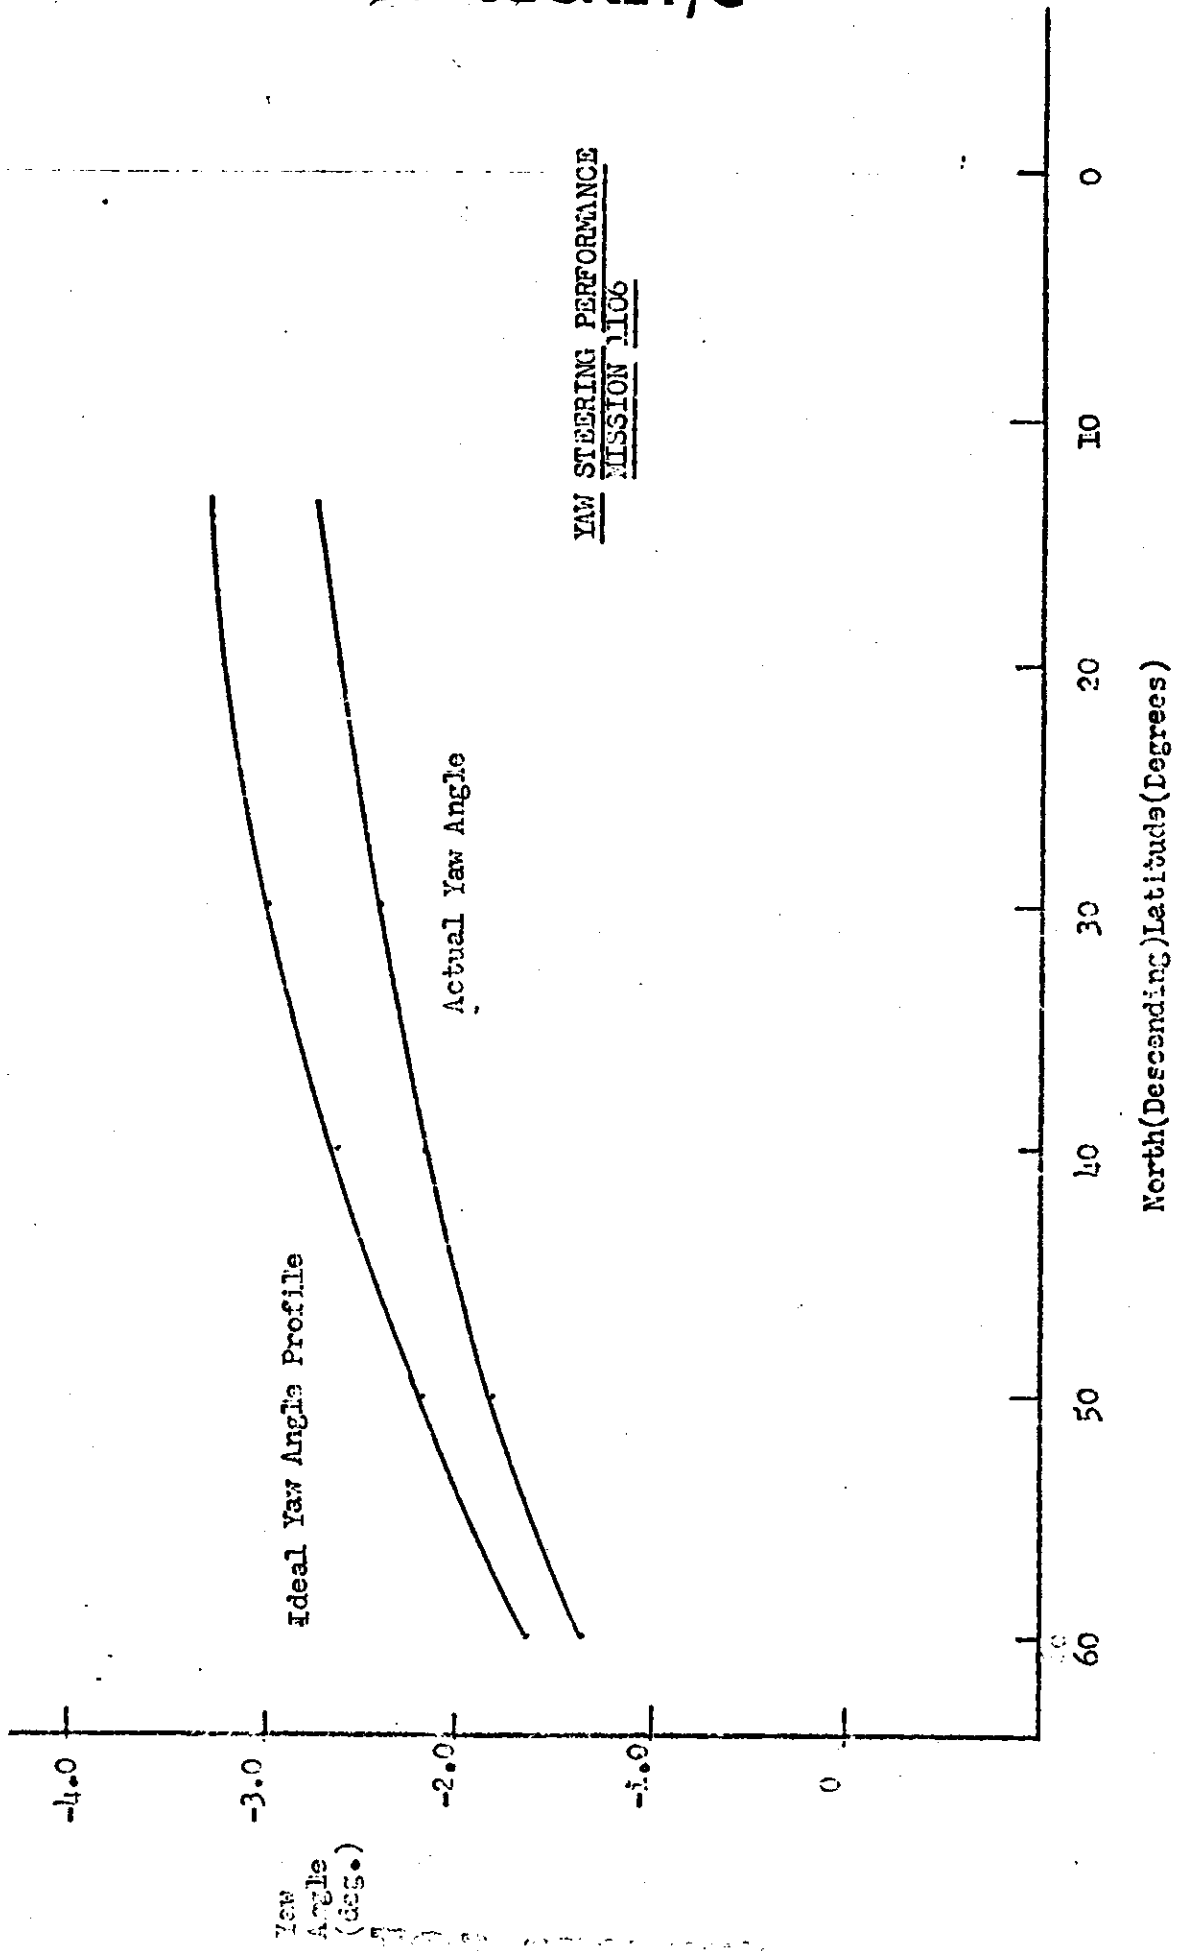
FIGURE 6-2

Vehicle attitude control is concluded to have been within the normal performance envelope for both mission segments. Attitude deviations or rates did not contribute significantly to reduction of panoramic photographic quality. A comparison of ideal to actual yaw can be observed in Figure 6-2.
