CORONA J
PERFORMANCE EVALUATION REPORT
MISSION 1105-1 AND 1105-2
FTV 1646, CR-5

17 June 1969

SUBJECT: MISSION 1105 FINAL REPORT (CR-5)

This document constitutes the final payload test and performance evaluation report for Mission 1105 which was launched on 3 November 1968.

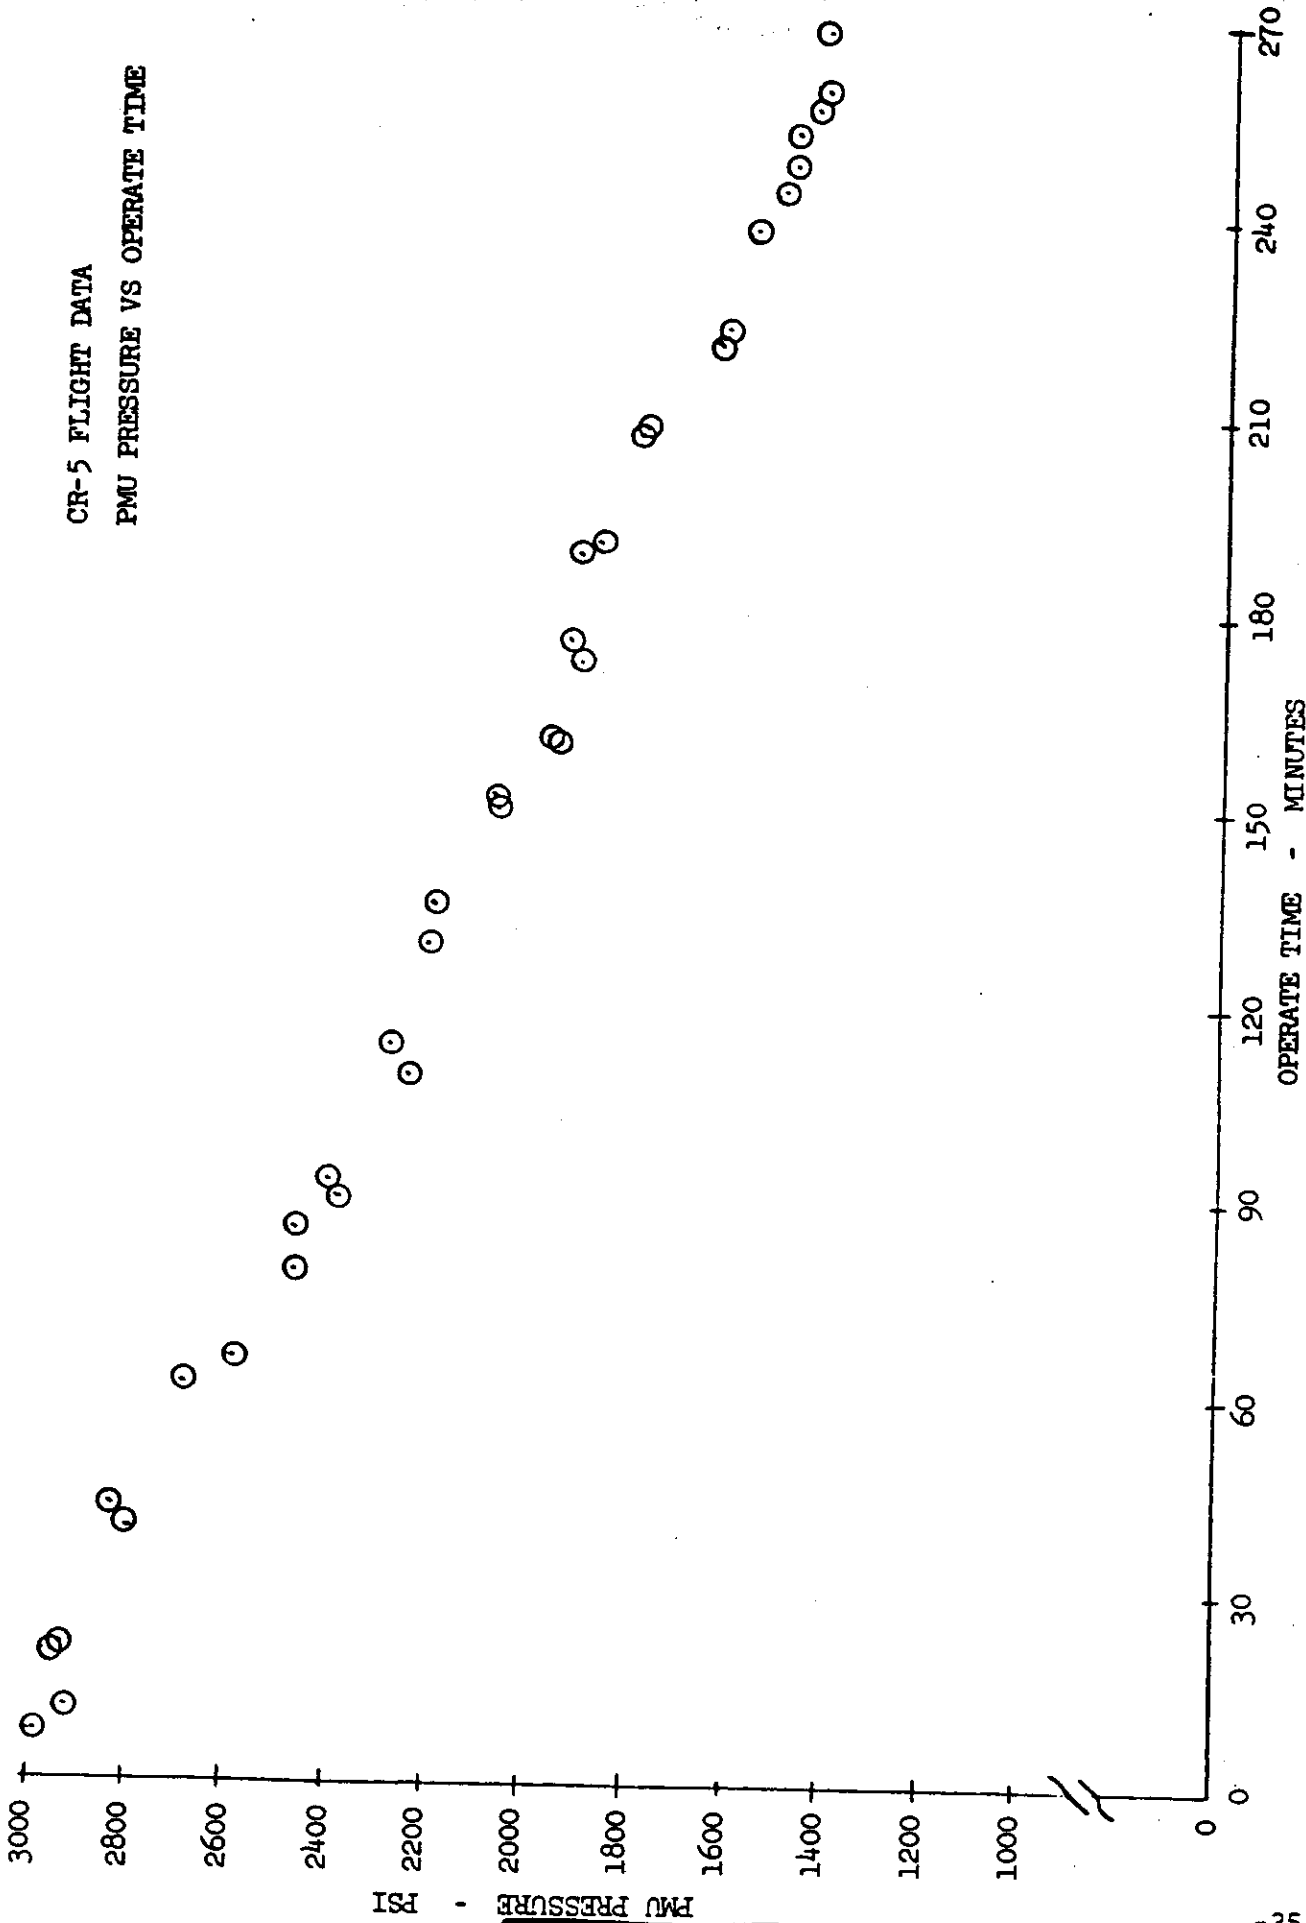
FIGURE 3-7 PMU PRESSURE VS OPERATE TIME

The PMU system on CR-5 was the first dual bottle PMU to be flown on the program. PMU operation was apparently normal with an average gas consumption of 5.90 delta PSI/min. with a total of 267.74 minutes of operation. There was 1420 PSI of gas remaining at the end of the mission. Figure 3-7 shows a plot of the PMU gas consumption versus operate time.
