CORONA J
PERFORMANCE EVALUATION REPORT
MISSION 1107-1 and 1107-2
FTV 1652, CR-7

This report details the performance of the payload system during the operational phase of the Program [REDACTED] Flight Test Vehicle 1652.

This document constitutes the final payload test and performance evaluation report for Mission 1107 which was launched on 24 July 1969.

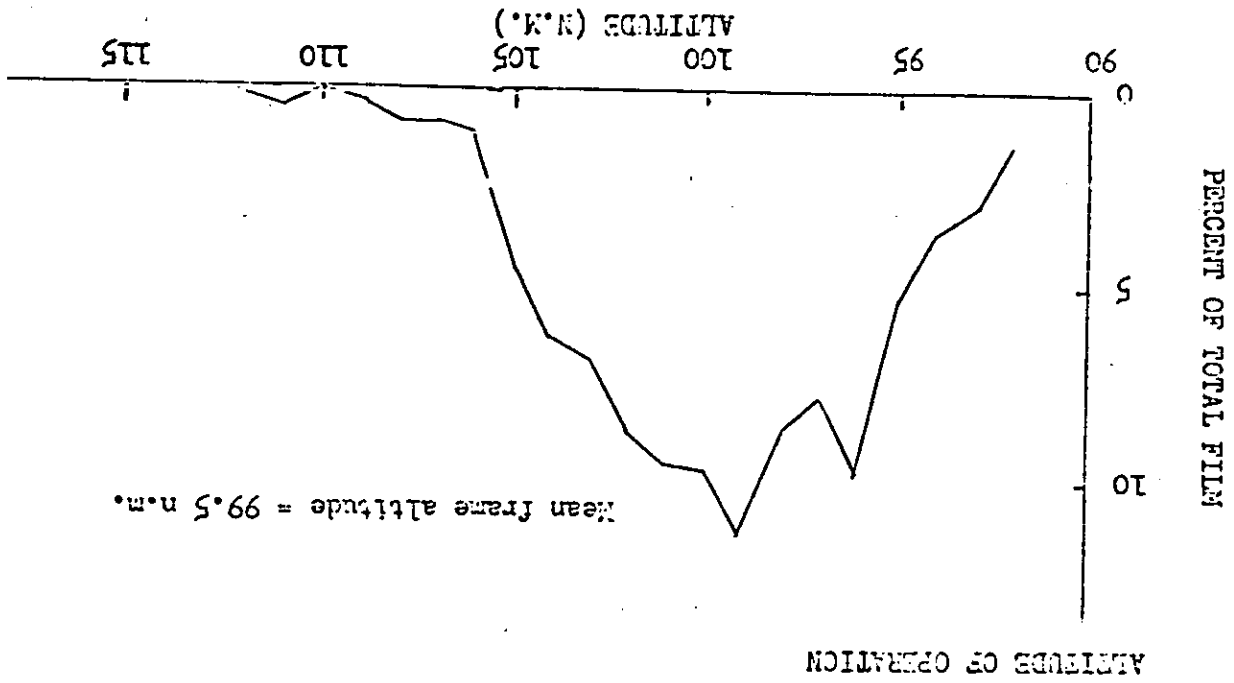
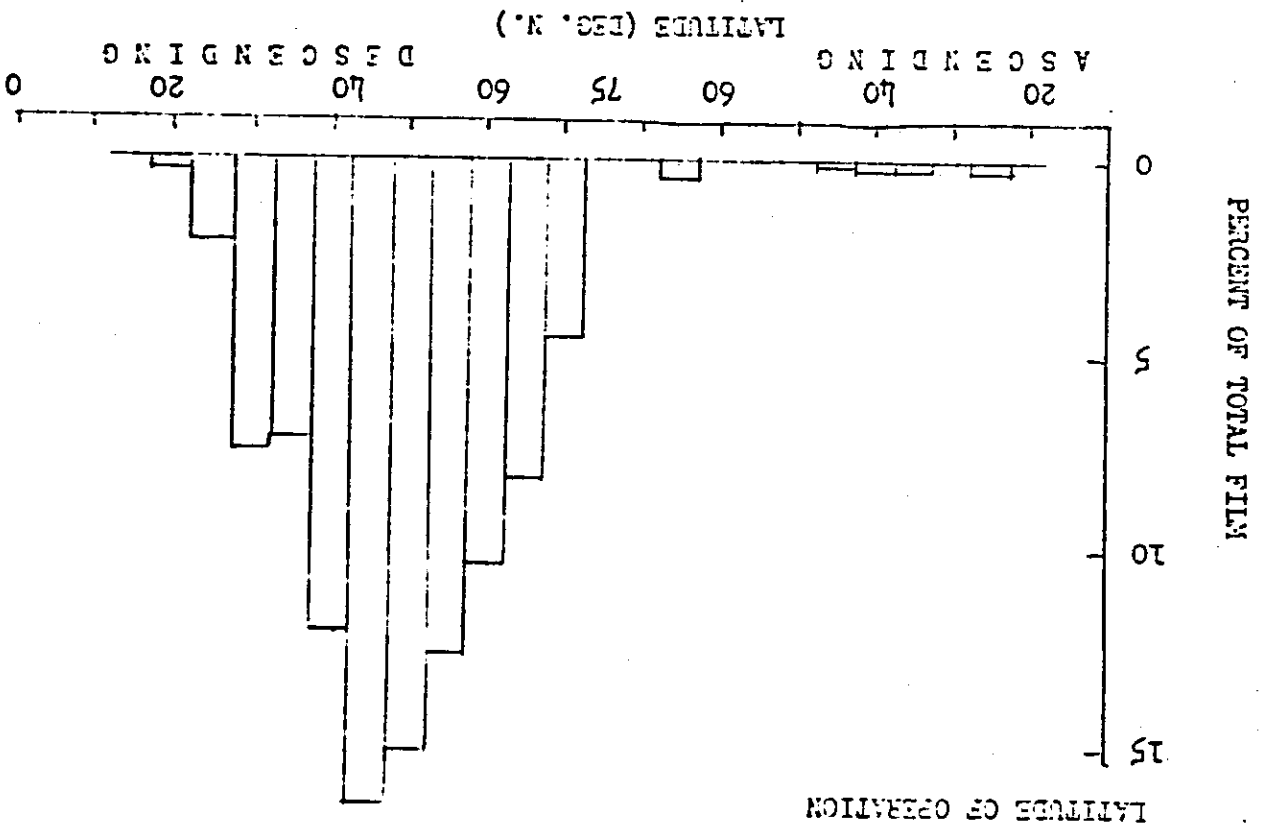
FIGURE 3-2 Location of Pan Camera Operations

nominal at Rev. 299 where the last operation was taken. Figure 3-1 shows the orbit history maintained throughout the mission. A summary of the DMU firings is shown in Table 3-2. Figure 3-2 shows the frequency distribution of operations and mean frame altitude of Mission 1107.

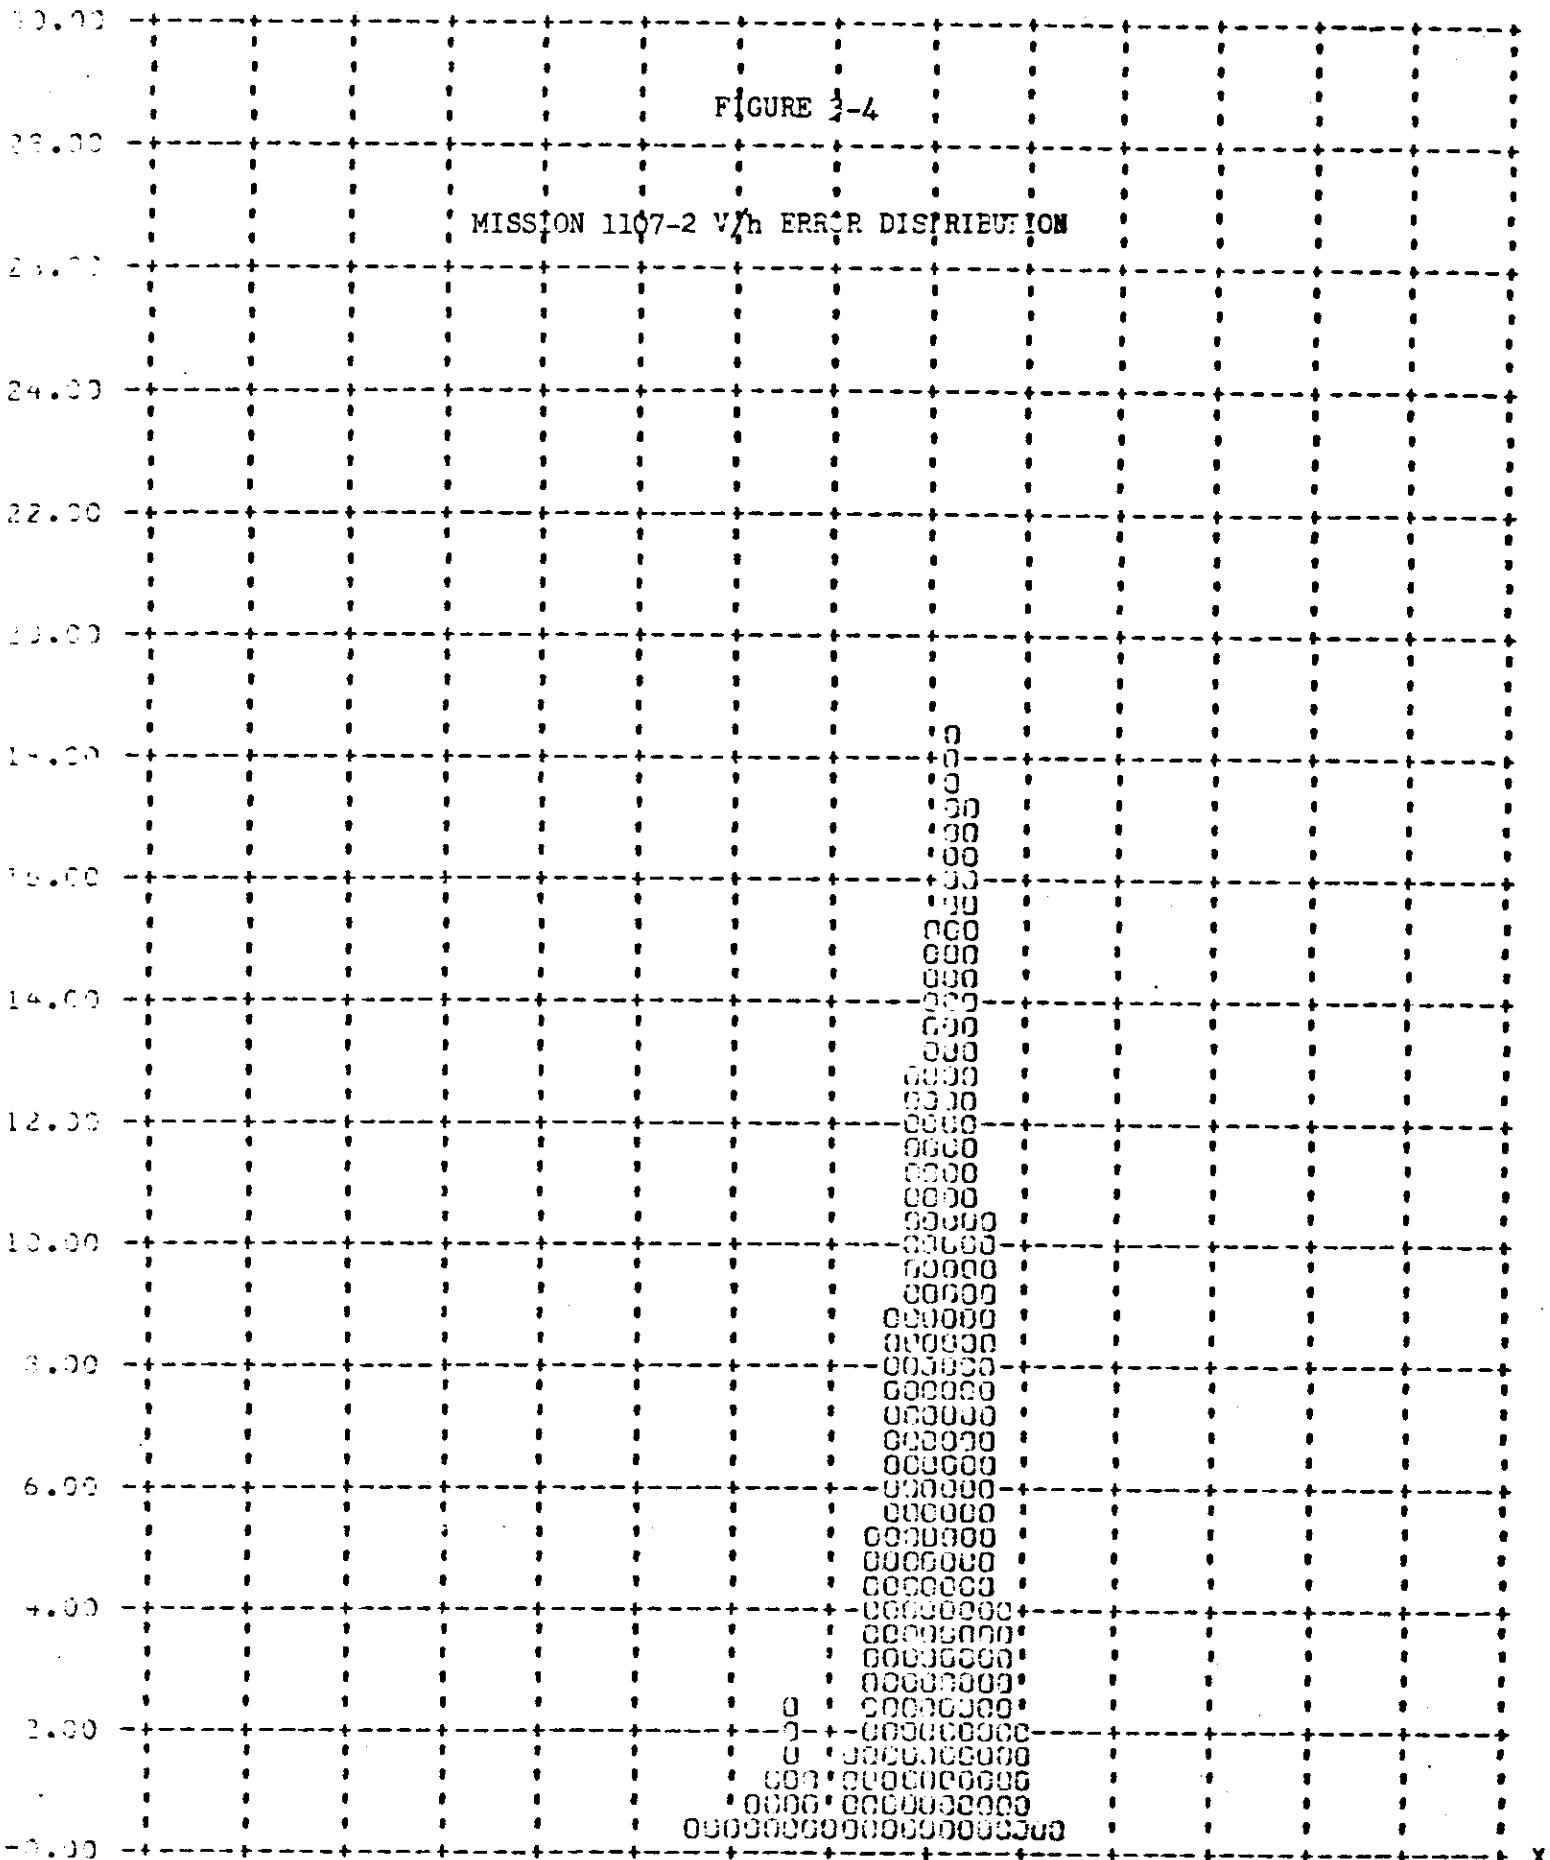
FIGURE 3-4

A satisfactory ramp-to-orbit match was maintained during both missions of the flight. Except for Revs. 1-8 and 23-25, the V/h mismatch was kept within plus or minus one percent for 95 percent of the frames taken. The ramp-to-orbit match is maintained by selecting the best combinations of start, half-cycle, and delay positions. The exceptions to accurate orbit matching mentioned above were due to use of incorrect orbit data. The V/h match performance is shown in Figures 3-3 and 3-4.

MISSION 1107-2 V/h ERROR DISTRIBUTION
