CORONA J

PERFORMANCE EVALUATION REPORT

MISSION 1050-1 and 1050-2

FTV 1651, J-43

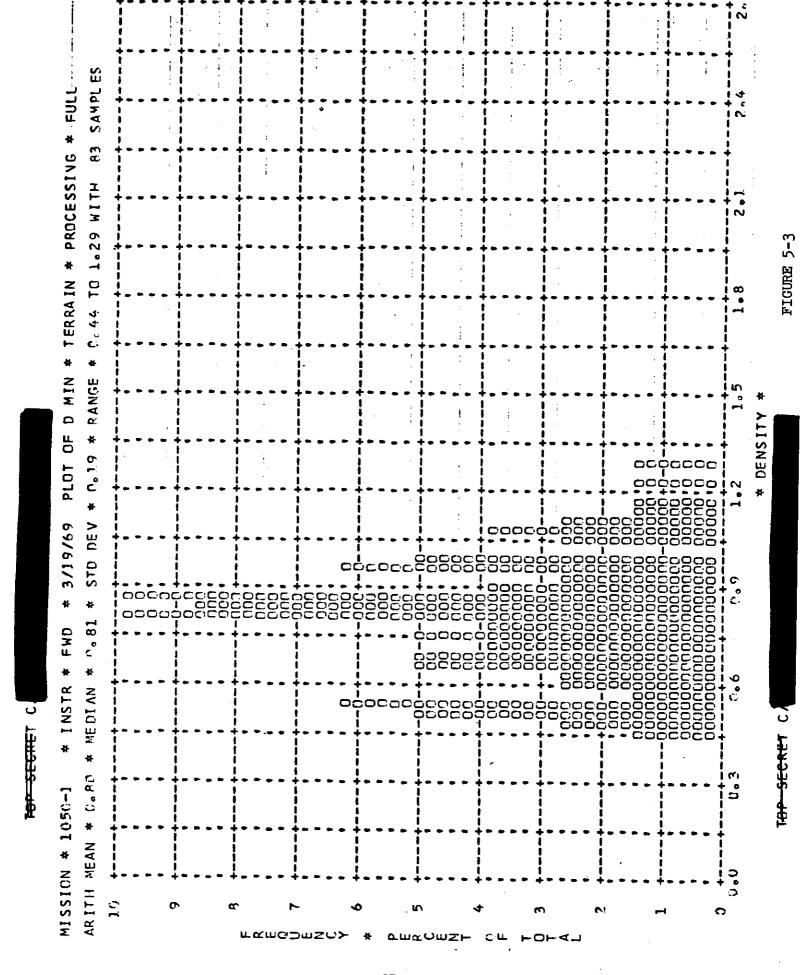
FIGURE 5-5

Representative terrain D-min, D-max values for Mission 1050-1 thru Rev. 22, fwd and aft cameras, are shown in Figures 5-3 to 5-6.
