CORONA J

PERFORMANCE EVALUATION REPORT

MISSION 1106-1 and 1106-2

FTV 1630, CR-6

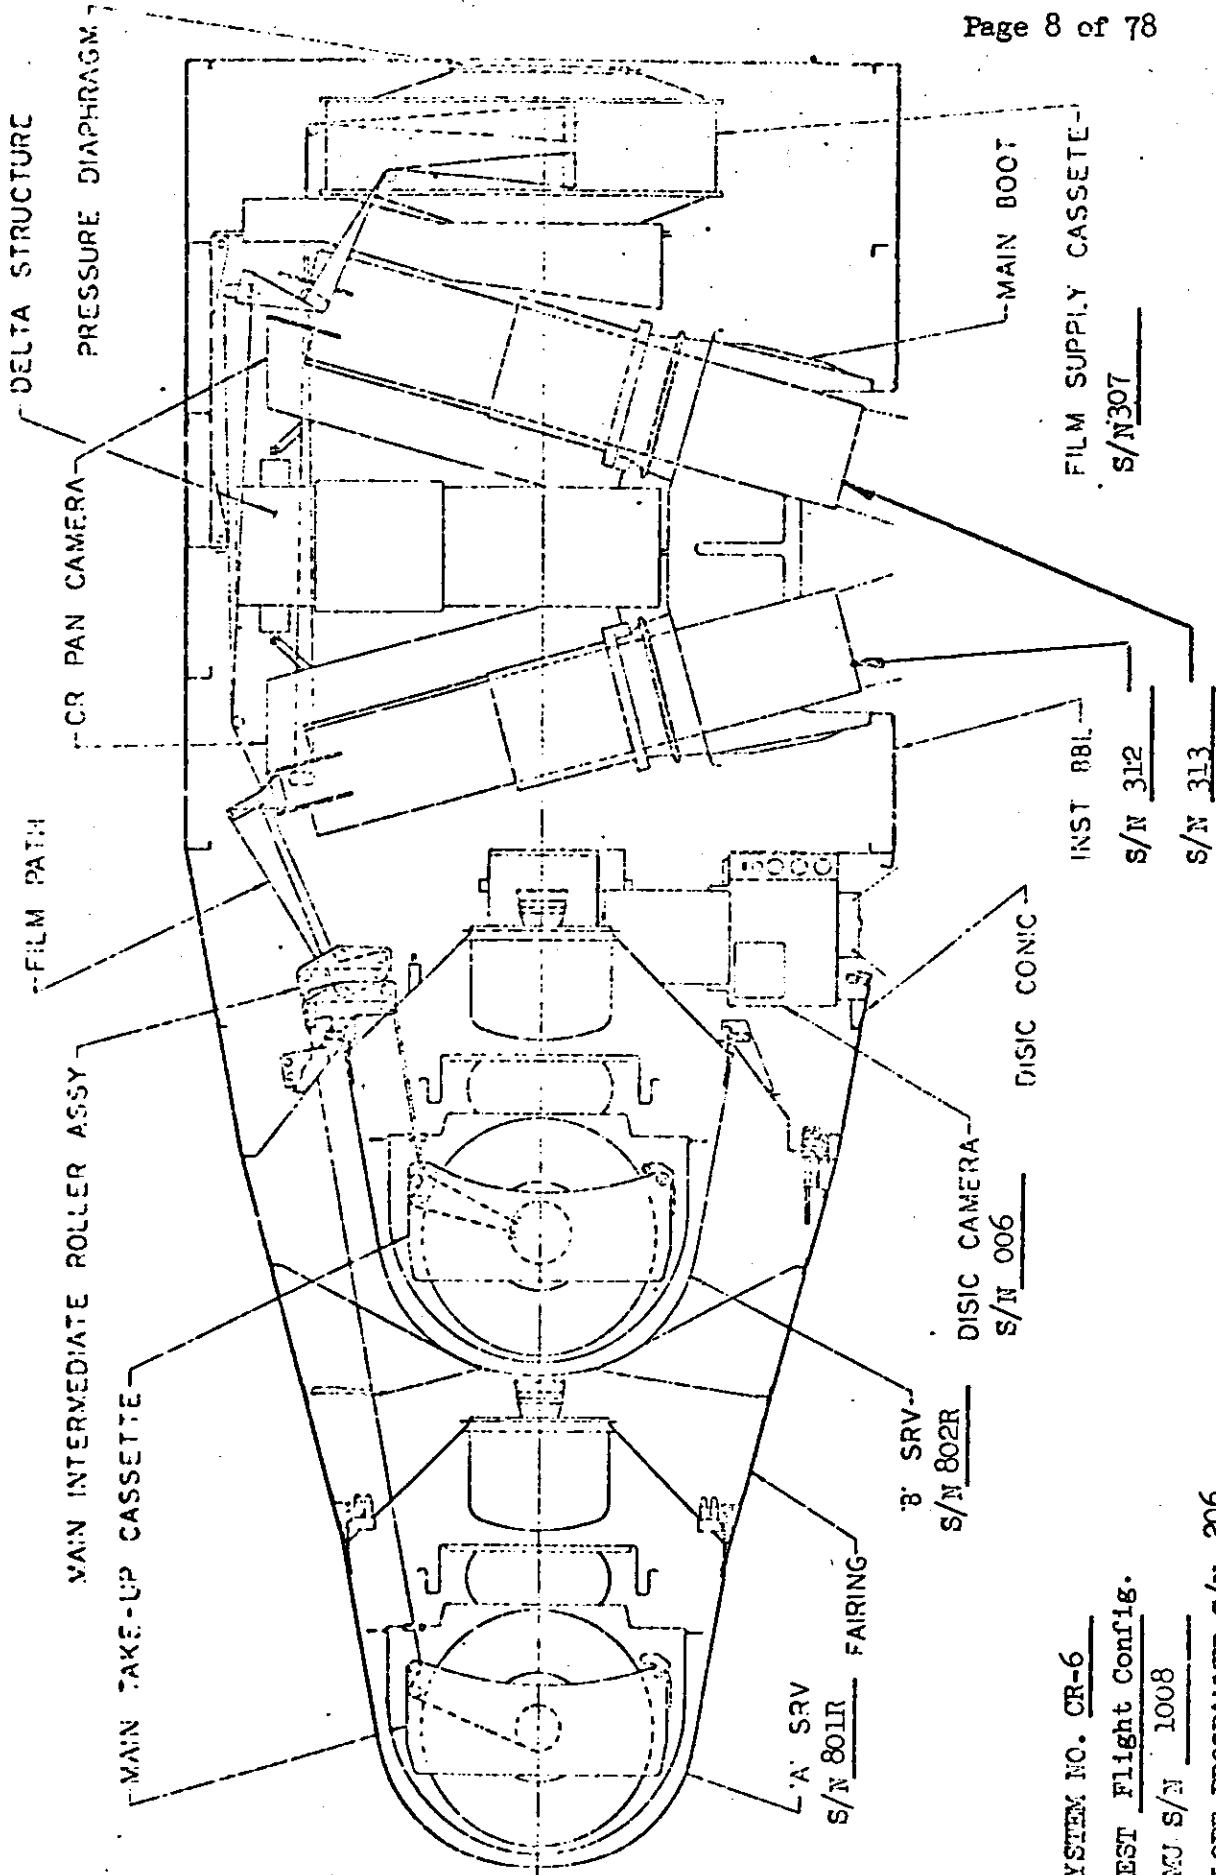
FIGURE 1-1

The payload section of Mission 1106, placed into orbit by Flight Test Vehicle 1650 and THORAD Booster #519, consisted of two panoramic cameras, one DISIC camera, two Mark 5A recovery capsules and a space structure to enclose the cameras and provide mounting surfaces for all equipment. Figure 1-1 presents an inboard profile of the CR-6 payload system. The Corona "J" system is designed to acquire search and reconnaissance photography of selected areas of the earth from orbital altitudes. An eight day -1 mission and a seven day -2 mission was planned.

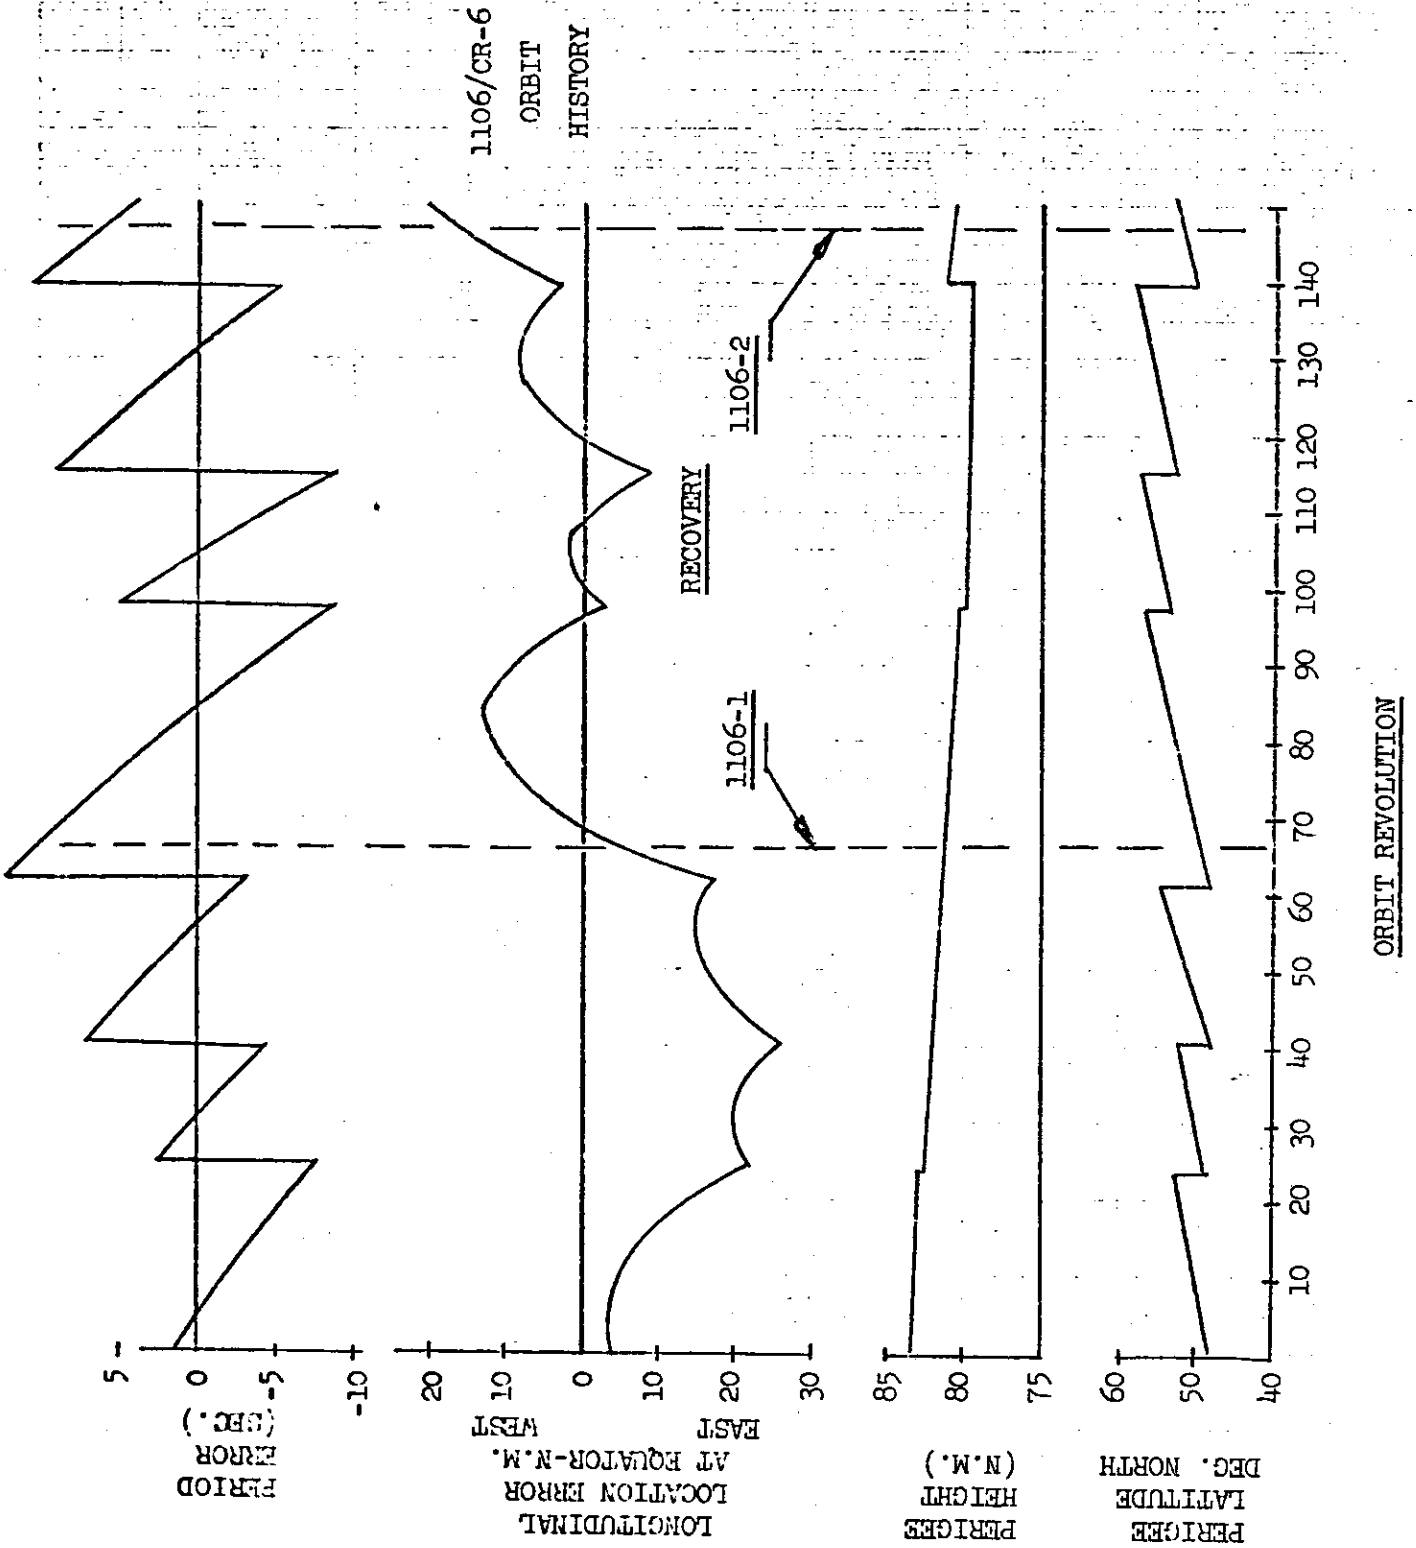
FIGURE 3-1

Figures 3-1 and 3-2 are plots of orbit history and operation distribution data.

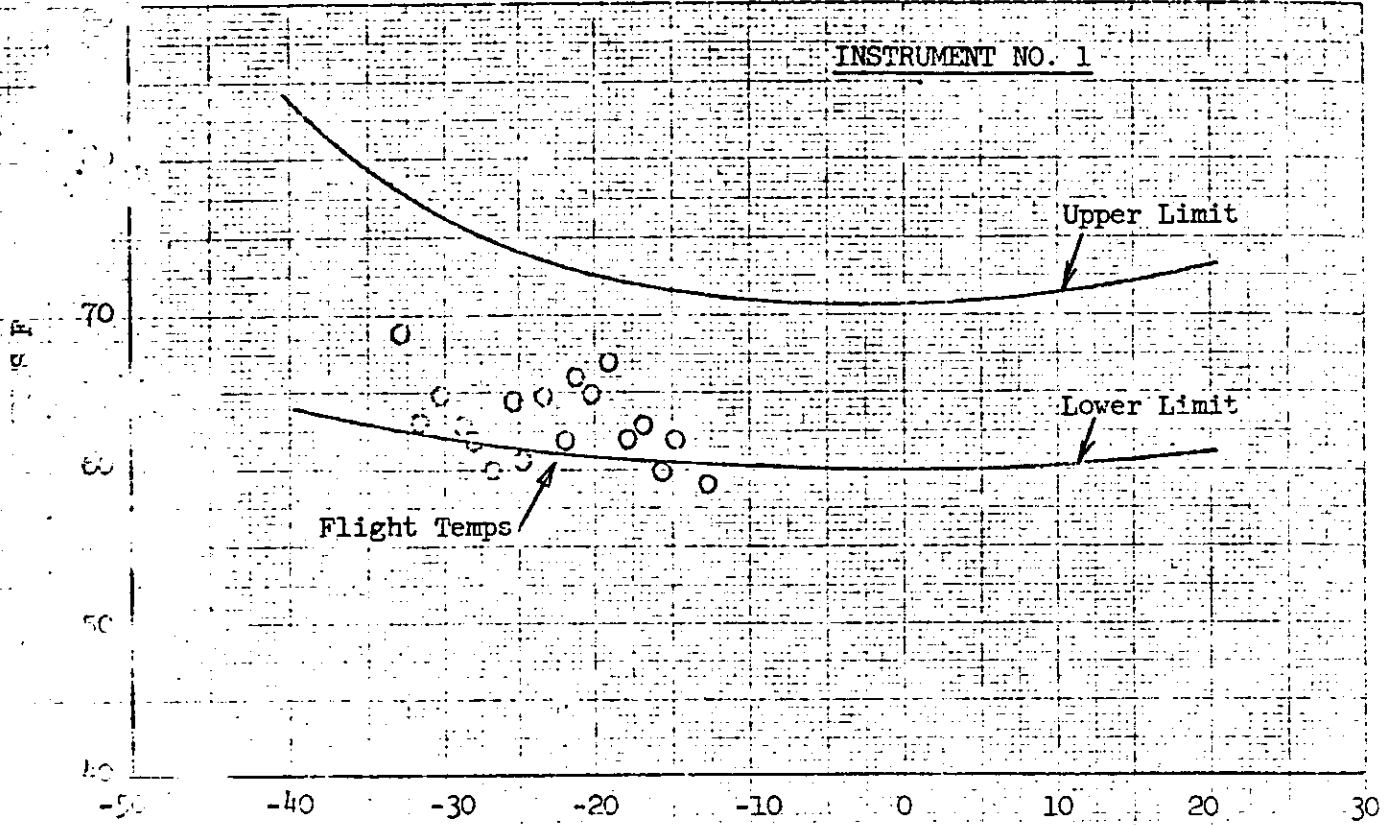
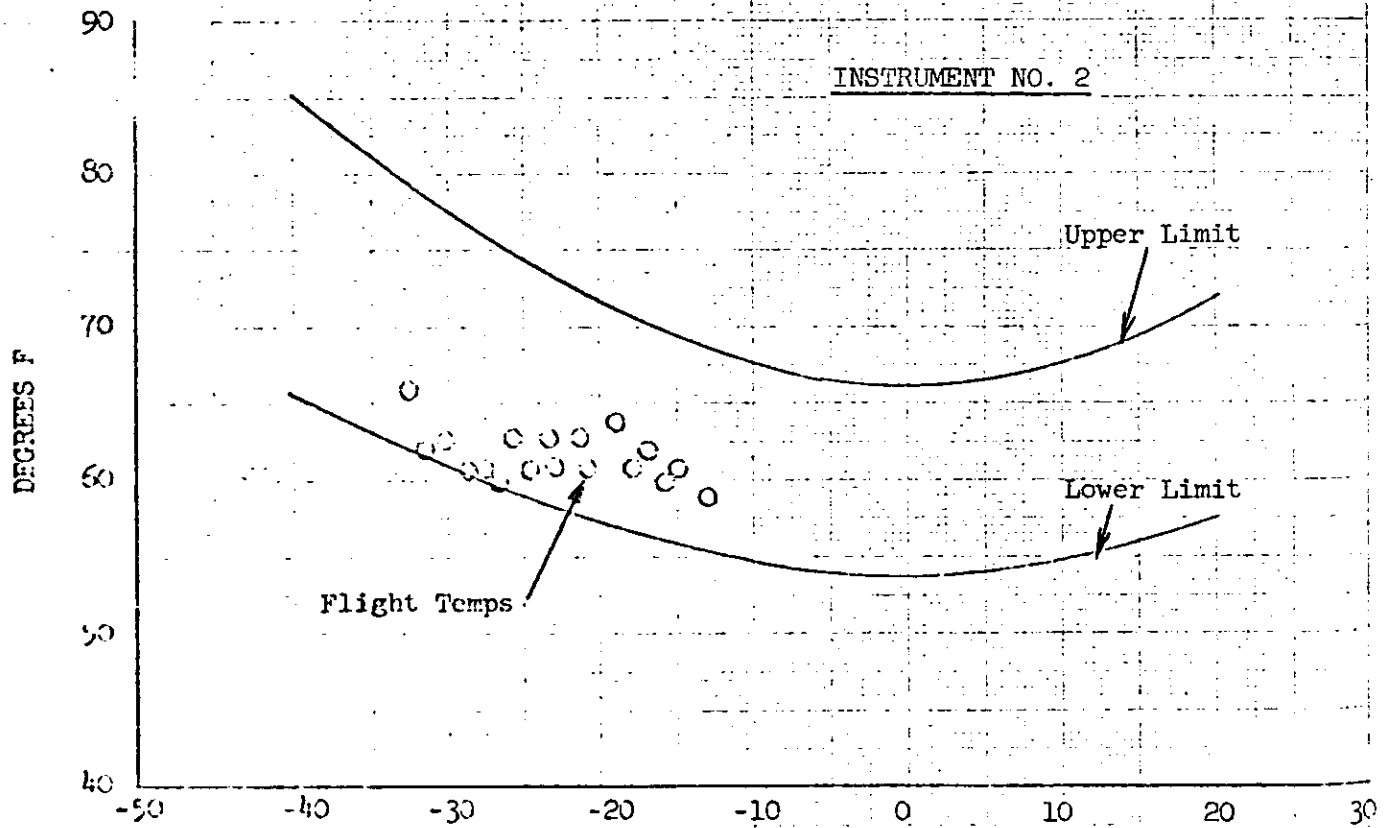
SPACE INSTRUMENT TEMPERATURES VERSUS BETA ANGLE

Temperature data acquired by the [REDACTED] tracking station show that panoramic camera temperatures were within the specified envelope. A modified paint pattern and increased lens insulation were utilized on this mission. The resulting thermal environment was the best ever obtained. The forward looking instrument had an average instrument temperature of 63 plus or minus 3 degrees F throughout both missions. The thermal gradient on the lens cell was approximately 4 degrees F and transients were plus or minus 1 degree F. The aft looking instrument had an average instrument temperature of 64 plus or minus 5 degrees F throughout both missions. The thermal gradient on the lens cell was approximately 2 degrees F and transients were plus or minus one degree. Figures 3-8 and 3-9 show each instrument's rail temperature for rev 8 and rev 137. Figure 3-7 shows a graphical plot of the actual average camera temperatures versus the predicted temperature as a function of the beta angle in degrees.
