CORONA J
PERFORMANCE EVALUATION REPORT
MISSION 1110-1 and 1110-2
FTV 1656, CR-11

This report details the performance of the payload system during the operational phase of the Program [REDACTED] Flight Test Vehicle 1656.

Lockheed Missiles and Space Company has the contractual responsibility for evaluating payload performance. This document is the final payload test and performance evaluation report for Mission 1110-1 and 1110-2 which was launched on 20 May 1970.

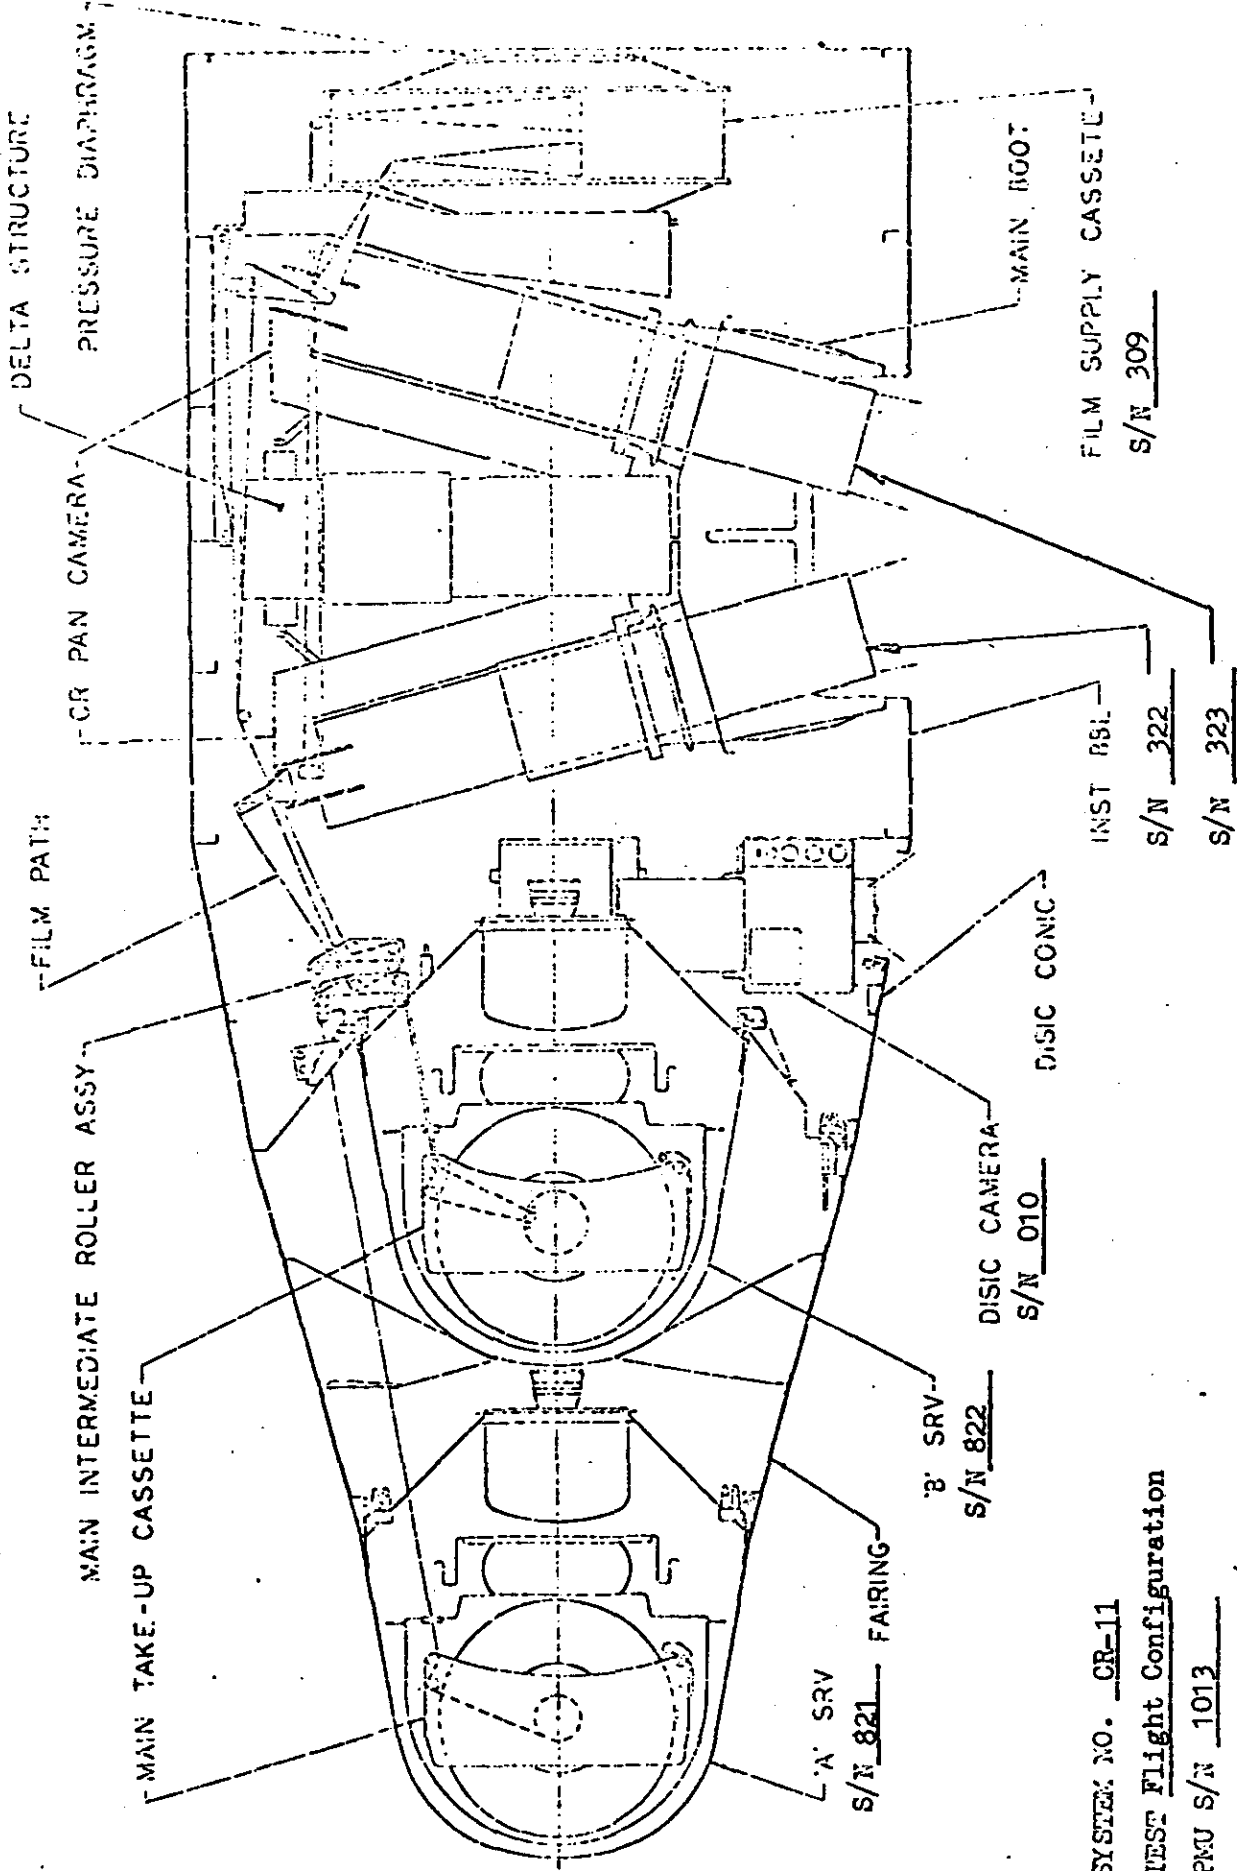
FIGURE 1-1

- SYSTEM NO. CR-11
- TEST Flight Configuration
- PMU S/N 1013
- SLOPE PROGRAMMER S/N 211
- CLOCK S/N 624
- SWITCH PROGRAMMER S/N 213
