MISSION 1201

SYSTEM
PERFORMANCE EVALUATION TEAM
MISSION 1201

27 SEPTEMBER 1971

PERFORMANCE EVALUATION TEAM
REPORT NO. 1201/71

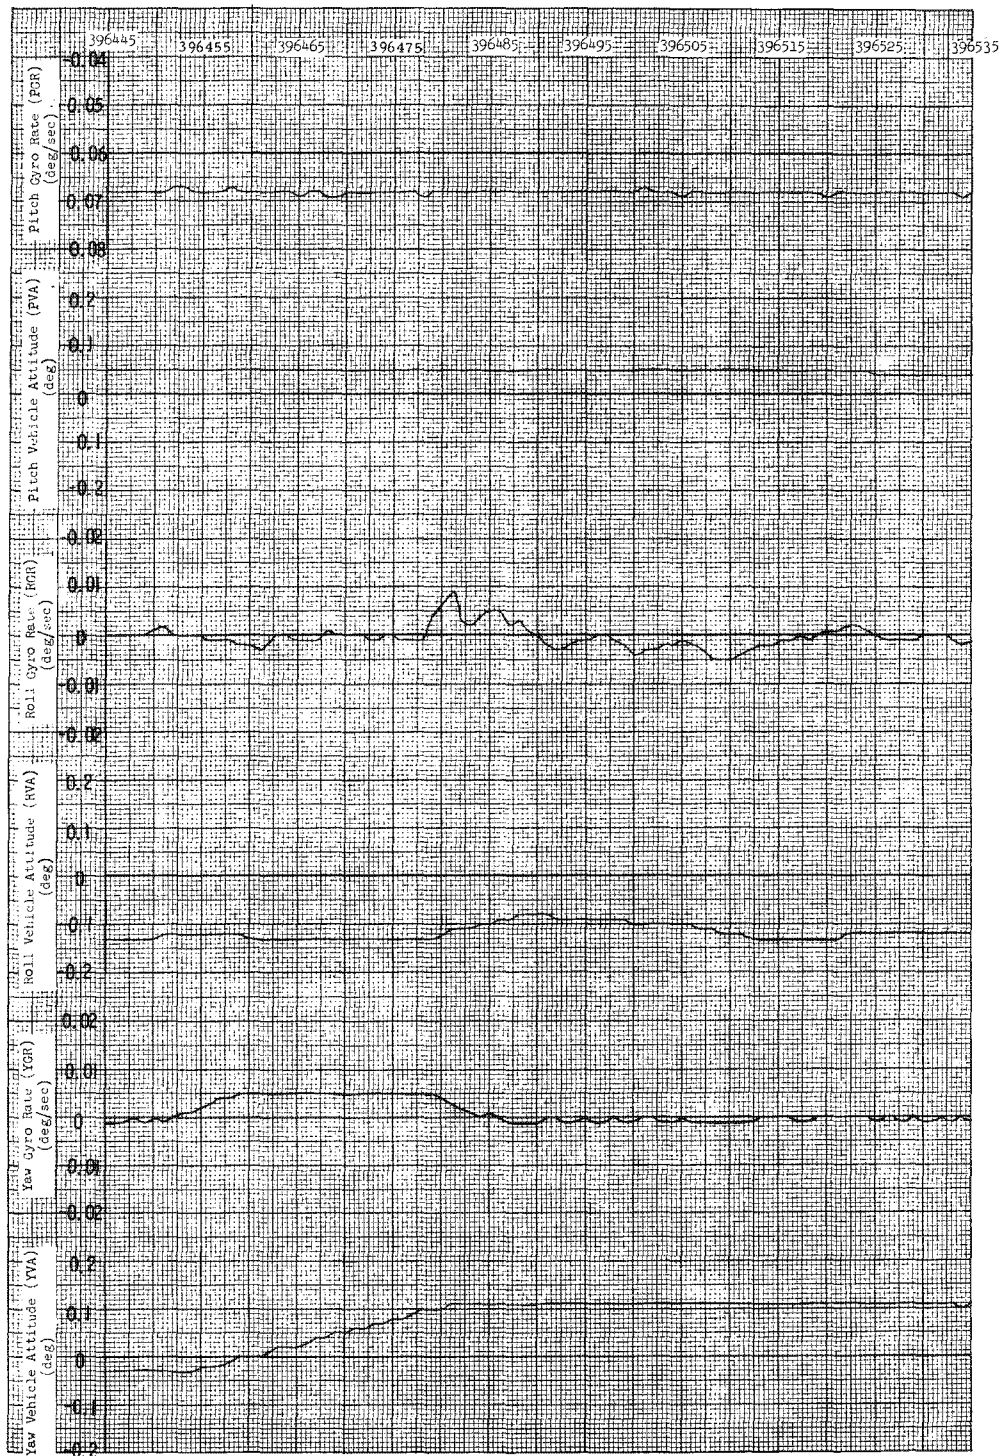
FIGURE 2-1a

A time history of the vehicle attitude and rates for a typical stereo operation are shown in Figure 2-1 (2 pages). Figure 2-2 (1 page) contains vehicle attitude control data for a payload Emergency Shut Down (ESD), while Figure 2-3 (6 pages) illustrates the system performance observed for RV-1 pitch down (PDWN) and RV separation. A compilation of vehicle attitude and rates for all typical maneuvers has been compiled and will be published as an Aerospace report (Attitude Control System Maneuver Histories) in the near future.

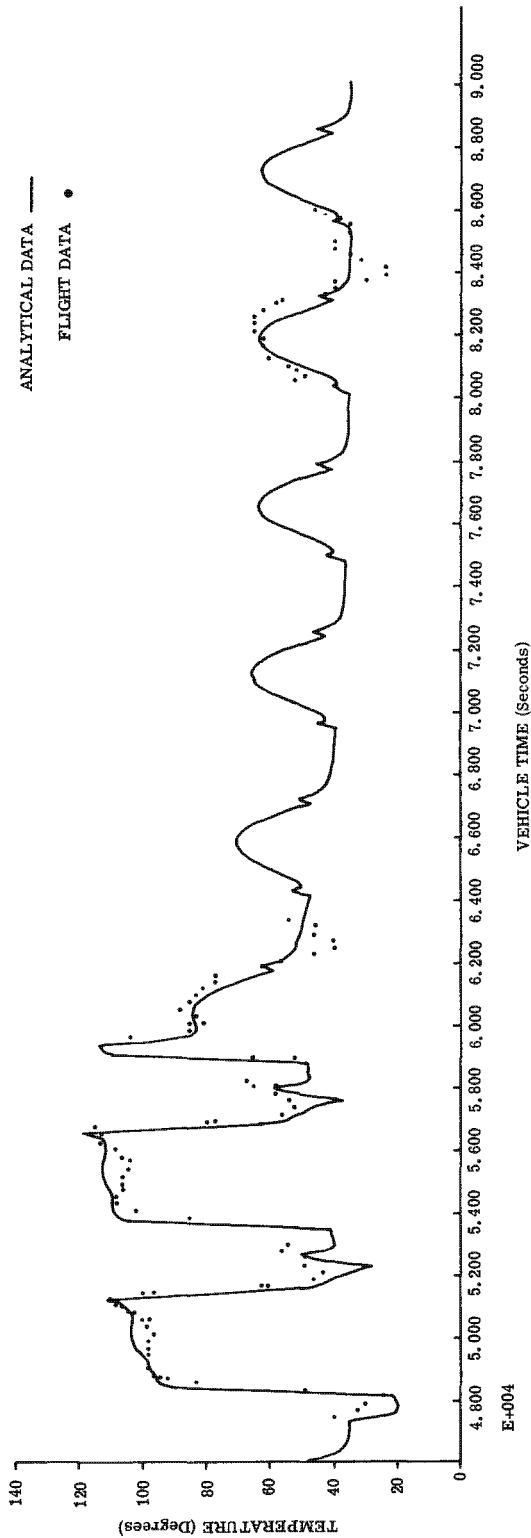
FIGURE 5-2

Analyses of the magnitude of contamination have been made for Bays 1, 6, 8, and 12. In Figure 5-2, a comparison of analytical model predictions and flight data indicate a solar energy absorption (α_s/ϵ) of 0.43/0.90 for Bay 6. In addition, a comparison of analytical versus flight data for Bay 8 (Figure 5-3) shows good correlation to Bay 6 results with a α_s/ϵ of 0.60/0.90. From the fly-reverse experiment, the data correlated with a value of solar absorptivity of 0.75 for the white paint. A comparison of flight data and analytical results with respect to the absorptivity is shown in Figure 5-4 and Figure 5-5 for Bays 1 and 2 respectively. The expected characteristic of the white paint is $\alpha_s = .18$, thus significant increases were noted over the entire Aft section.

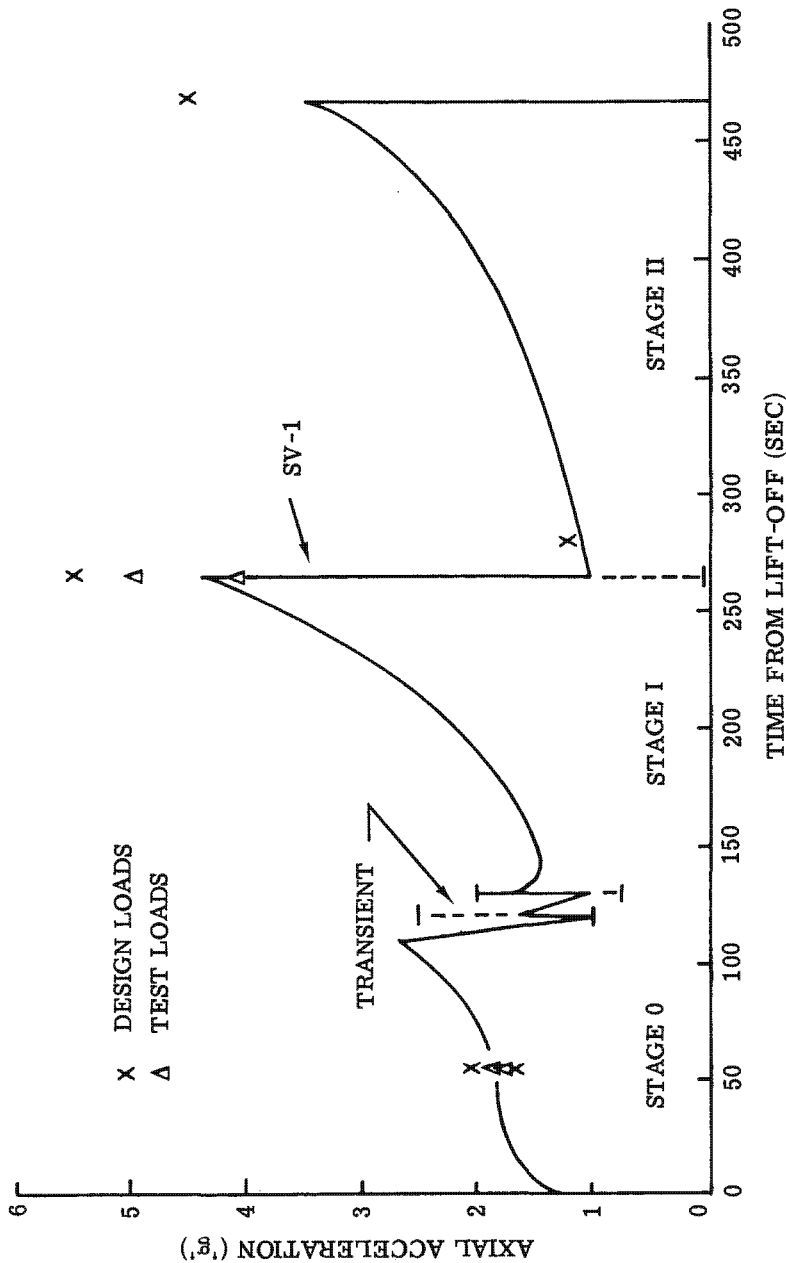
FIGURE 6-1

The axial accelerations were measured at Station 1642 and 2180 and are shown in Fig. 6-1 along with the design and static test levels for the complete ascent. The significant dynamic acceleration levels (measured on the SV forward bulkhead at Station 1642) are presented in Table 6-3.

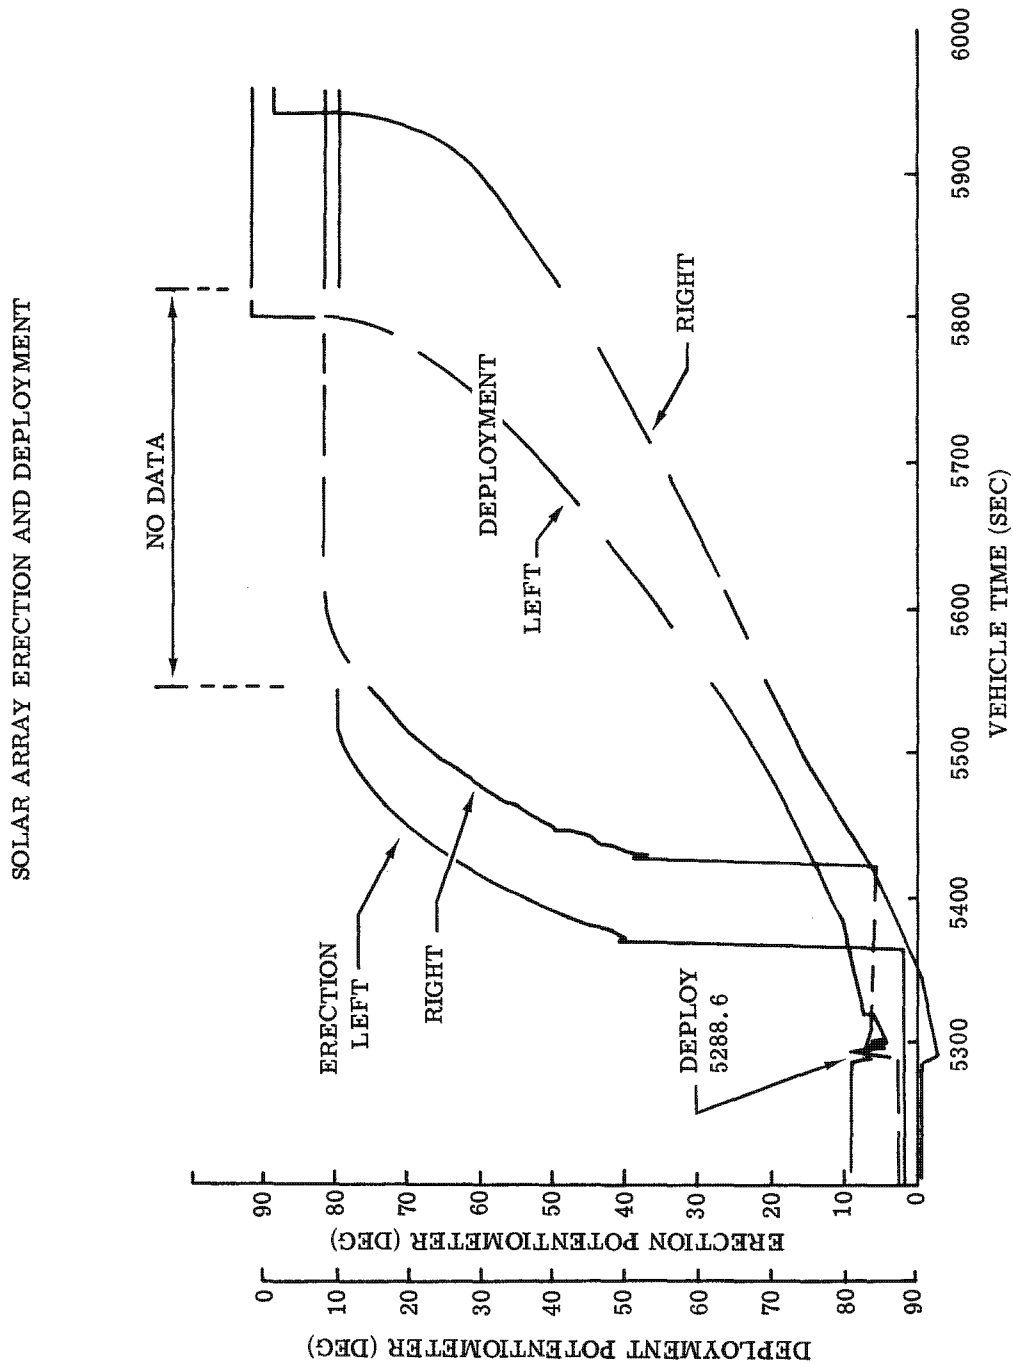
FIGURE 6-3

The history of the solar array erection and deployment are shown in Fig. 6-3. Since the arrays were deployed and erected in the proper position for this flight's beta angle, no positioning was necessary and none was performed.

Data exists to describe completely the erection of the left solar array and it was completed 230 sec after deployment was commanded. Only partial data is available for the other motions; however, data for the final portion of the deployment of the right array permits probable histories for all the motions to be sketched in on Fig. 6-3. It is estimated that the right solar array erected in 320 sec. The time for the right deployment was 650 sec and the time for the left deployment is estimated at 510 sec. Temperatures of the left and right erection dampers were 63° and 65°F respectively. The right array also took longer to erect and deploy during ground tests.
