Performance Evaluation Team Report

MISSION 1204

SYSTEM
PERFORMANCE EVALUATION TEAM
MISSION 1204

PERFORMANCE EVALUATION TEAM
REPORT NO. 1204/73

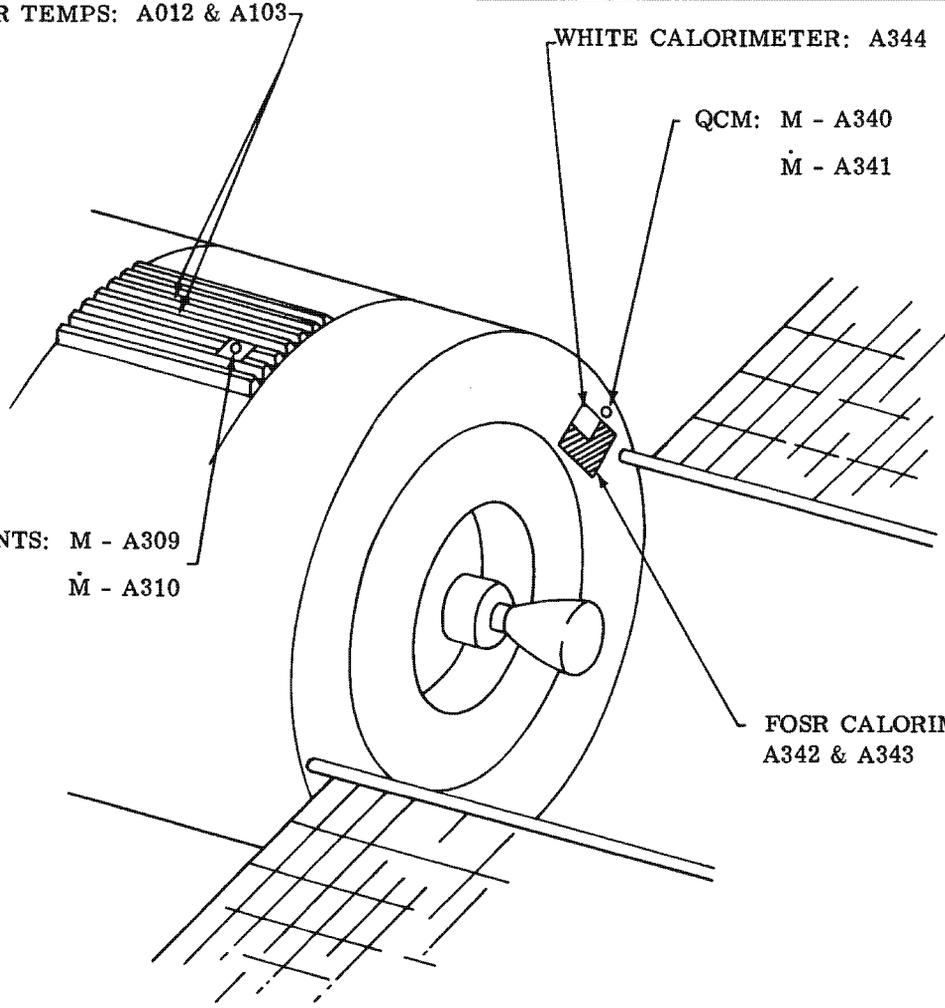
FIGURE 3-4

Additional contamination experiments were flown on SV-4 to measure two distinct contamination environments. The first group of experiments, installed on Bay 12 of the Aft-section as shown in Figure 3-4, were designed to measure the ascent contamination in terms of mass deposit and the effect of this mass deposit on the surface properties of flexible optical solar reflector (FOSR). Note that the blowoff shield was not used, as on SV-2 and SV-3, to isolate the effects of the ground lift-off cloud. Note also that the quartz crystal microbalances (QCM) have a mass rate channel added for this flight as was done for SV-3 to help interpret the readings of the mass channel. The second set of experiments were installed on the Aft bulkhead at Station 2203. These devices were designed to monitor the mass deposit produced by the RV retro motors and to assess the effect of the mass deposit on the surface properties of white silicone paint and FOSR.
