Performance Evaluation Team

MISSION 1201

SYSTEM
PERFORMANCE EVALUATION TEAM
MISSION 1201

PERFORMANCE EVALUATION TEAM
REPORT NO. 1201/71

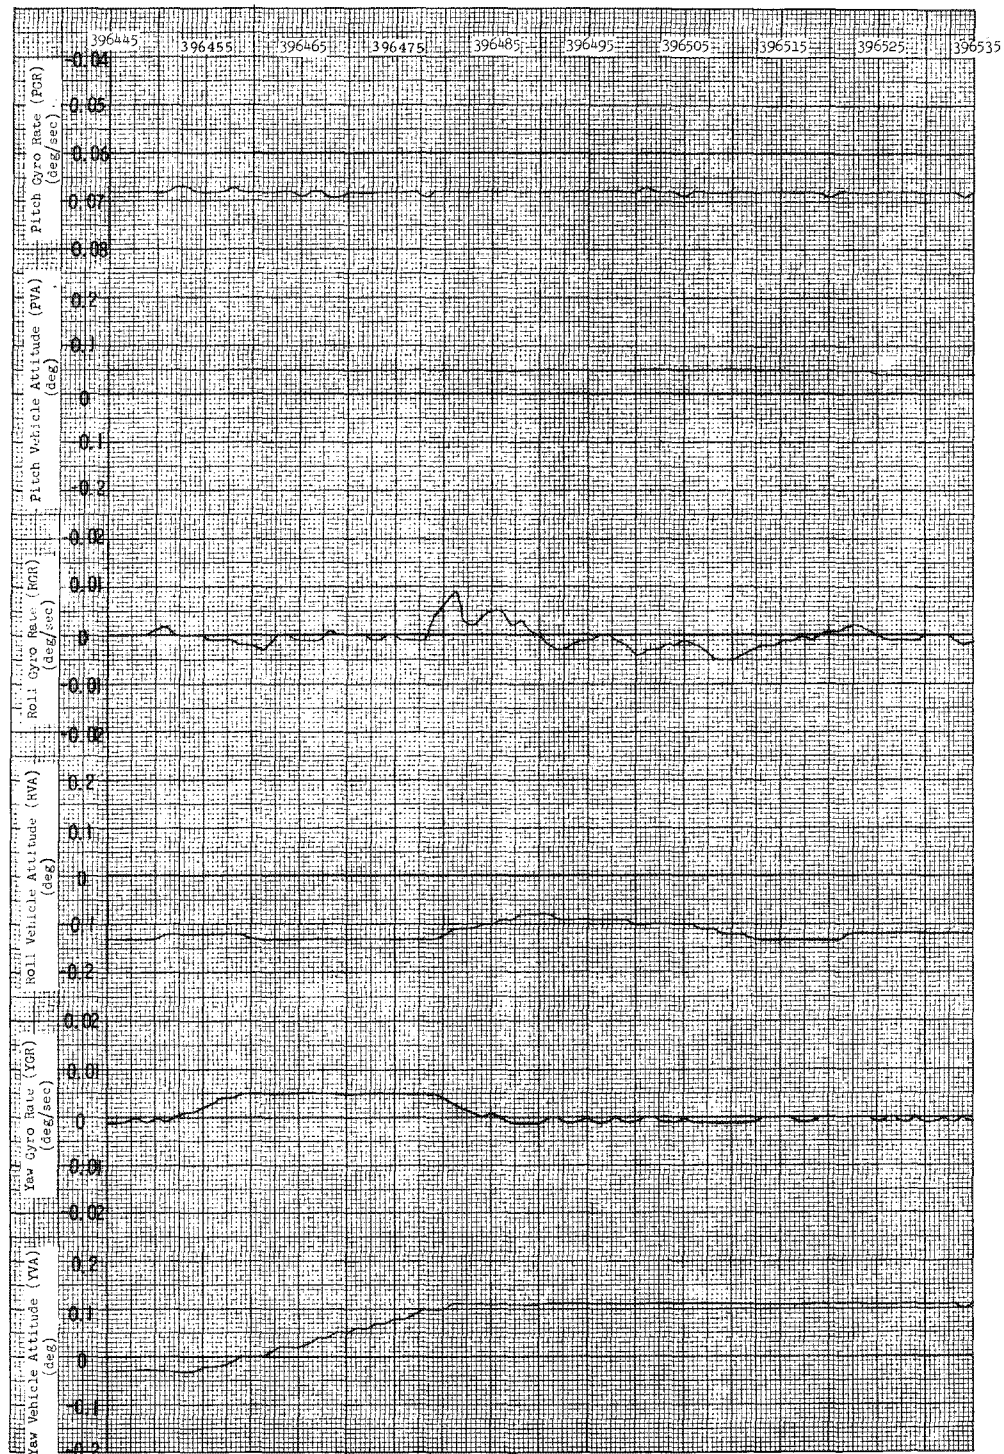
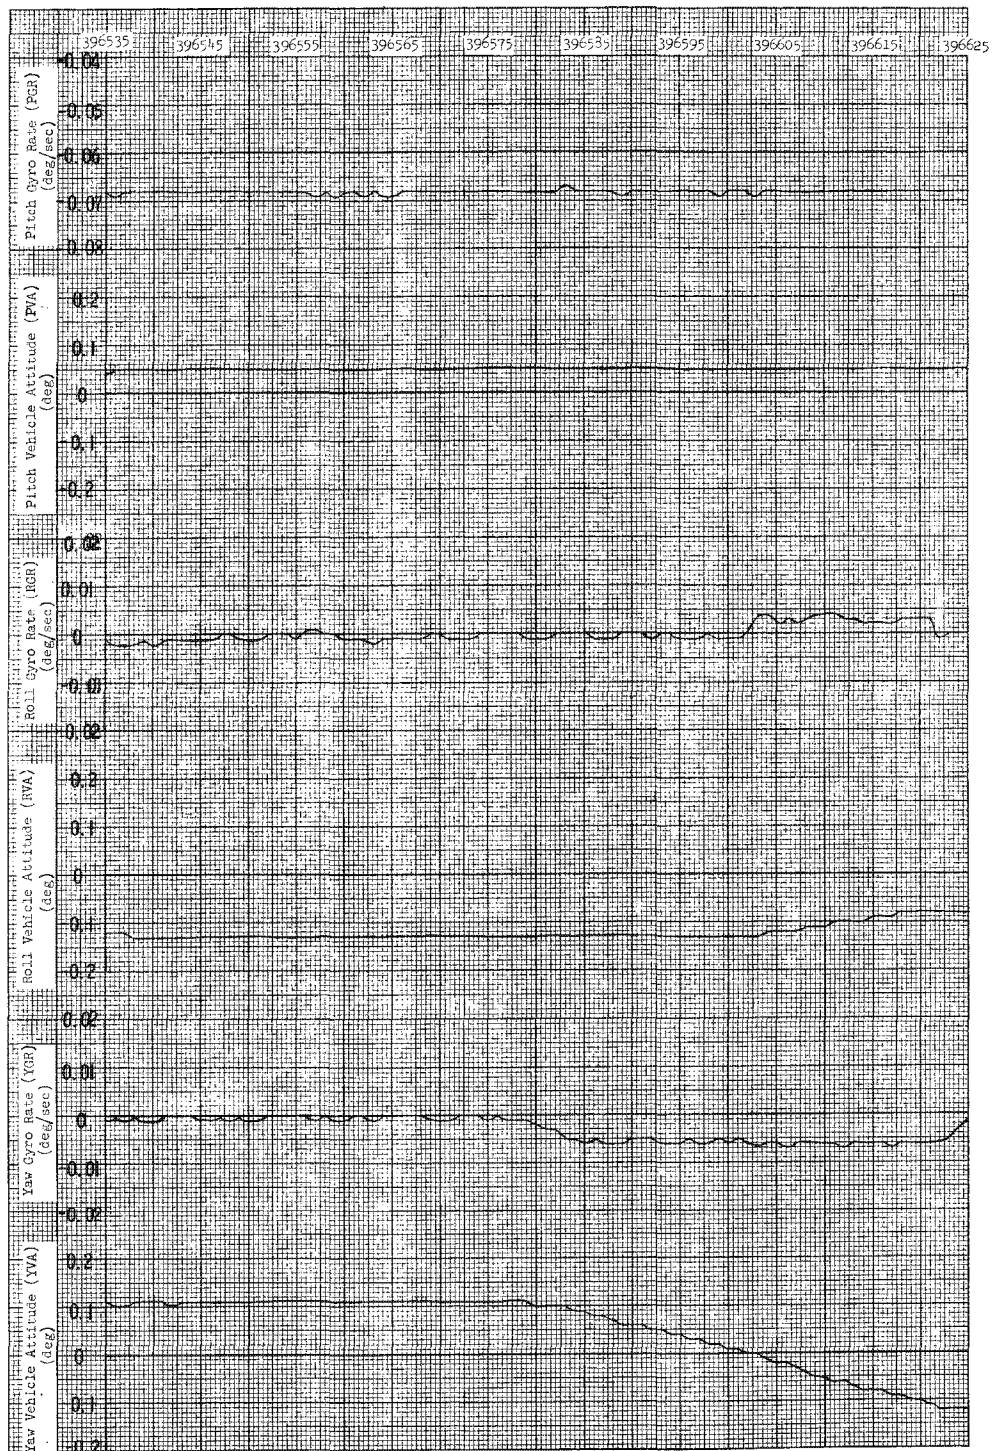
FIGURE 2-1a

A time history of the vehicle attitude and rates for a typical stereo operation are shown in Figure 2-1 (2 pages). Figure 2-2 (1 page) contains vehicle attitude control data for a payload Emergency Shut Down (ESD), while Figure 2-3 (6 pages) illustrates the system performance observed for RV-1 pitch down (PDWN) and RV separation. A compilation of vehicle attitude and rates for all typical maneuvers has been compiled and will be published as an Aerospace report (Attitude Control System Maneuver Histories) in the near future.

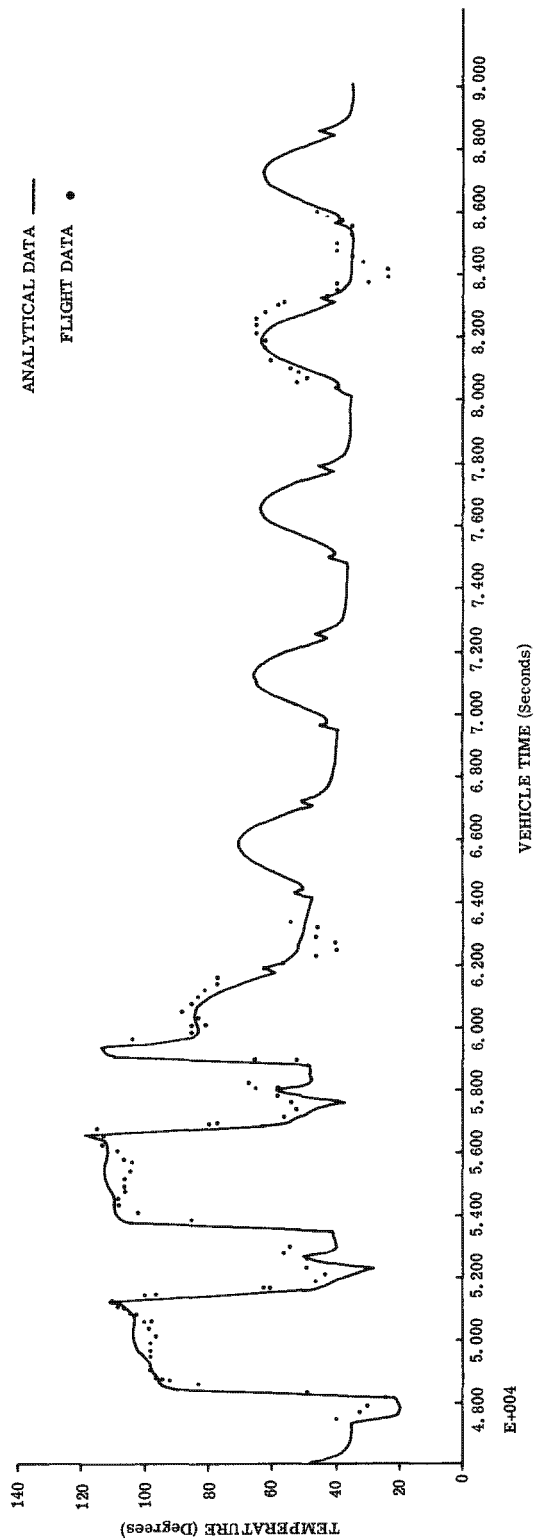
FIGURE 5-2

Analyses of the magnitude of contamination have been made for Bays 1, 6, 8, and 12. In Figure 5-2, a comparison of analytical model predictions and flight data indicate a solar energy absorption (α_s/ϵ) of 0.43/0.90 for Bay 6. In addition, a comparison of analytical versus flight data for Bay 8 (Figure 5-3) shows good correlation to Bay 6 results with a α_s/ϵ of 0.60/0.90. From the fly-reverse experiment, the data correlated with a value of solar absorptivity of 0.75 for the white paint. A comparison of flight data and analytical results with respect to the absorptivity is shown in Figure 5-4 and Figure 5-5 for Bays 1 and 2 respectively. The expected characteristic of the white paint is $\alpha_s = .18$, thus significant increases were noted over the entire Aft section.

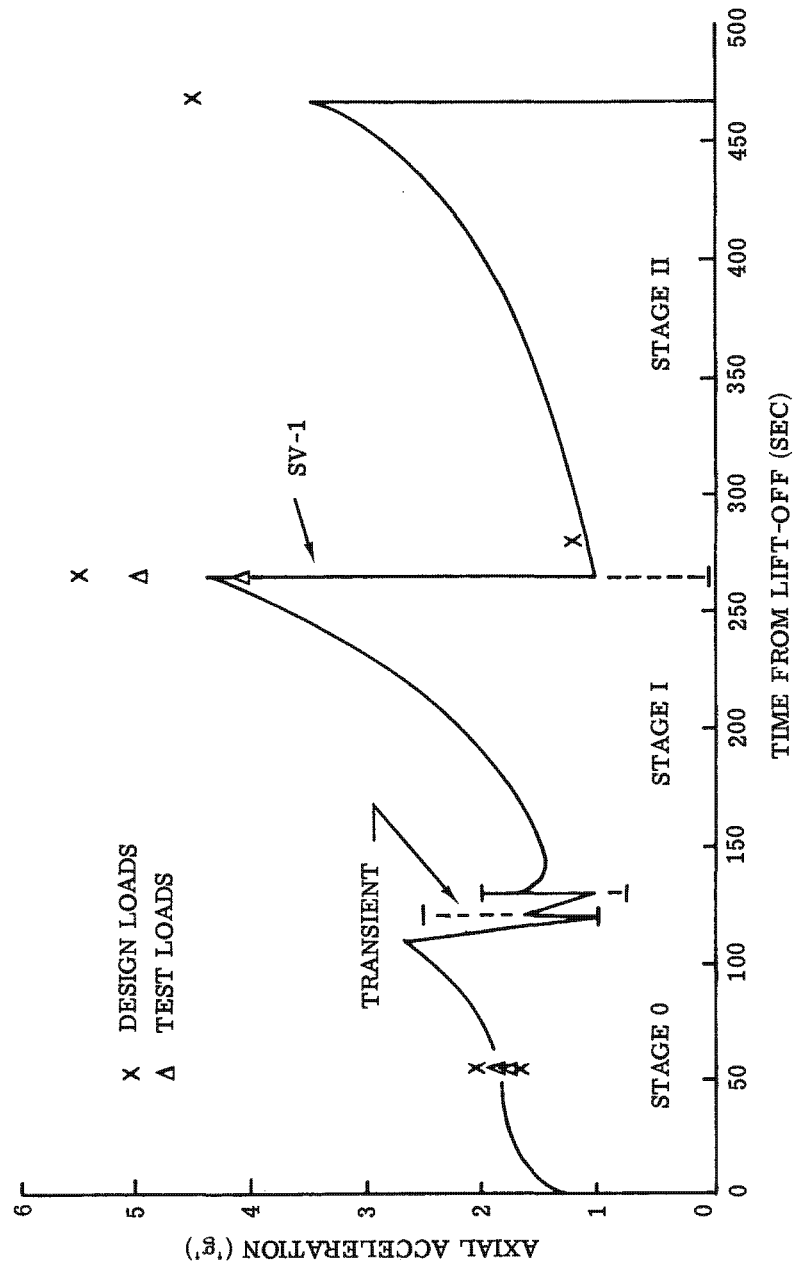
FIGURE 6-1

The axial accelerations were measured at Station 1642 and 2180 and are shown in Fig. 6-1 along with the design and static test levels for the complete ascent. The significant dynamic acceleration levels (measured on the SV forward bulkhead at Station 1642) are presented in Table 6-3.

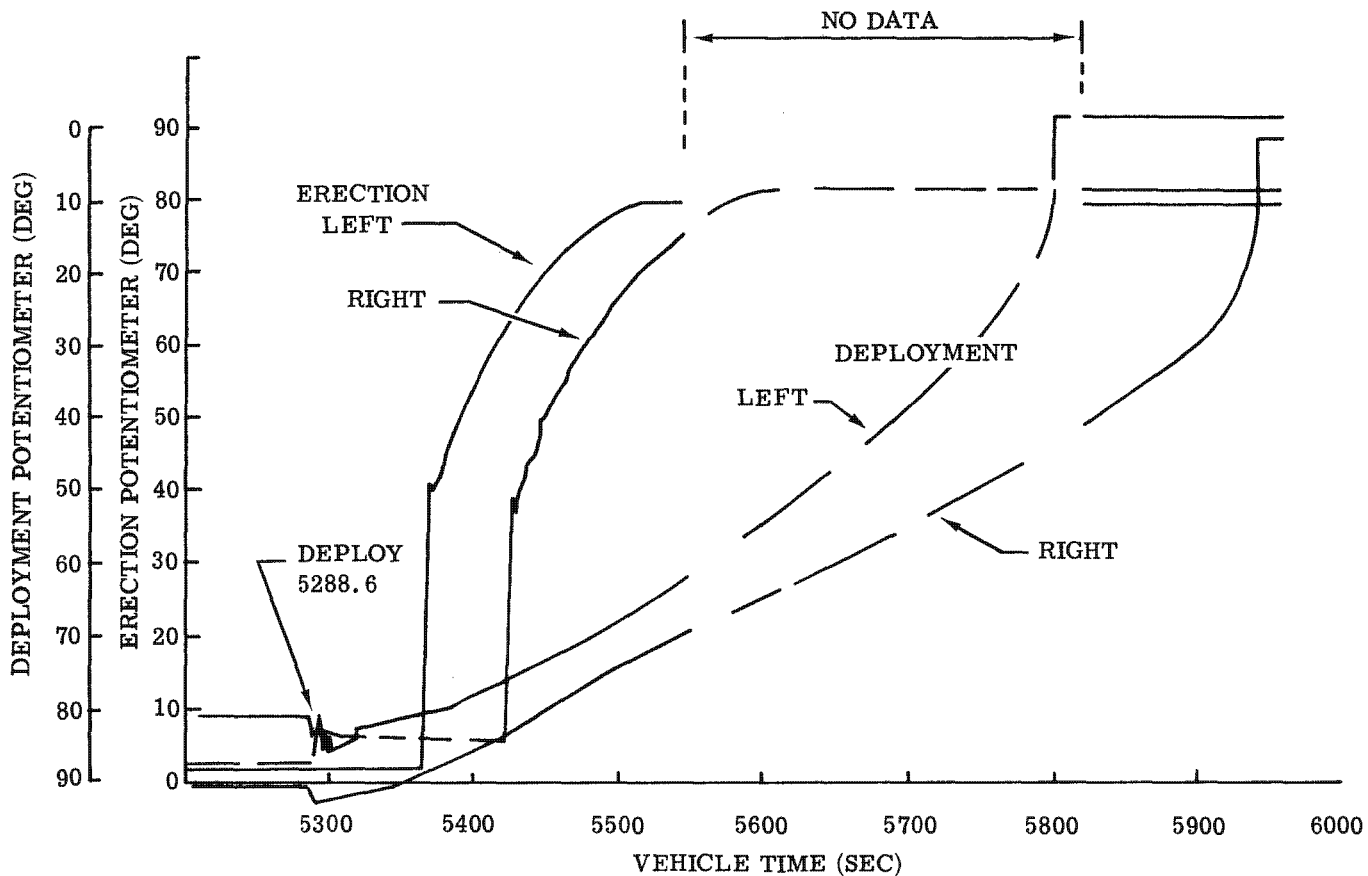
FIGURE 6-3

The history of the solar array erection and deployment are shown in Fig. 6-3. Since the arrays were deployed and erected in the proper position for this flight's beta angle, no positioning was necessary and none was performed.

Data exists to describe completely the erection of the left solar array and it was completed 230 sec after deployment was commanded. Only partial data is available for the other motions; however, data for the final portion of the deployment of the right array permits probable histories for all the motions to be sketched in on Fig. 6-3. It is estimated that the right solar array erected in 320 sec. The time for the right deployment was 650 sec and the time for the left deployment is estimated at 510 sec. Temperatures of the left and right erection dampers were 63° and 65°F respectively. The right array also took longer to erect and deploy during ground tests.
