BIF003W/2-067069-72  
HEXAGON Cy 5

13 April 1972  
Sheet Count: 79

FLIGHT TEST ENGINEERING ANALYSIS REPORT  
FOR  
THE HEXAGON PROGRAM SATELLITE VEHICLE NUMBER TWO ~~(S)~~

This report describes the performance of the second HEXAGON Program Satellite Vehicle (SV-2). The vehicle was launched on 20 January 1972 and completed its primary mission with the recovery of RV number four on 28 February 1972. This report encompasses these 40 days.

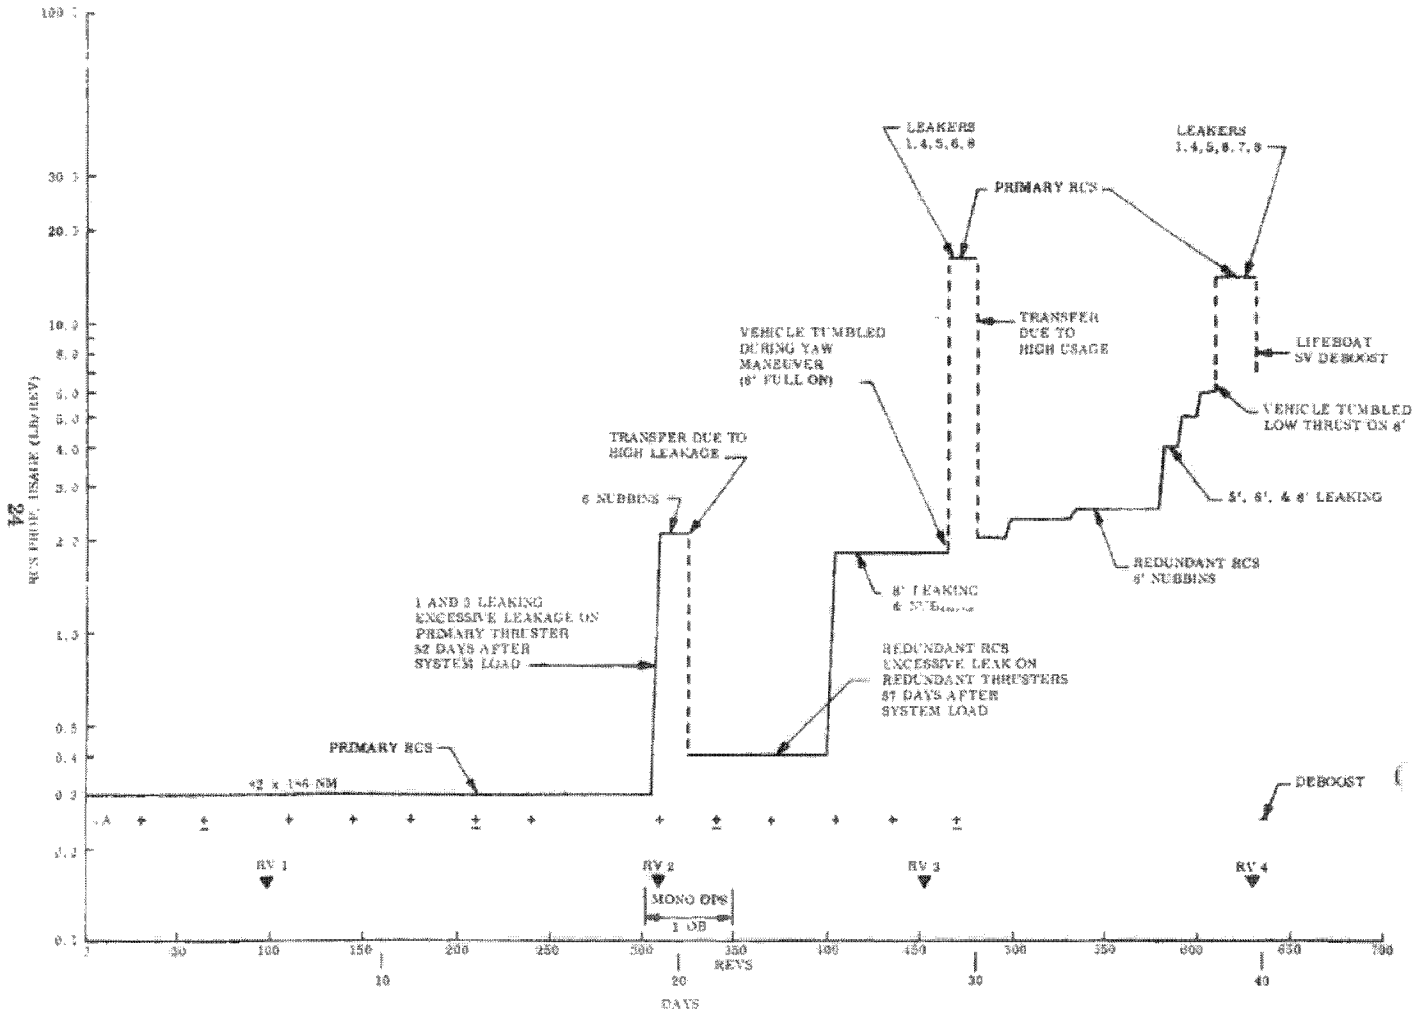
Fig. 2-1 RCs Usage Summary

History of the RCS performance is shown in Fig. 2-1 and tabulated in Table 2-8.

The RCS propellant consumption for the mission was 1108 lb as indicated in Fig. 2-2. This consumption required transfer of 808 pounds from the OAS to the RCS. This large consumption rate of 2 to 17 lb per rev as compared to the normal rate of 0.3 to 0.4 lb per rev was attributed to REM valve leakage and opposing thruster activity. The normal rate did occur on both the Primary and Secondary RCS prior to the development of the leakage.

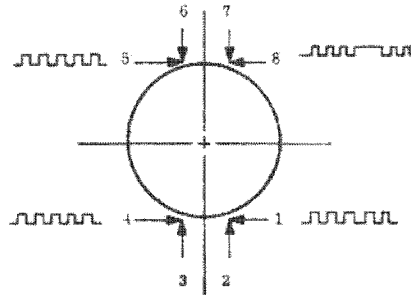
On Rev 478, RCS 2 was again used and worked essentially as well as it did on Rev 435. By avoiding maneuvers, the vehicle used RCS 2 from Rev 478 to 611. Typical performance during payload operation is shown in Fig. 2-6. It can be observed that Thruster 8 departed from a pulsing mode to a steady state type of operation suggesting that nubbins were encountered to the extent that not enough thrust was produced and an increase in duty cycle approaching steady state firing was required. The system further deteriorated in this interval and by Rev 611 could no longer control the vehicle even in the quiescent state; consequently, tumbling occurred.

+OB (START)		REV ↓
NO. 4	NO. 5	
17 PULSES 15 17	16 PULSES 16 16	491
17 21 20	16 15 15	500
16 32 18 20 19 18 19	17 34 18 17 18 16 18	507
19 20 24	13 18 23	539
17 25 19	13 22 18	540

-OB (STOP)	
NO. 1	NO. 8
15 PULSES 13 13	32 (3 SEC SS) 63 38
12 NA 10	68 NA 65 (4.5 SEC SS)
17 NA NA NA NA NA 11	35 NA NA NA NA NA 32 (0.6 SEC SS)
16 14 13	14 (0.5 SEC SS)* 64 53
9 - 13	30 (1.4 SEC SS)* - 38 (.7 & .6 SEC SS)

\*THRUST IMBALANCE BETWEEN NOS. 1 AND 8 PRODUCE ROLL TO BRING ON NOS. 2 AND 6.
