FLIGHT TEST ENGINEERING ANALYSIS REPORT
FOR
THE HEXAGON PROGRAM SATELLITE VEHICLE NUMBER THREE (S)

Prepared and Submitted by the
Satellite Vehicle Integrating Contractor

This report describes the performance of the third HEXAGON Program Satellite Vehicle (SV-3). The vehicle was launched on 7 July 1972 and after a 58 day primary mission and a 10 day SOLO mission was deboosted on 13 September 1972.

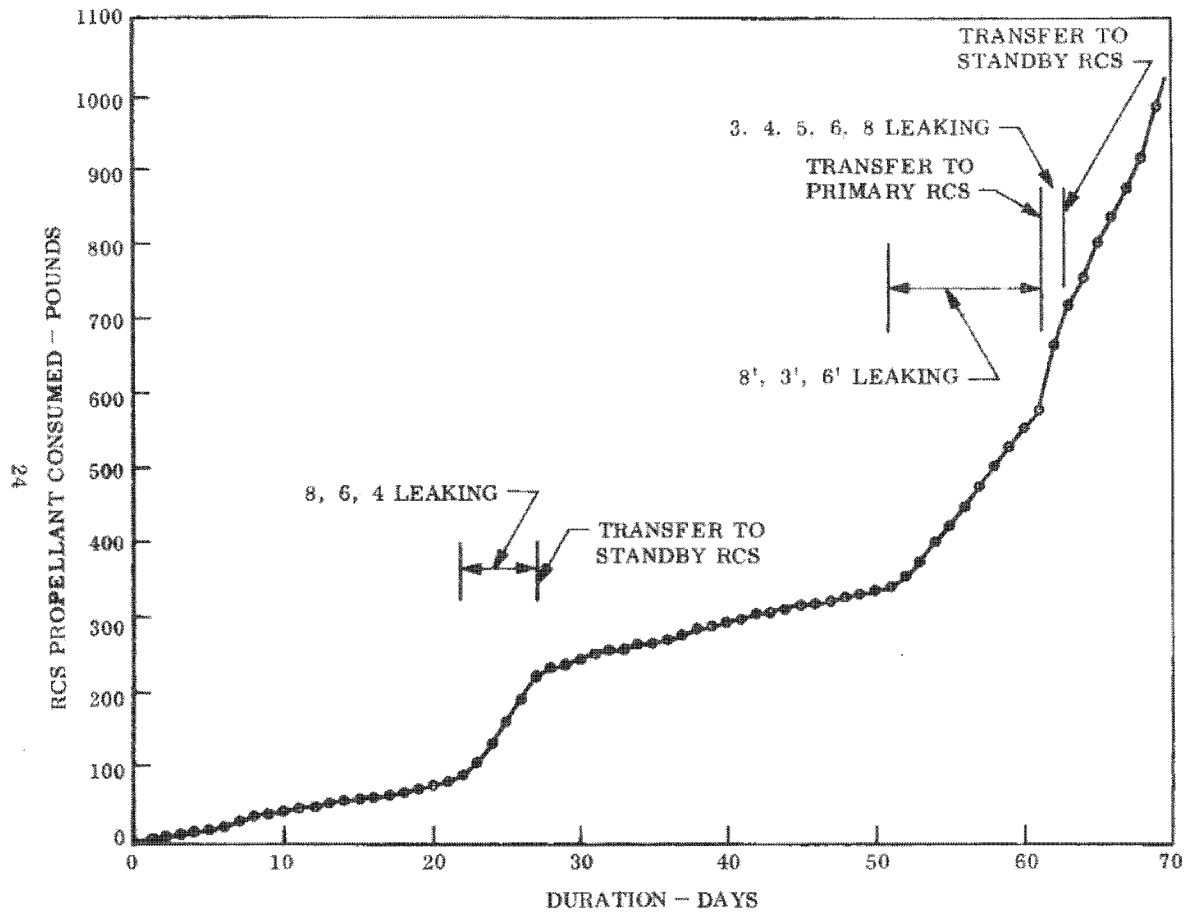
Fig. 2-2 RCS Propellant Consumption

RCS propellant consumption for the mission was 1021 lb as shown in Fig. 2-2. Propellant was consumed only from RCS tanks 1 and 2 until the 22nd day when isolation valve 3 was opened to allow usage from the OAS tank as well.

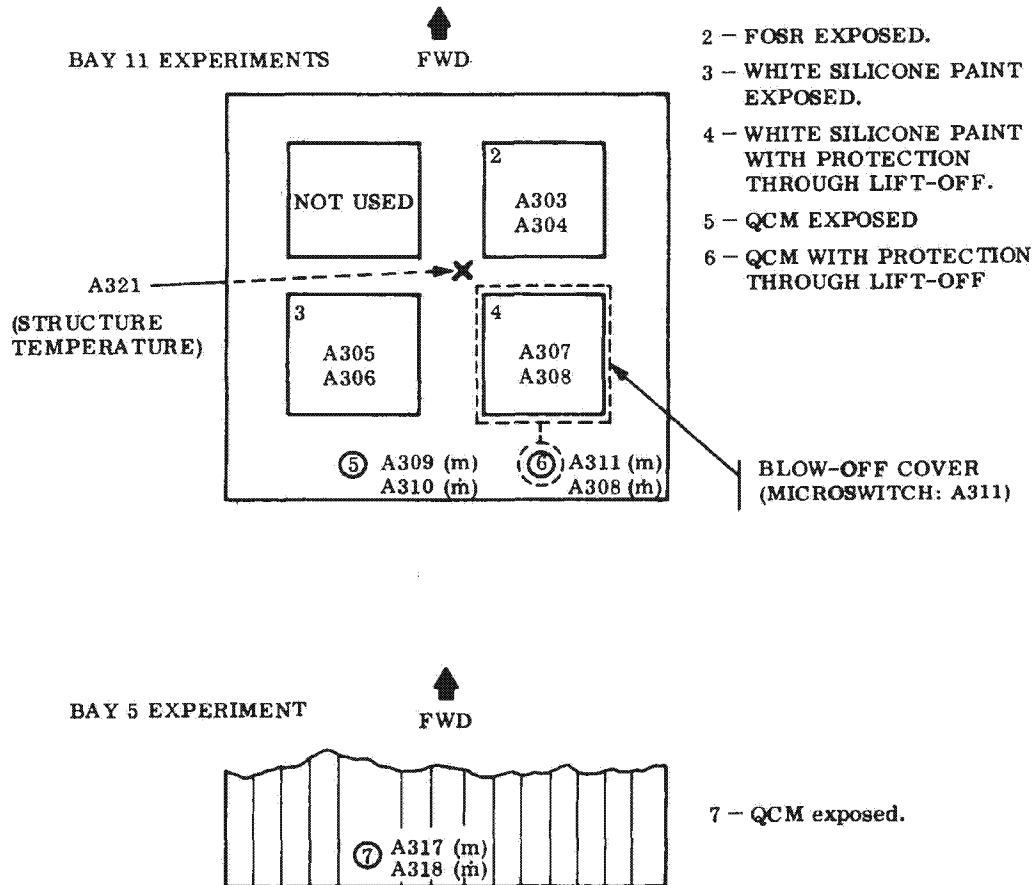
Fig. 12-1 8003 Aft Section Contamination Experiments

Additional contamination experiments were flown on SV-3 to measure two distinct contamination environments. The first group of experiments, installed on Bays 5 and 11 of the Aft Section as shown in Fig. 12-1, were designed to measure the ascent contamination in terms of mass deposit at locations 180 degrees apart and the effect of this mass deposit on the surface properties of white silicone paint and FOSR (Flexible Optical Solar Reflector). Note that the blow-off shield was again used as on SV-2 to isolate the effects of the ground lift-off cloud. Note also that the QCM's (Quartz Crystal Microbalances) have a mass rate channel added for this flight to help interpret the readings of the mass channel. A proposed one-bay model of a fiberglass cloth contamination shield was to be flown on Bay 12. This experiment was deleted, however, after wind tunnel tests indicated mechanical deficiencies in the cloth shield design. The second set of experiments were installed on the forward bulkhead at Station 1642 as shown in Fig. 12-2. These devices were designed to monitor the mass deposit produced by the RV spin motors and to assess the effect of this mass deposit on the surface properties of black and white silicone paints, and aluminized Kapton. These are the thermal control surfaces to be used on the MCP module on SV-5.

The stationary calorimeter panel is used as a reference while the moveable panel is exposed to the RV spin motor plumes then flipped up and compared with the stationary panel. The "conductivity experiment" incorporated in the stationary panel in Fig. 12-1 was an SBAC piggy-back experiment whose objectives are unrelated to this program and are not reported on here.

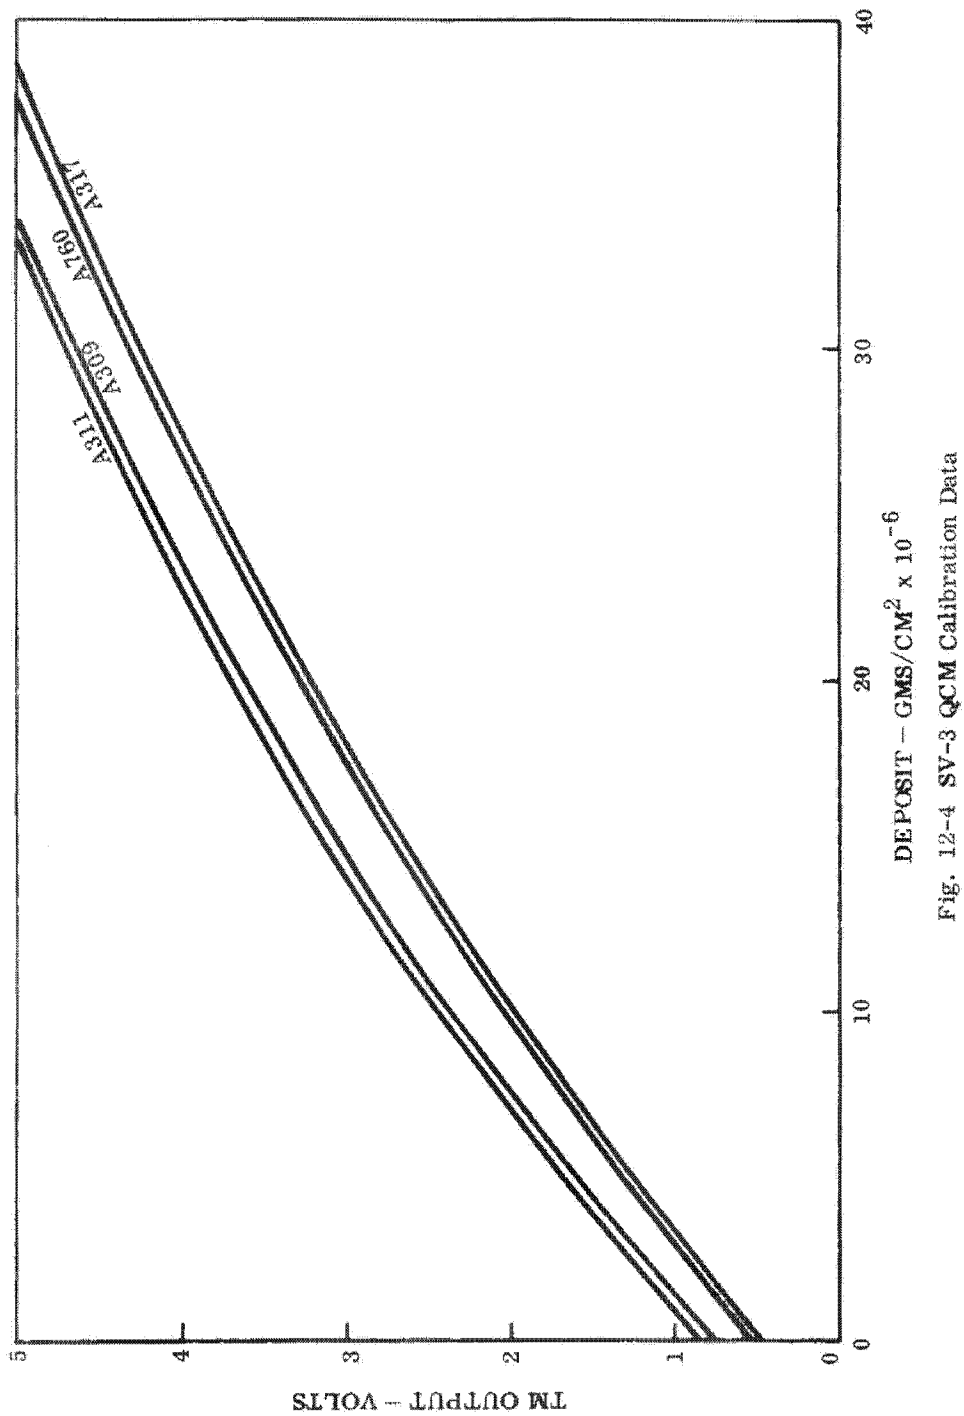
Fig. 12-4 SV-3 QCM Calibration Data

The mass deposition measured during ascent by the three Aft Section QCM's is shown in Fig. 12-3. The results are shown in TM volts. The calibration curves for conversion to actual mass deposit in grams/cm² is presented in Fig. 12-4.

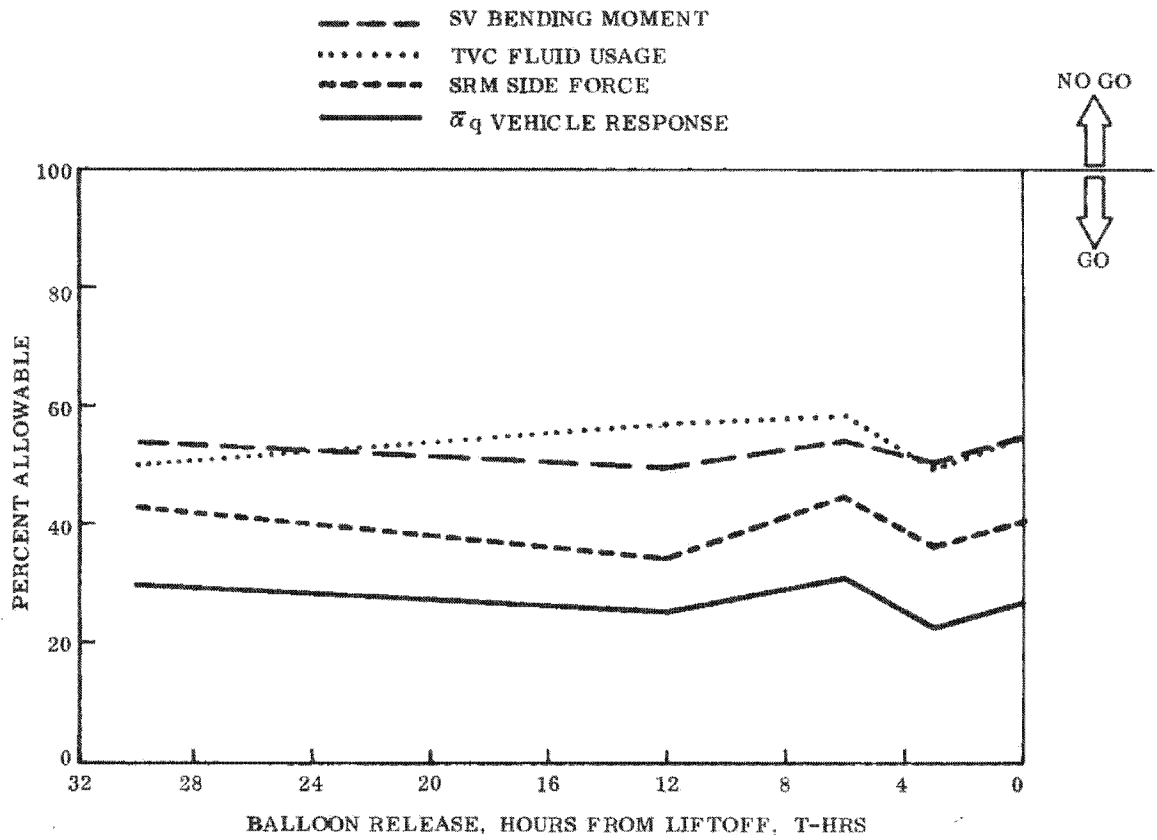
Fig. 14-1 Critical Parameter Summary

Table 14-1 presents a chronological tabulation of the winds aloft computer runs for SV-3. The results are plotted on Fig. 14-1.

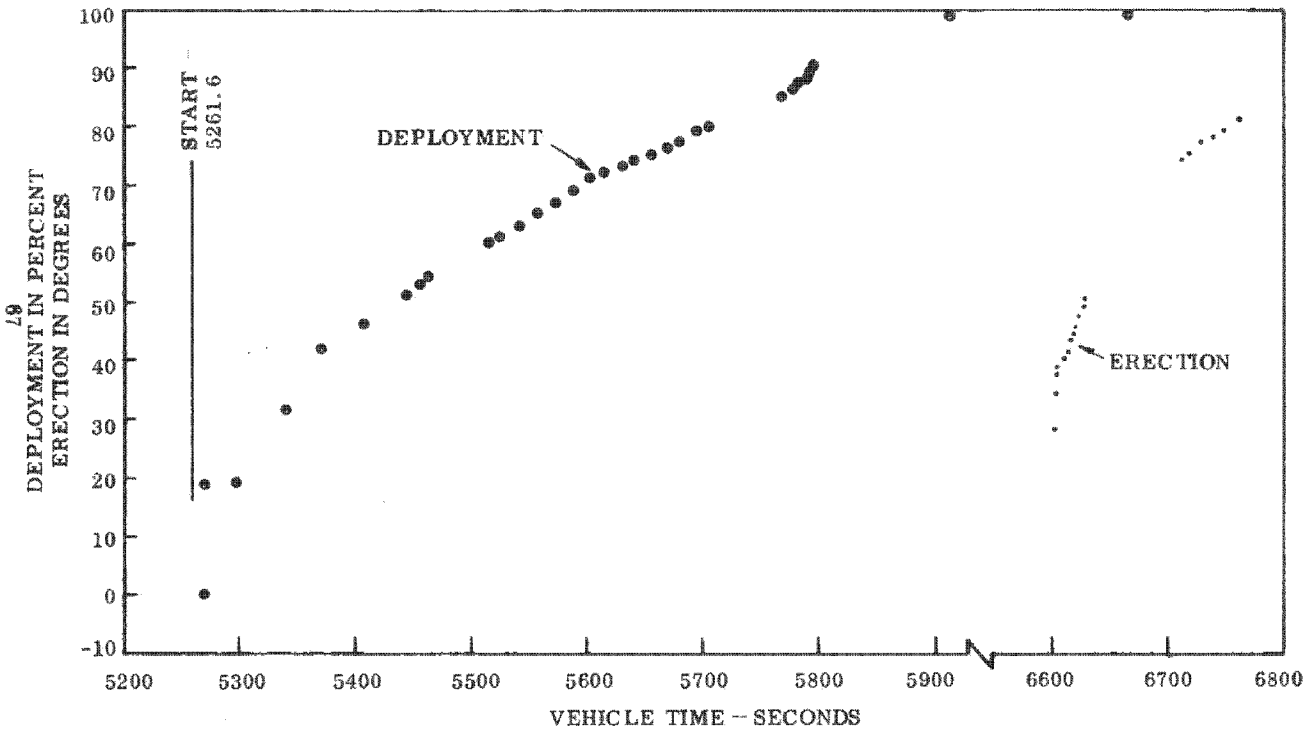
Fig. 14-2 Left Hand Solar Array Erection and Deployment Time Histories

The erection and deployment time histories are shown in Fig. 14-2 for the left (-Y) solar array and in Fig. 14-3 for the right (+Y) solar array. Since the arrays were deployed and erected in the proper position for the flight beta angle, no positioning was necessary and none was performed during the basic mission. Positioning to the standard positions of ± 18 and 0 degrees were accomplished on both arrays during the SOLO mission.
