FLIGHT TEST ENGINEERING ANALYSIS REPORT
FOR
THE HEXAGON PROGRAM SATELLITE VEHICLE NUMBER FOUR ~~(S)~~

Prepared and Submitted by the
Satellite Vehicle Integrating Contractor

This report describes the performance of the fourth HEXAGON Program Satellite Vehicle (SV-4). The vehicle was launched on 10 October 1972 and after a 69 day primary mission and a 22 day SOLO mission was deboosted on Rev 1463 on 8 January 1973.

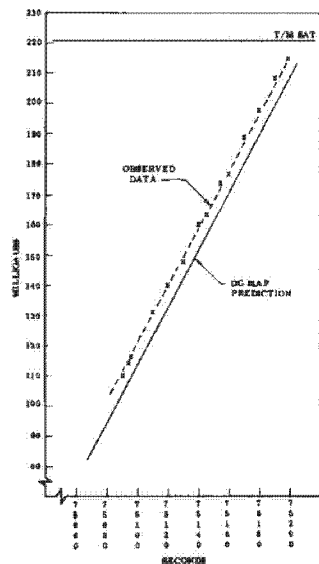
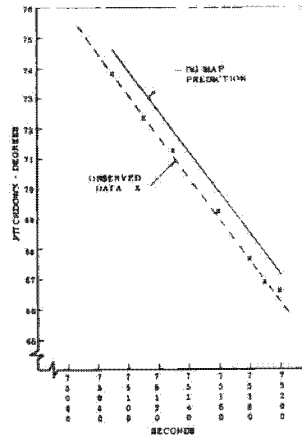
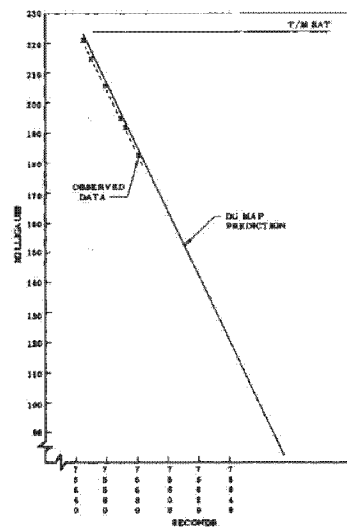
Fig. 6-1a

The vehicle was inertially flown so as to be in an RV recovery attitude with a pitchdown of -40.7 degrees at KOD1 at System Time 75785.6 on Rev 813. Based on the observed position of the vehicle after the ACS programmed pitchup, the actual pitchdown at separation was 0.22 degrees greater than desired.

DGMAP using the inertial stabilization option was used to predict the theoretical P, Q and R magnetometer readings to be expected at POGO and KOD1 for the predicted inertial position of the vehicle. The predicted and observed sensor readings and the predicted and observed pitch angles are shown in Fig. 6-1. It can be seen that the R sensor reading at POGO established the attitude to be about one degree less than the true position of the vehicle if the 0.22 degree error is added to the difference on the graph. The P sensor is above the saturation level of the TM at POGO. At KOD1 the R sensor saturates the TM but the P sensor established the pitch attitude to be about 0.4 degrees less than the actual.

R Sensor in N-S RV Recovery Mode Over POGO (P Sensor Saturates TM)

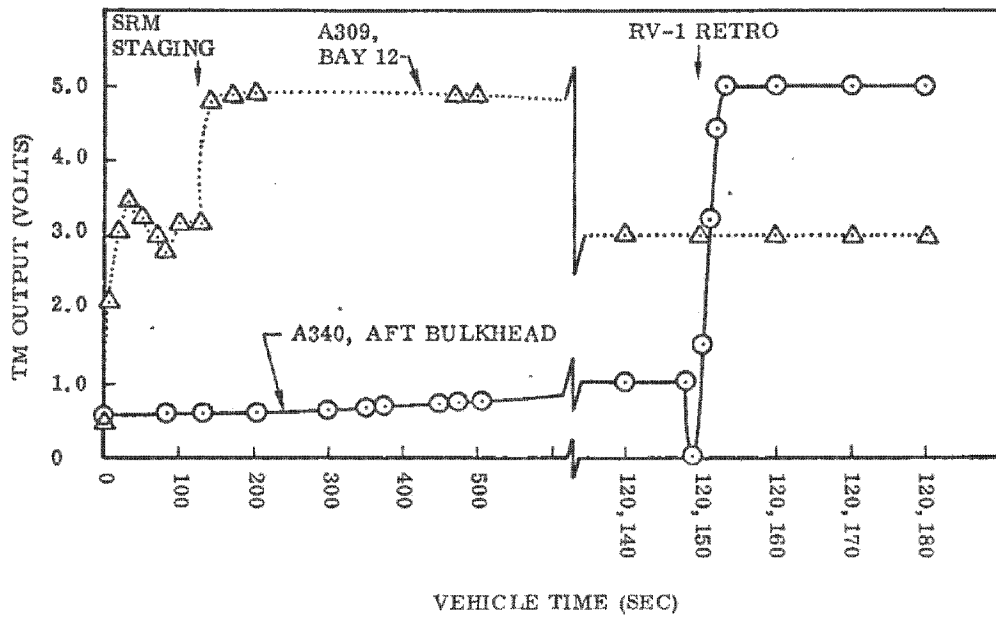
Fig. 12-3 8004 QCM Data

The mass deposition measured during ascent by the QCM's is shown in Fig. 12-3. The results are shown in TM volts, but the calibration curves for the QCM's indicate that the actual mass deposit during ascent was $3.8 \times 10^{-5} \text{ g/cm}^2$.

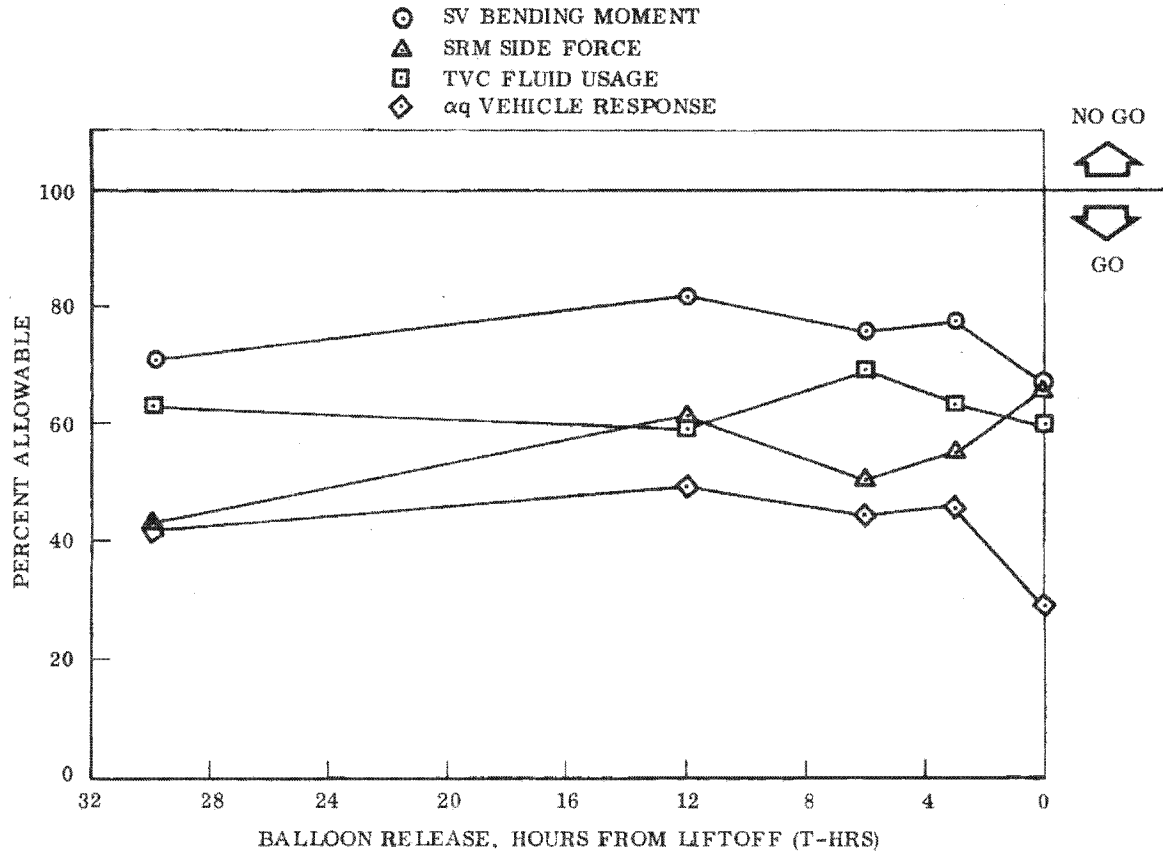
Fig. 14-1 Critical Parameter Summary

Table 14-1 presents a chronological tabulation of the winds aloft computer runs for SV-4. The results are plotted on Fig. 14-1.
