BIF003W/2-069747-73

27 June 1973

FLIGHT TEST ENGINEERING ANALYSIS REPORT
FOR
THE HEXAGON PROGRAM SATELLITE VEHICLE NUMBER FIVE ~~(S)~~

Prepared and Submitted by the
Satellite Vehicle Integrating Contractor

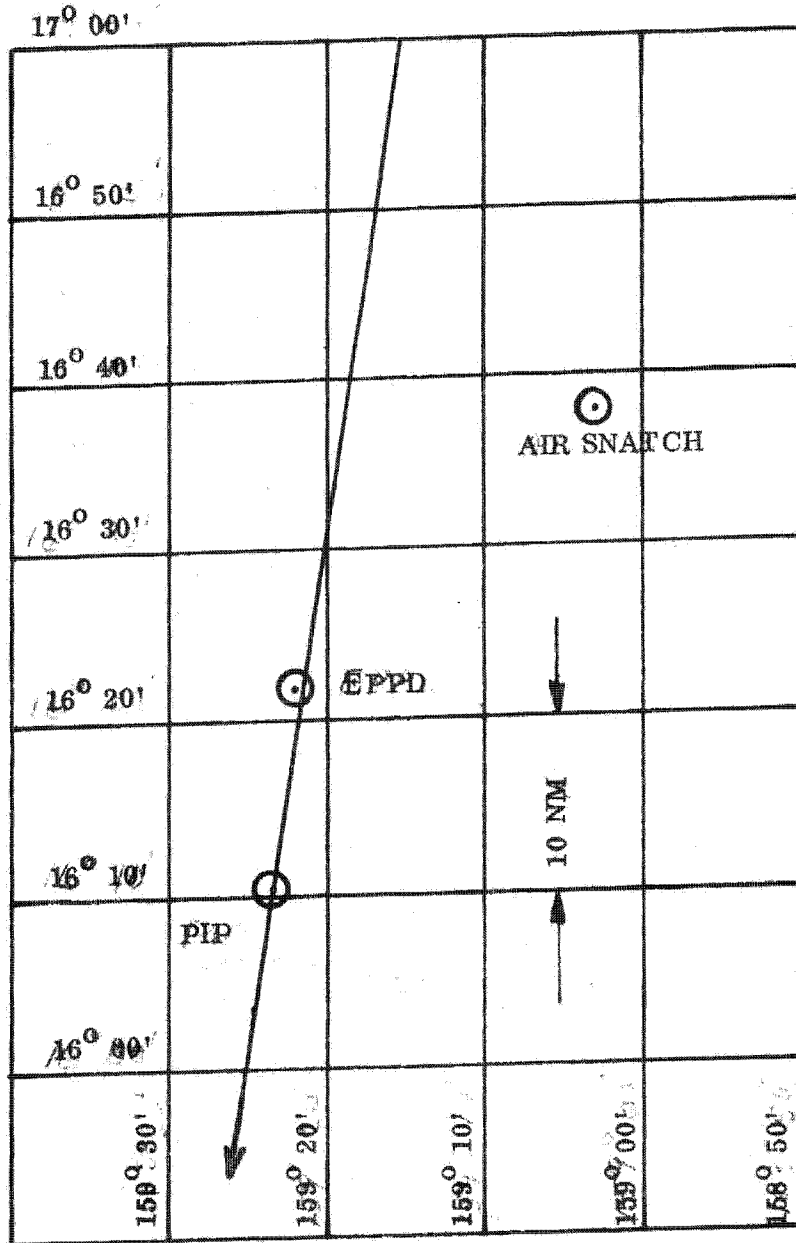
Fig. 11-1 ST-RV Recovery Locations

The predicted impact point (PIP), the estimated point of parachute deployment (EPPD) and the air snatch point are shown in Figure 11-1. The miss distance between the PIP and EPPD was calculated to be 11.68 nm short and 1.46 nm west of the ground track. The capsule was affected by a 125 KTS jet stream and was blown 16 nm from the EPPD by a 105 KTS wind from 250 degrees.

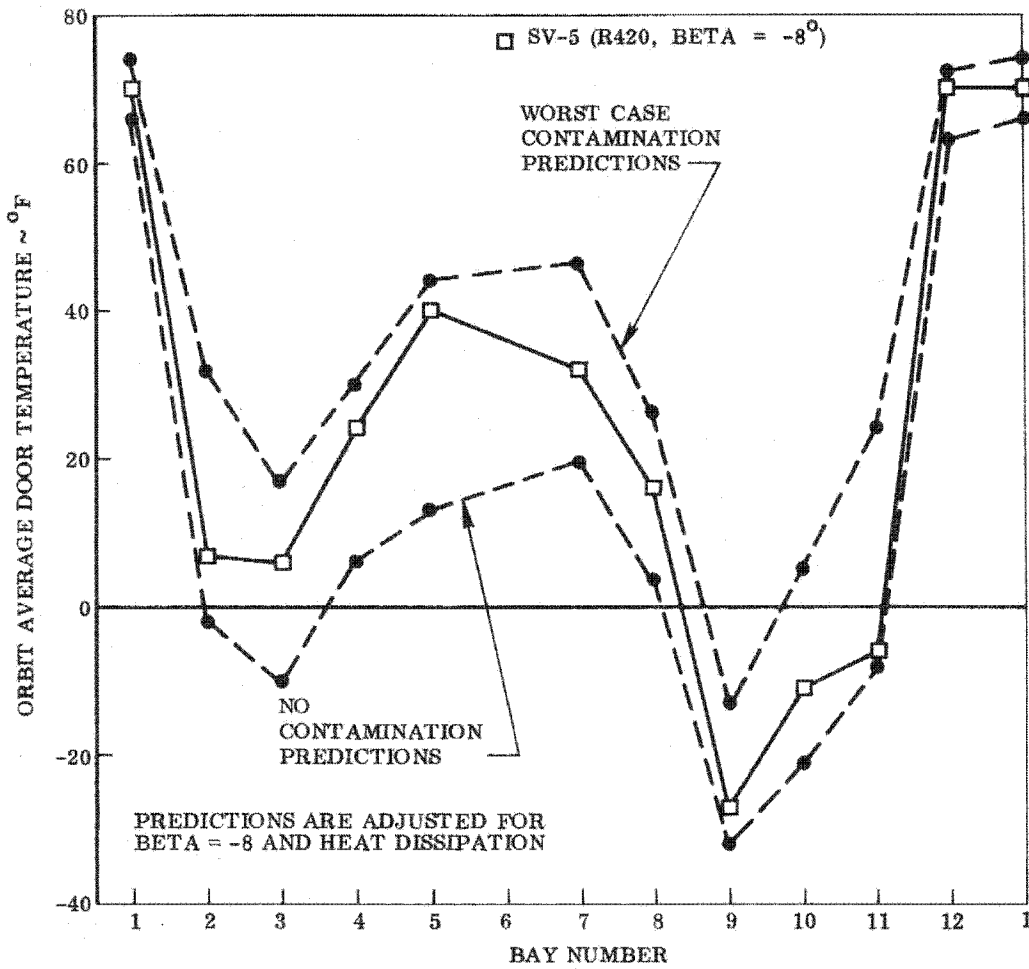
Fig. 12-2 SV-5 Equipment Door Temperatures

Equipment and structural temperatures indicated contamination degradation to external vehicle thermal control surfaces similar to that of all other flights. The amount of degradation was within the bounds of preflight analysis as indicated by Fig. 12-2, which compares actual Equipment Section door temperatures with predictions of a Beta angle of -8 degrees. Solar absorptance (α_s) for the degraded FOSR was estimated to be 0.30 to 0.36, less than the $\alpha_s = 0.50$ assumed for the worst case.

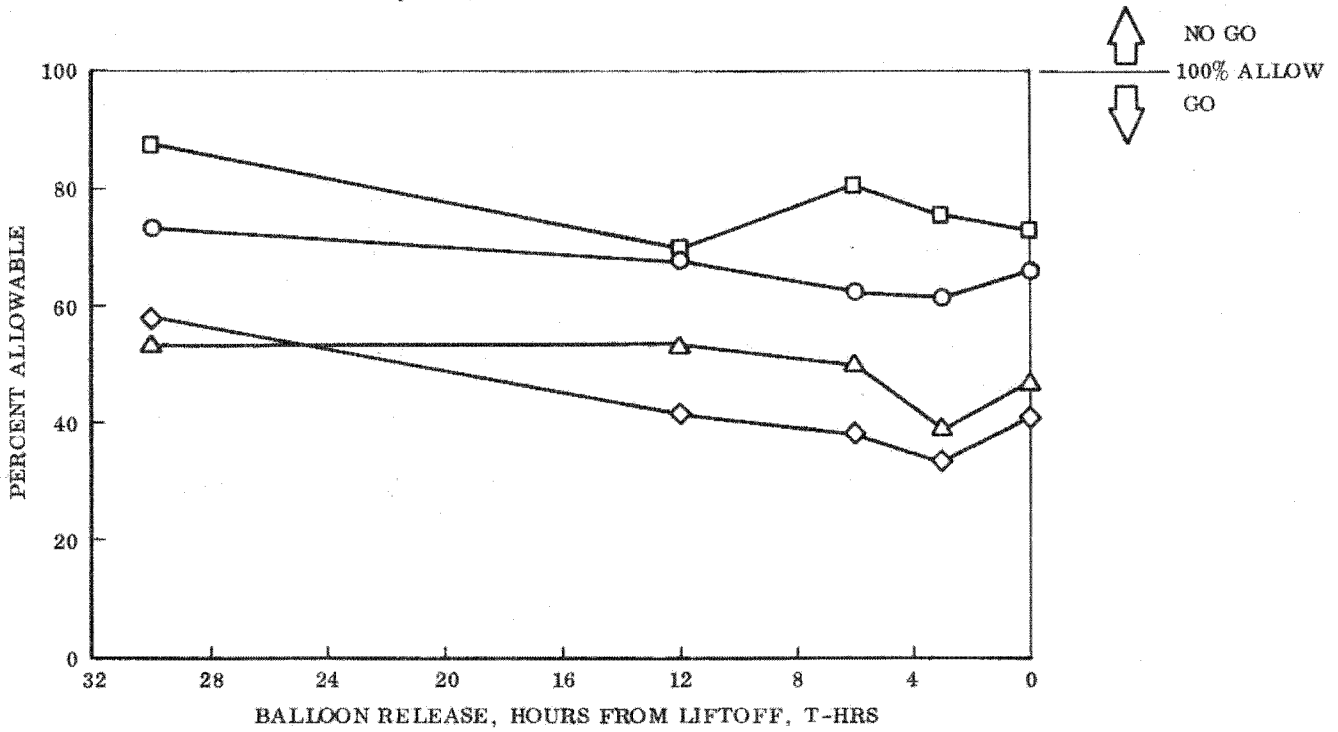
Fig. 14-1 Critical Launch Parameter Summary

Table 14-1 presents a chronological tabulation of the winds aloft computer runs for SV-5. The results are plotted on Fig. 14-1.

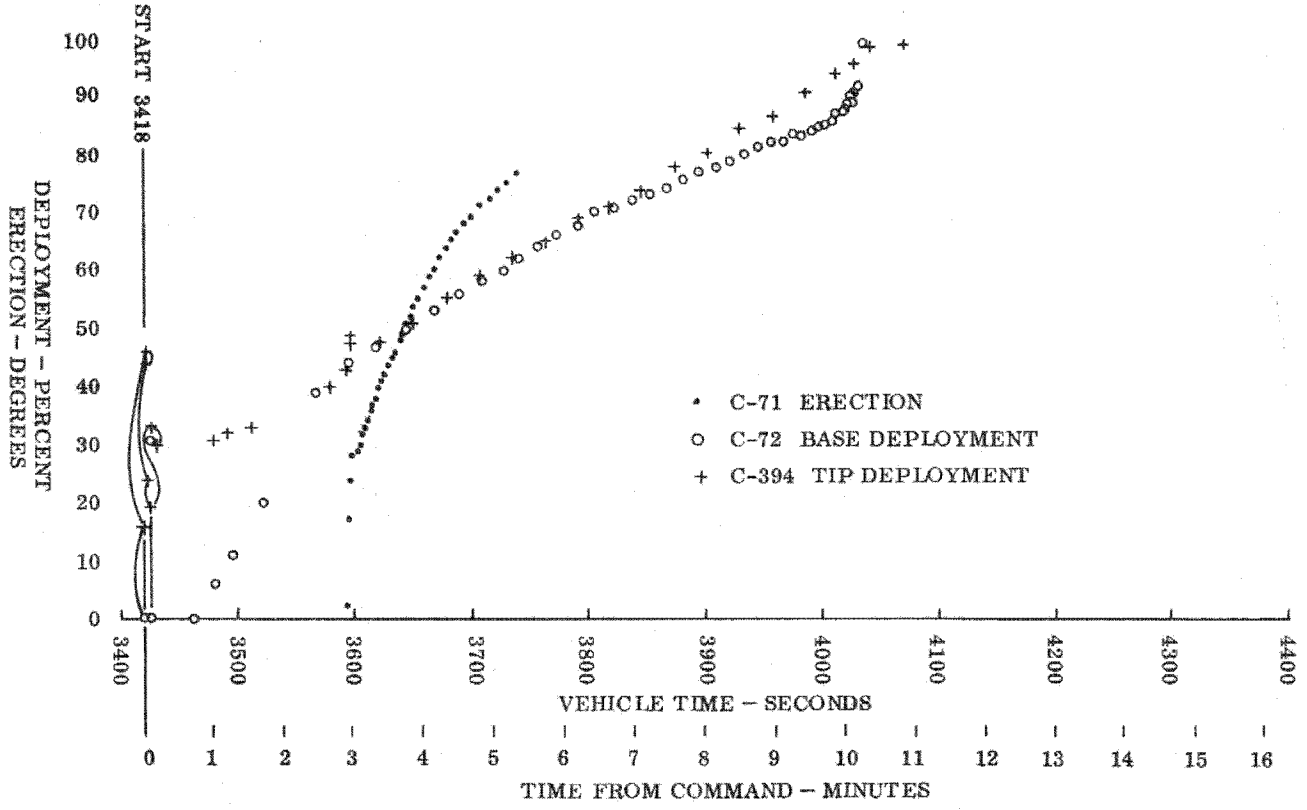
The erections and deployment time history for the left (-Y) solar array is shown in Fig. 14-2 and for the right (+Y) solar array in Fig. 14-3. It should be noted that the arrays were deployed at the first station pass, INDI. The arrays were fully deployed and erected by the next station, POGO, and they were then repositioned from +18 deg to 0 deg and then to -18 deg for maximum output at the flight beta angle of -7.8 deg. Deployment potentiometers have been added on the outboard solar panels which more accurately show the initial motion of the arrays (C-393 and C-394) and these are shown together with the potentiometers common to this and preceding vehicles.

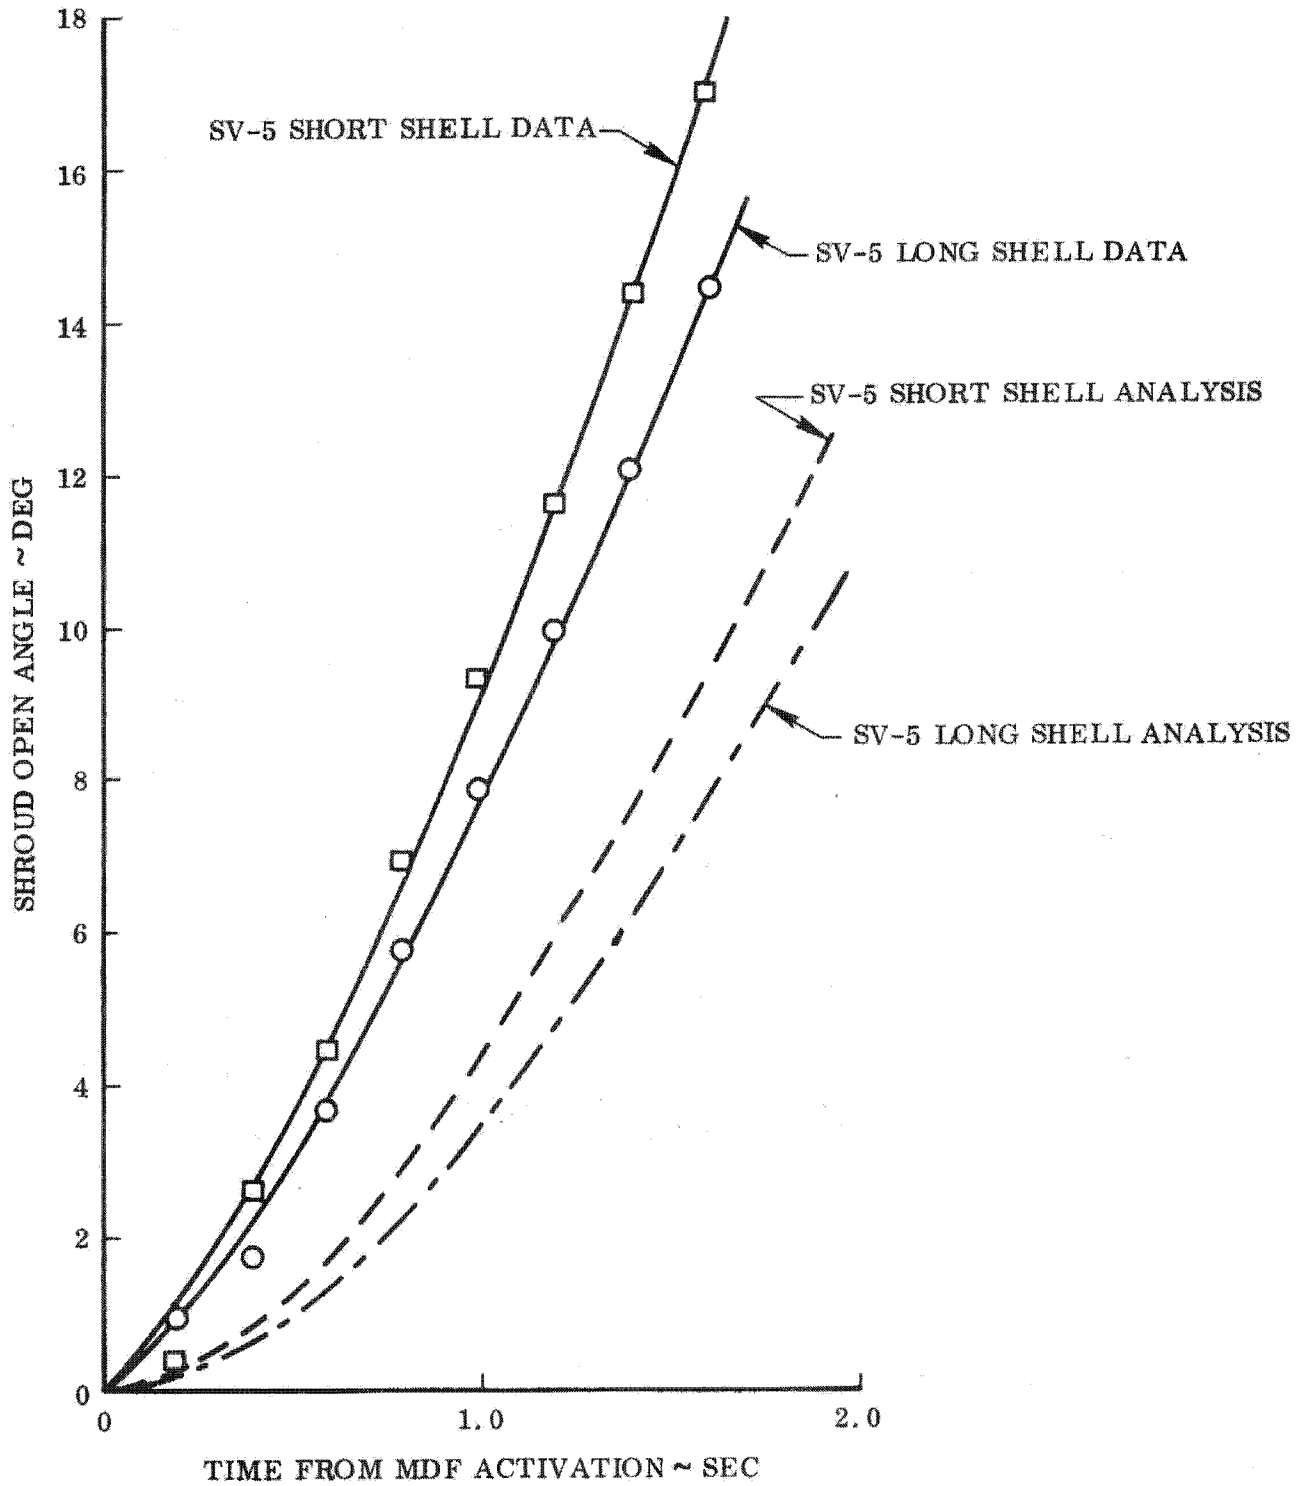
Fig. 14-4 Shroud Separation History

Previous flights have indicated the shroud separates faster than predicted. The potentiometer end was relocated on SV-5 to more accurately measure the initial 10 deg of shroud rotation by measuring only 18 deg rather than the full rotation (approximately 60 deg) before separation. The measured initial rates are shown in Fig. 14-4 to be 5 deg/sec faster than accounted for in pre-flight analysis. Two possible contributors to this initial velocity are being investigated:
