25 August 1971  
Sheet Count: 73

FLIGHT TEST ENGINEERING ANALYSIS REPORT  
FOR  
THE HEXAGON PROGRAM SATELLITE VEHICLE NUMBER ONE (S)

This report describes the performance of the first HEXAGON Program Satellite Vehicle (SV-1). The vehicle was launched on 15 June 1971 and completed its primary mission with the recovery of RV number four on 16 July 1971. This report encompasses only these 31 days.

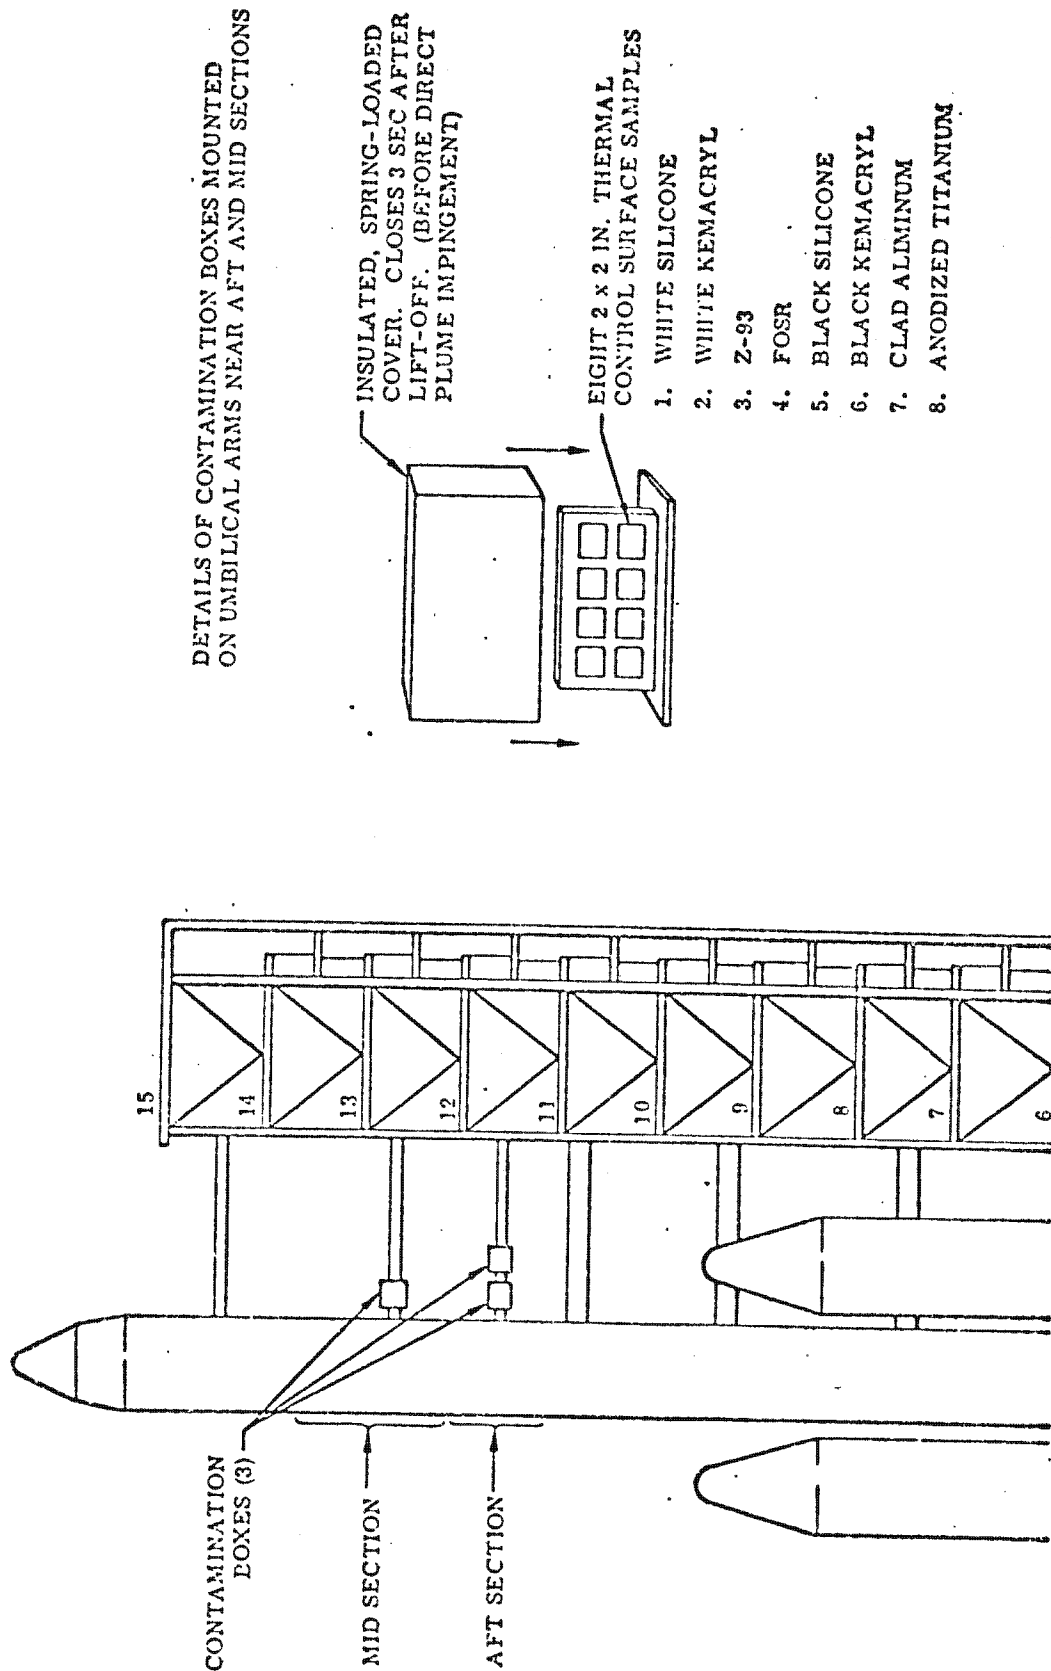
Fig. 12-2 Umbilical Arm Contamination Sample Boxes

Three boxes containing eight thermal control surface samples will be mounted on the umbilical arms near the SV aft and mid sections. The boxes will be closed shortly after SRM ignition so that the samples are exposed to the lift-off cloud but are subsequently protected from direct SRM exhaust impingement. The layout for these boxes is shown in Fig. 12-2. Surface property data pre- and post-launch should satisfy objective 7.

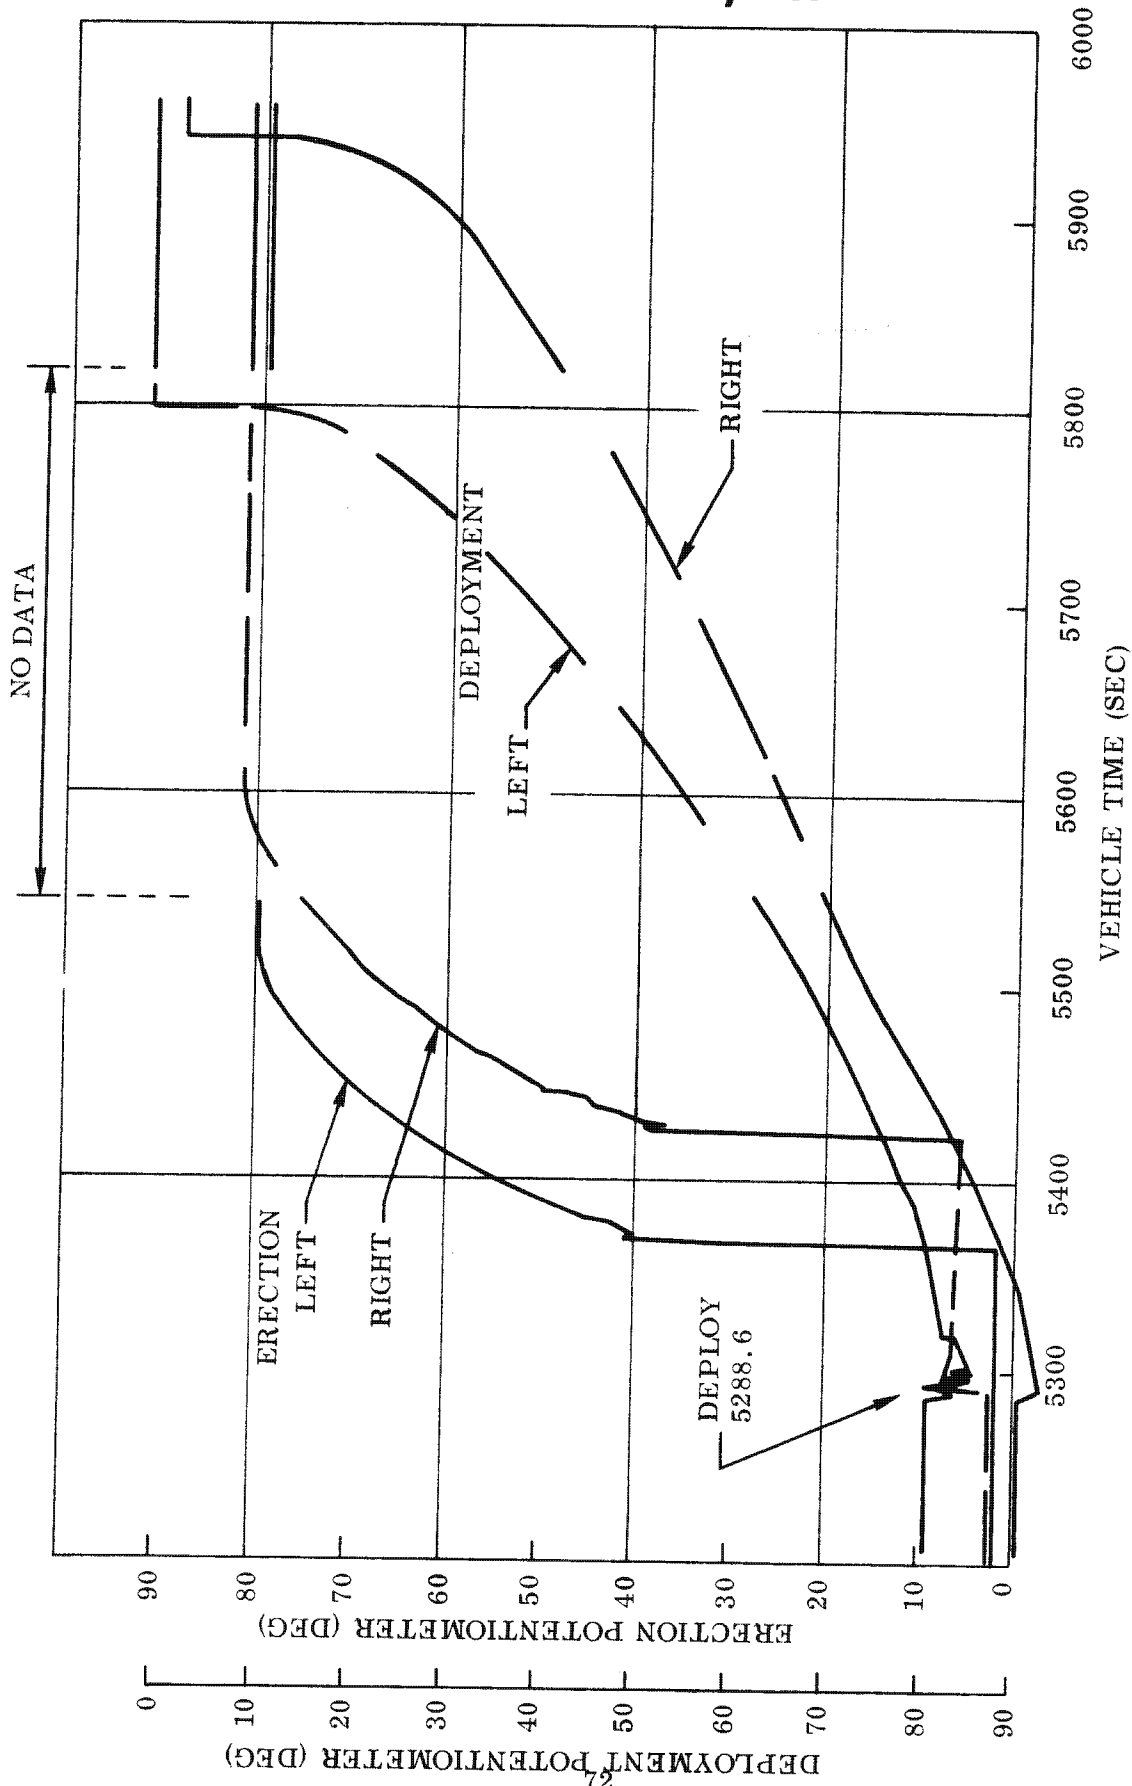
Fig. 14-3 Solar Array Erection and Deployment

The history of the solar array erection and deployment are shown in Fig. 14-3. Since the arrays were deployed and erected in the proper position for this flight's beta angle, no positioning was necessary and none was performed.

Data exists to describe completely the erection of the left solar array and it was completed 230 sec after deployment was commanded. Only partial data is available for the other motions; however, data for the final portion of the deployment of the right array permits probable histories for all the motions to be sketched in on Fig. 14-3. It is estimated that the right solar array erected in 320 sec. The time for the right deployment was 650 sec and the time for the left deployment is estimated at 510 sec. Temperatures of the left and right erection dampers were 63 and 65<sup>o</sup>F respectively. The right array also took longer to erect and deploy during ground tests.
