SYSTEM

PERFORMANCE EVALUATION TEAM

MISSION 1208

PERFORMANCE EVALUATION TEAM REPORT NO. 1208/74

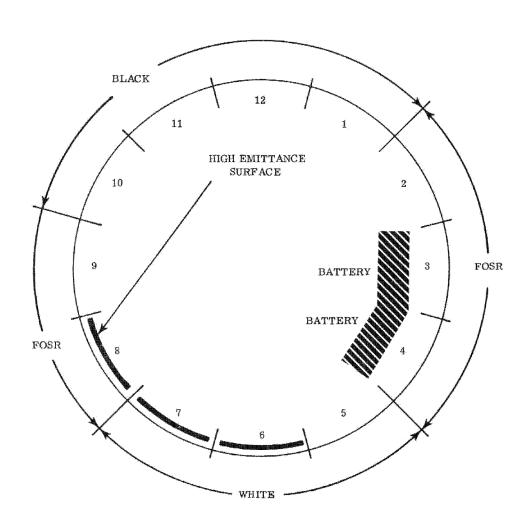
FIGURE 3-3

- A. Batteries were relocated to Bays 3 and 4.
- B. More Flexible Optical Solar Reflector (FOSR) was used in the new paint pattern, see Figure 3-3.
 - C. RCS Tanks 1, 2, 3, and 4 were all installed.

NOTE: OAM-RCM: RCS skins Bays 3 and 4 all white, while the remainder are all black/aluminum.
