PROGRAM REPORT

QUALIFICATION TEST REPORT

EASTMAN KODAK COMPANY
Apparatus and Optical Division
Rochester 4, New York

Date: 17 April 1964

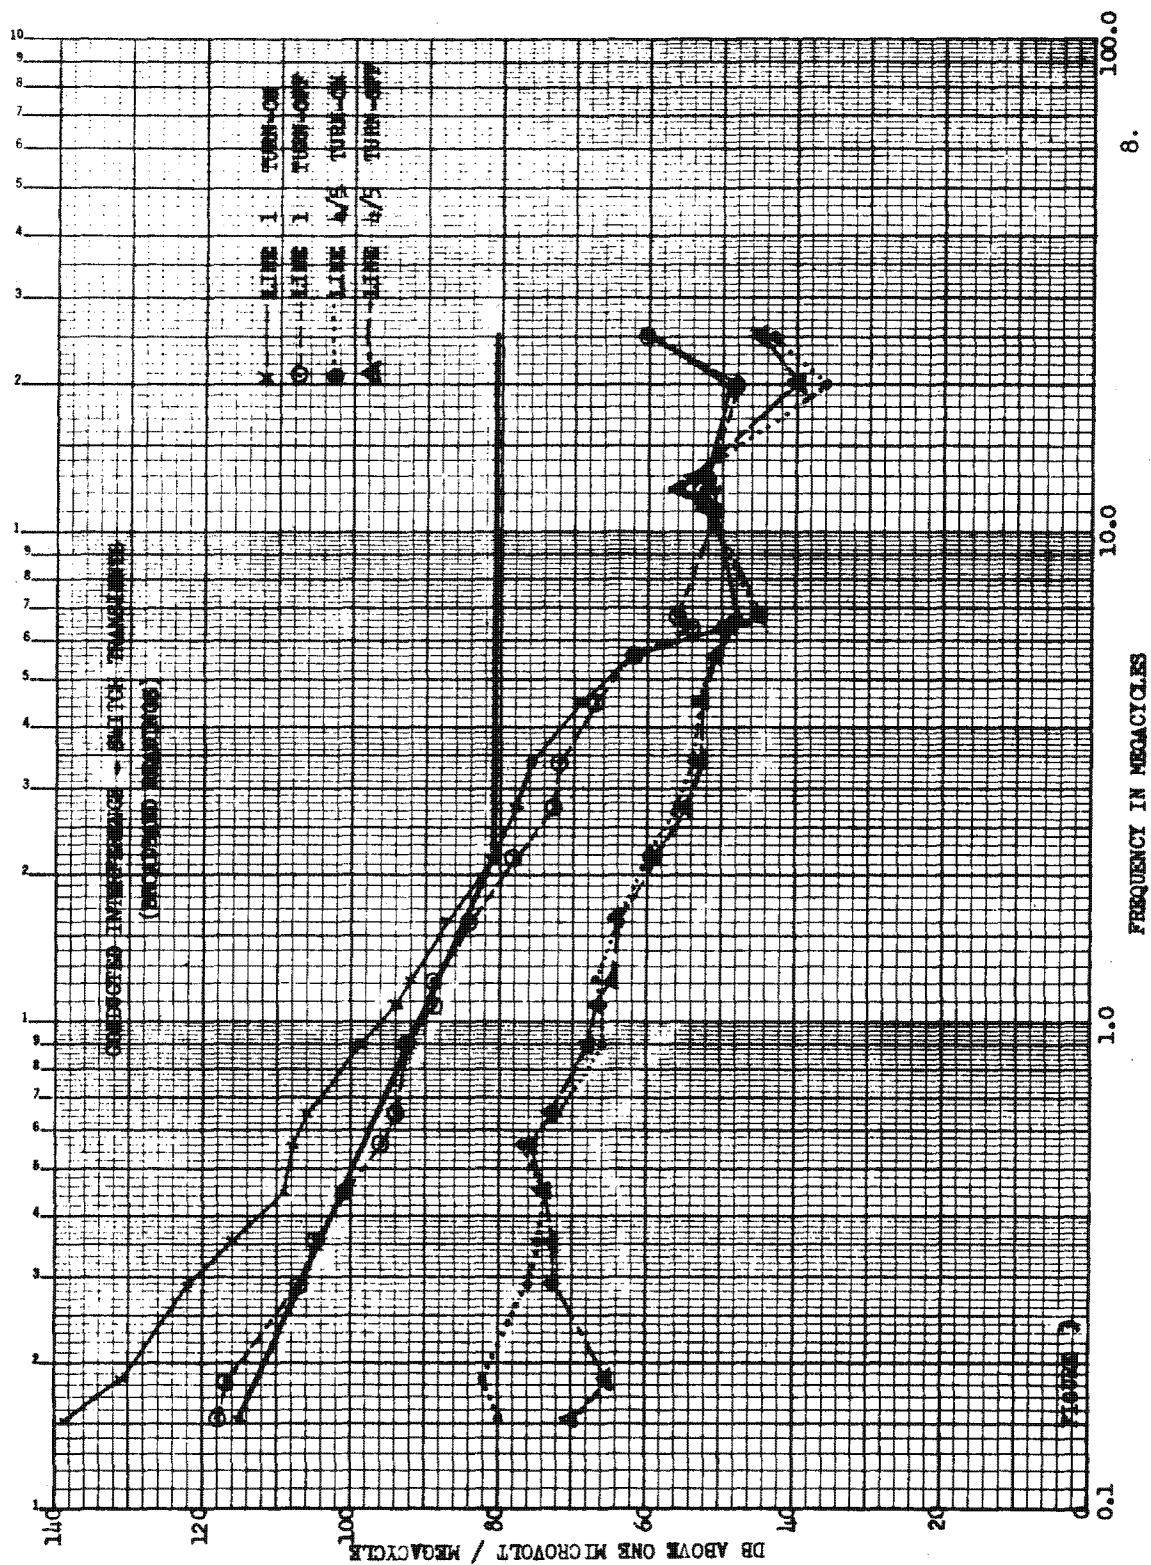
Conducted Interference - Noise levels exceeding those specified in Figure 3 were detected when supplying power to and removing power from the Regulated Power Supply with a SPST mercury switch. The out-of-spec values vs. frequencies are shown in Figure 3 of this report.

Figure 3. Conducted Interference - Switch Transients (Broadband)

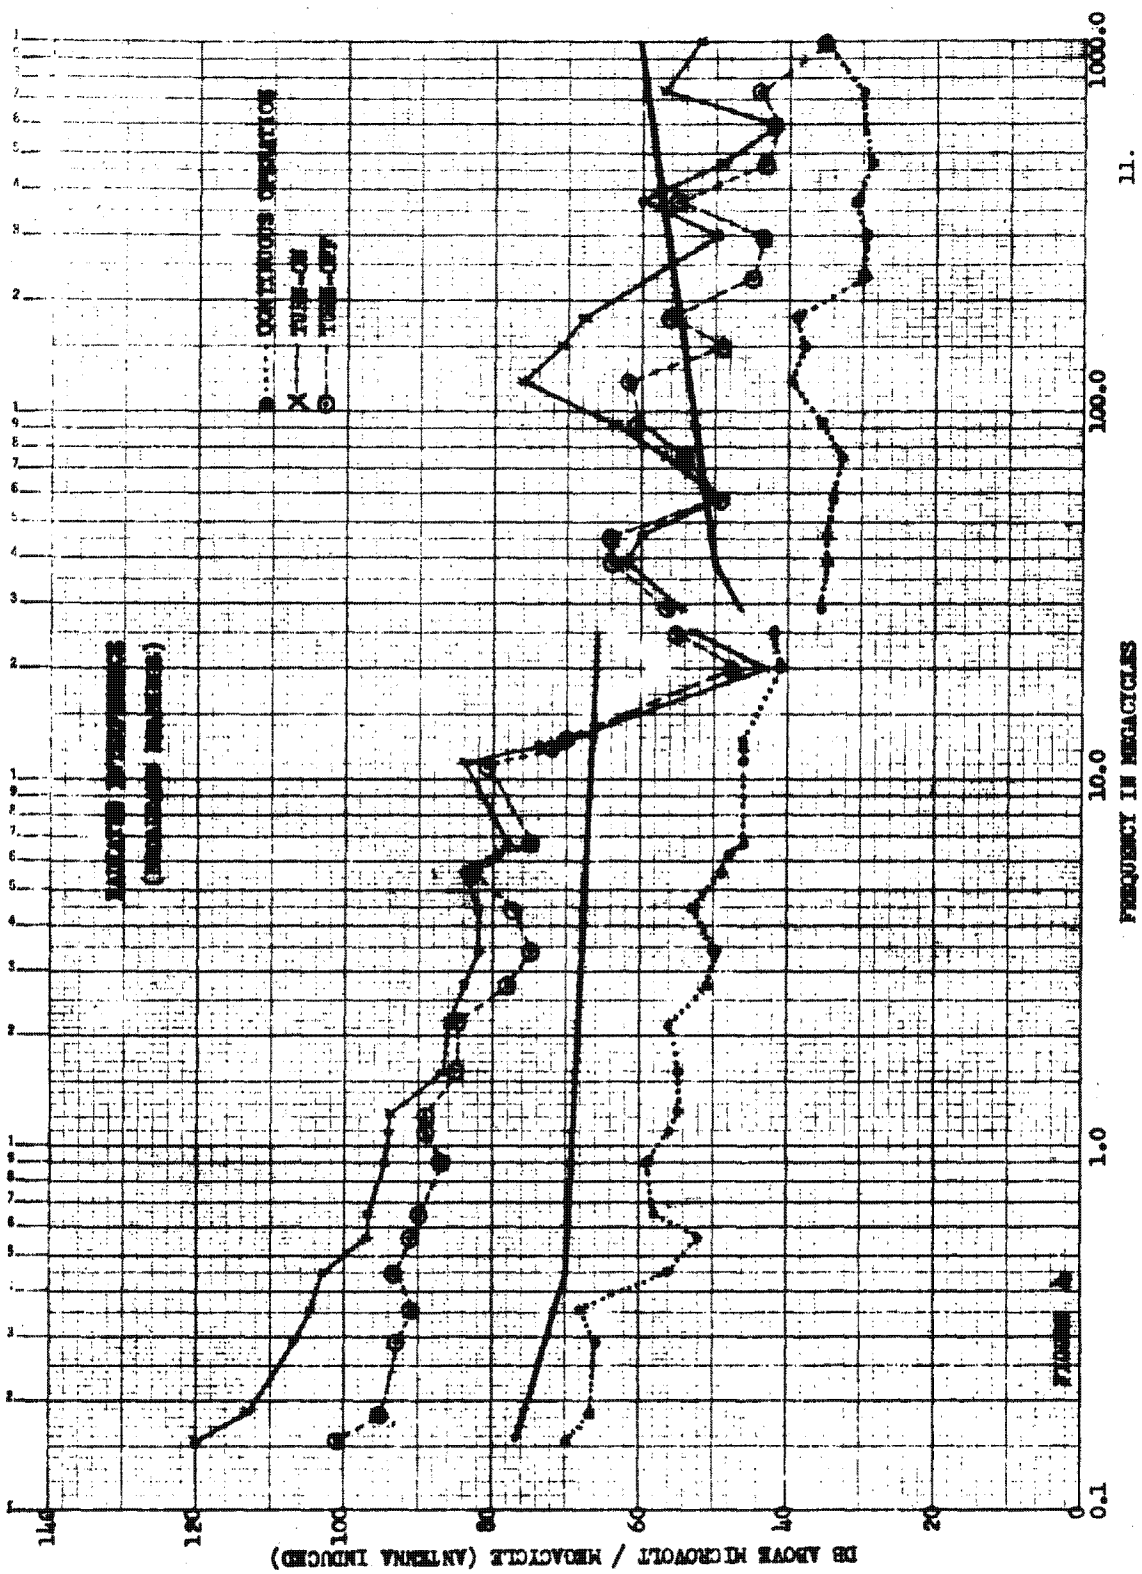
Radiated Interference - Noise levels exceeding allowable limits were detected when supplying power to and removing power from the Regulated Power Supply with a SPST mercury switch. The out-of-spec values vs. frequency are shown in Figure 4 of this report.

Figure 4. Radiated Interference - Broadband

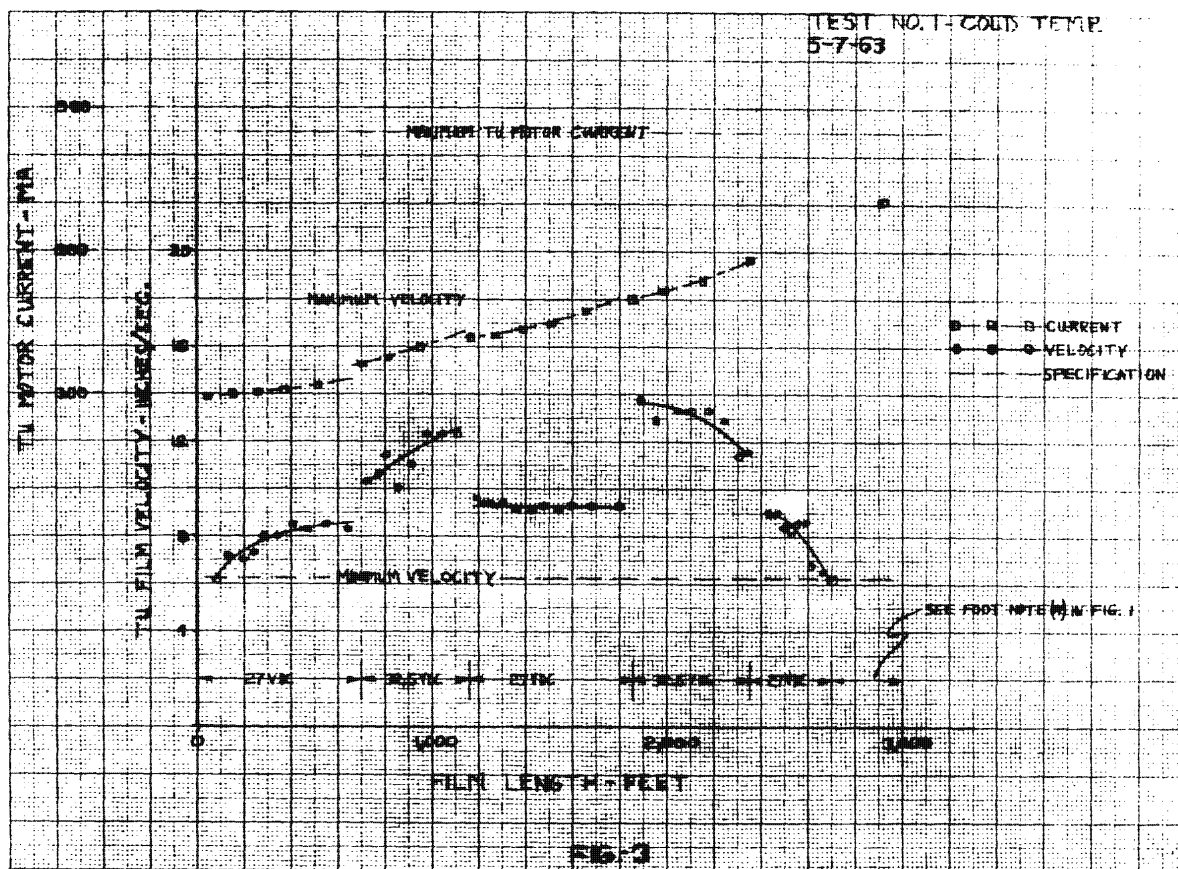
Figure 3 shows the take-up motor current and take-up film velocity throughout the test. The speed vs. torque curve for the take-up motor was out of specification prior to this test and this condition would attribute to the low film velocities near the beginning and end of the test.

Figure 3. Curve of Take-up Motor Current and Take-up Film Velocity - Cold Temperature Test

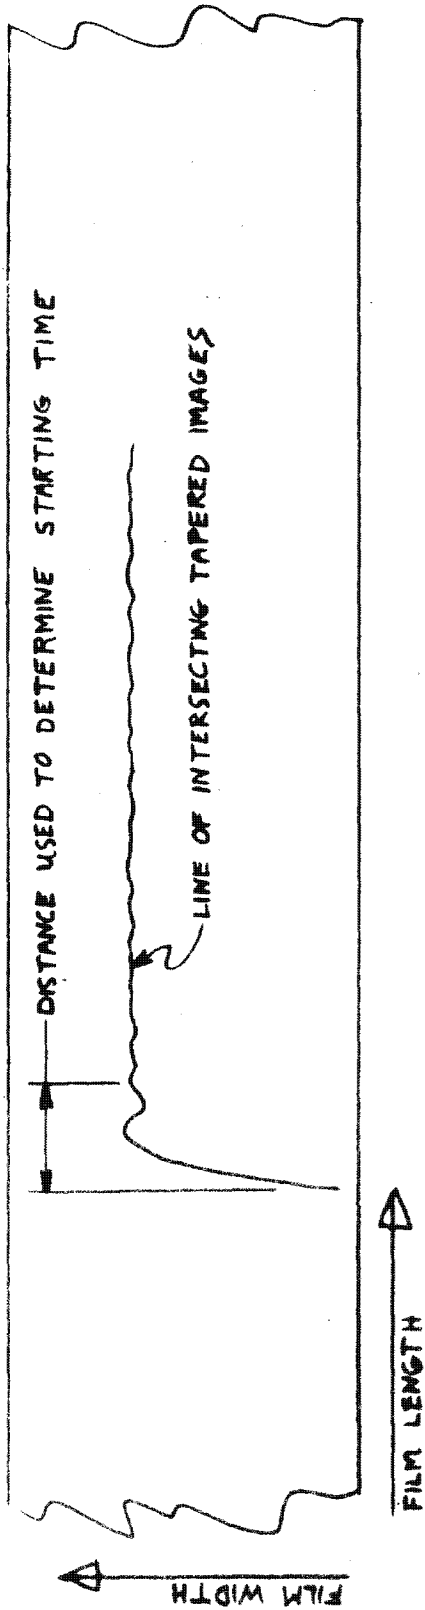
Discussion of Figure 1 - Throughout the low pressure test on the RC Camera the bellows did not perform satisfactorily. The film velocity smoothness and normal starting time at atmospheric pressure is represented in Figure 3. Figure 4 shows the effects of low pressure (<0.1 PSI) on film velocity and starting time.

Figure 3. Typical Velocity Smoothness and Starting Time, Atmospheric Pressure

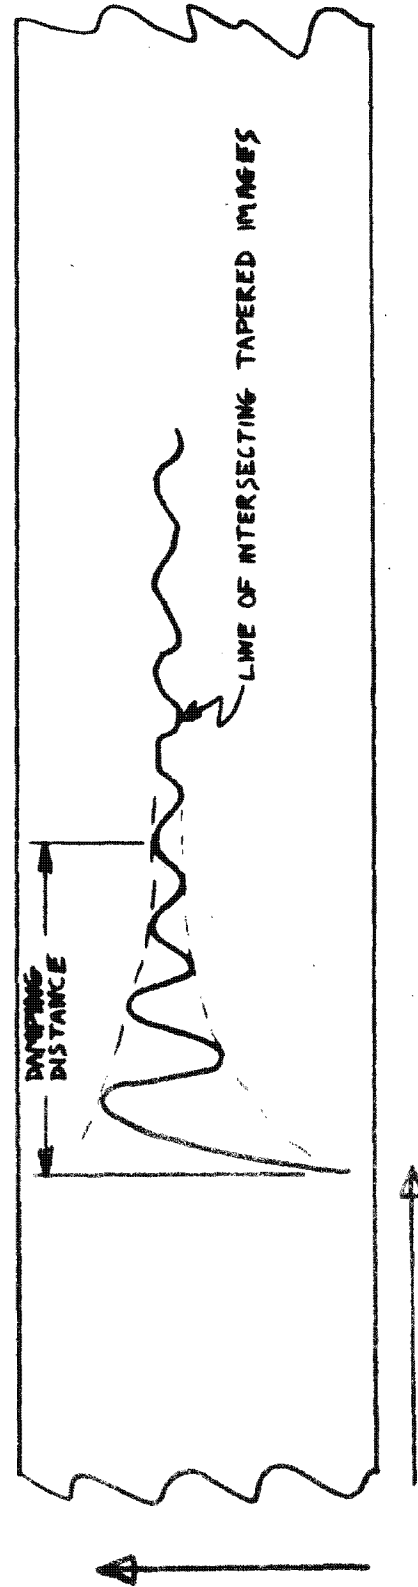
Figure 4. Typical Velocity Smoothness and Damping Distance, Low Pressure
