PHOTOGRAPHIC
EVALUATION REPORT
MISSION 1046

SPECIAL STUDY: COMPARISON OF
SO-230 & 3404 FILM TYPES FROM
MISSION 1102-2

MISSION 1046

NATIONAL PHOTOGRAPHIC INTERPRETATION CENTER

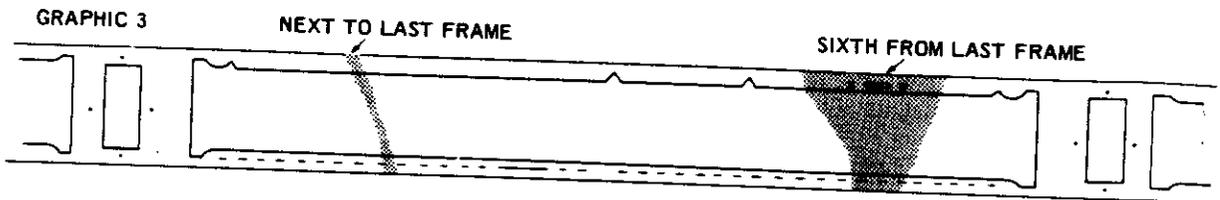
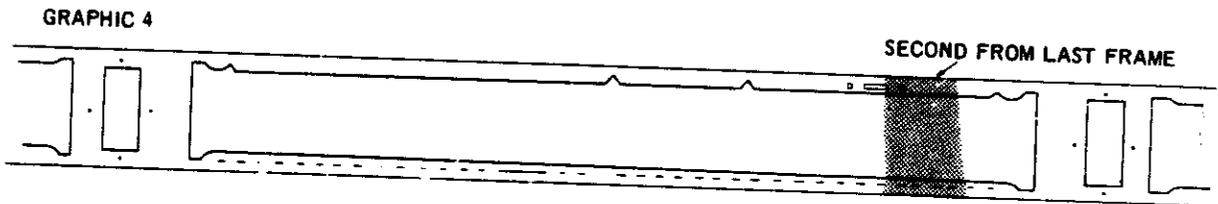
G. Graphic Display (Mission 1046)

a. Light Leaks: Light leak induced fog patterns appear more often and are of greater severity than on the more recent missions of this system. The fogging that occurred near the intermediate roller assembly is especially severe when there is a long sit period between camera operations. The fog patterns correlated directly with the duration of camera sit periods. The major fog patterns occurred on the last, first and fifth from last frame, and fifth frame of most passes. The more severe fog patterns cause some degradation to the imagery. The fog patterns are illustrated on Graphics 1 and 2, page 10.

a. Light Leaks: Light leak induced fog patterns occurred with varying severity. The patterns are more frequent and of greater density than those normally encountered from this system. This may be due in part to the faster film type (SO-230) used in this mission. Fog patterns occurred on the first, second, third, and sixth from the last and the last frame of most passes. The major patterns are illustrated on Graphic 3 and 4, page 10. The more severe fog patterns degrade the imagery to the extent where interpretation is difficult. This is especially true on the first bucket (Mission 1046-1).
