27 June 1973

FLIGHT TEST ENGINEERING ANALYSIS REPORT
FOR
THE HEXAGON PROGRAM SATELLITE VEHICLE NUMBER FIVE (S)

Prepared and Submitted by the
Satellite Vehicle Integrating Contractor

This report describes the performance of the fifth HEXAGON Program Satellite Vehicle (SV-5). The vehicle was launched on 9 March 1973 and after a 64-day primary mission and a 7-day SOLO mission was deboosted on Rev 1139 on 18 May 1973.

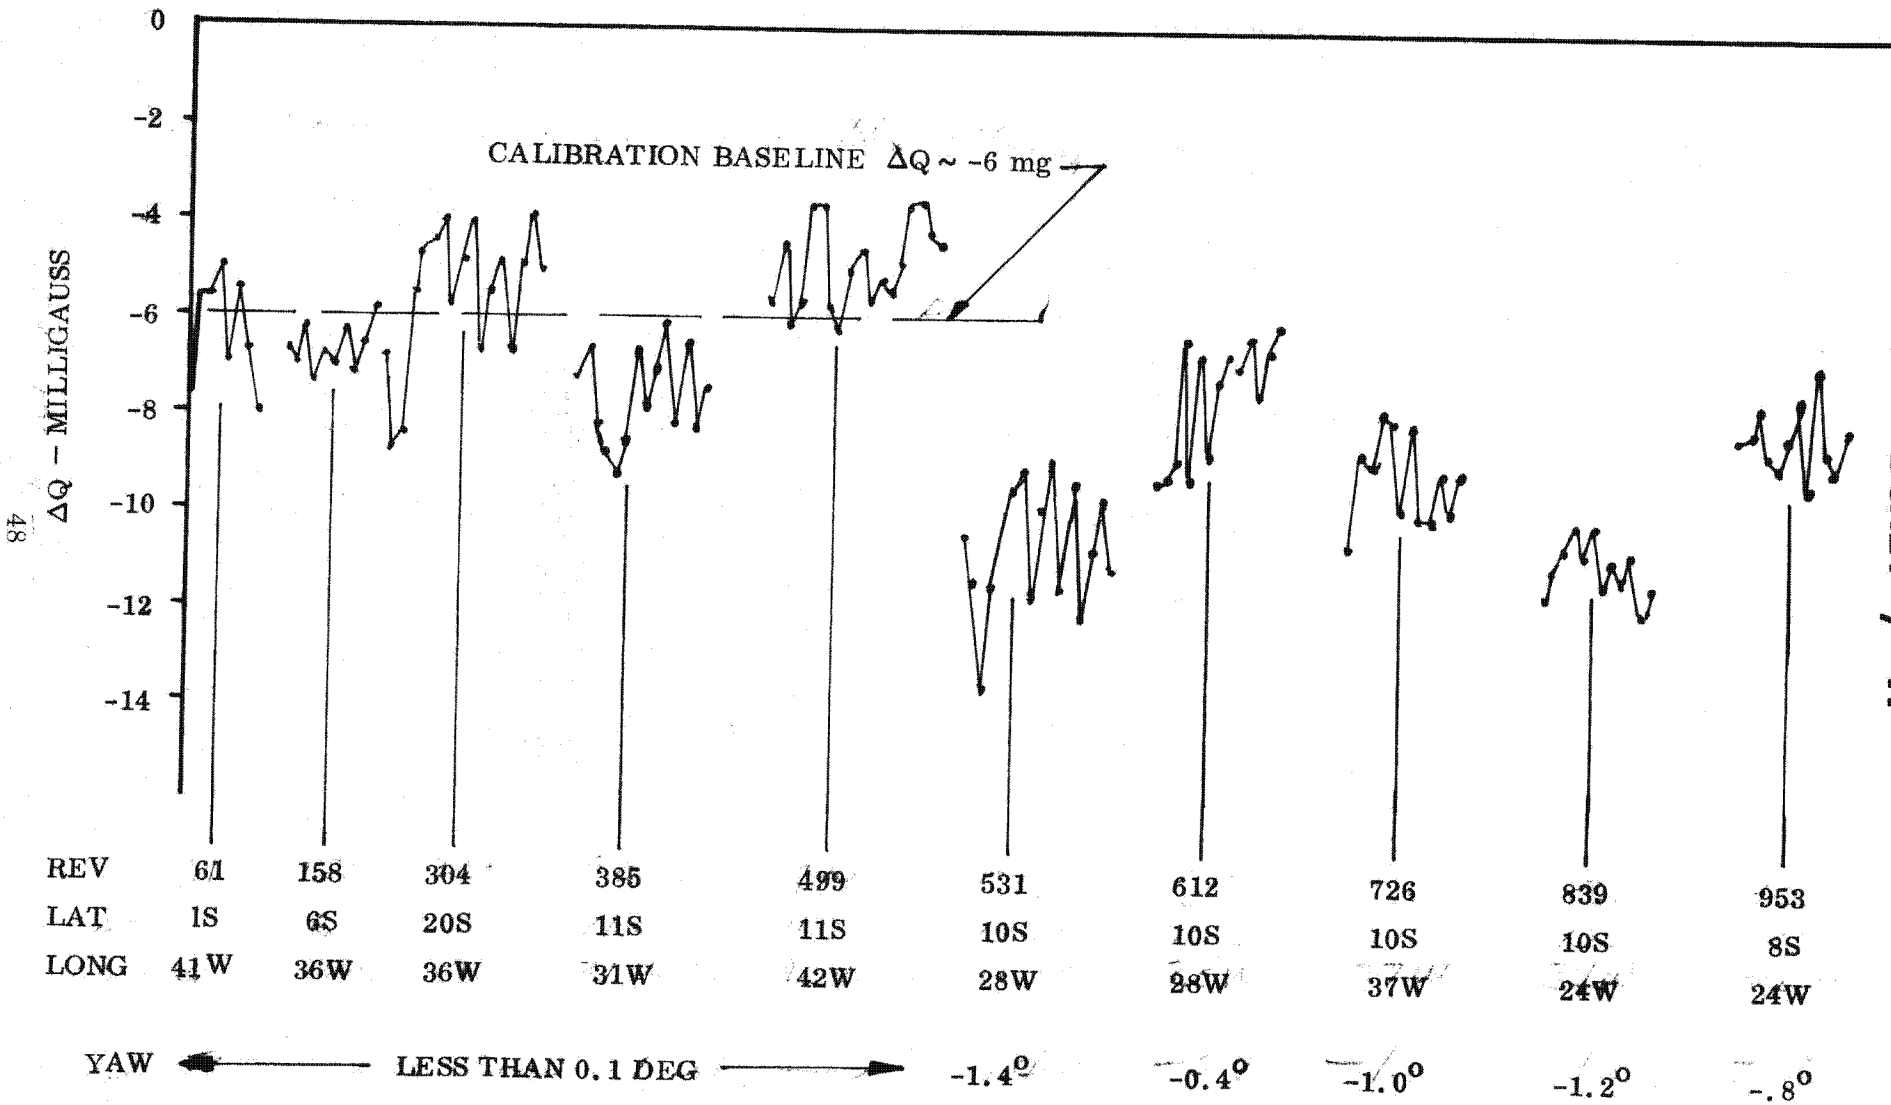
Figure 6-1 Yaw Effect on Q Magnetometer

determined. In the test this was done by spacing the tests approximately a week apart. Table 6-2 shows the test results derived from the test data shown in Fig. 6-1.

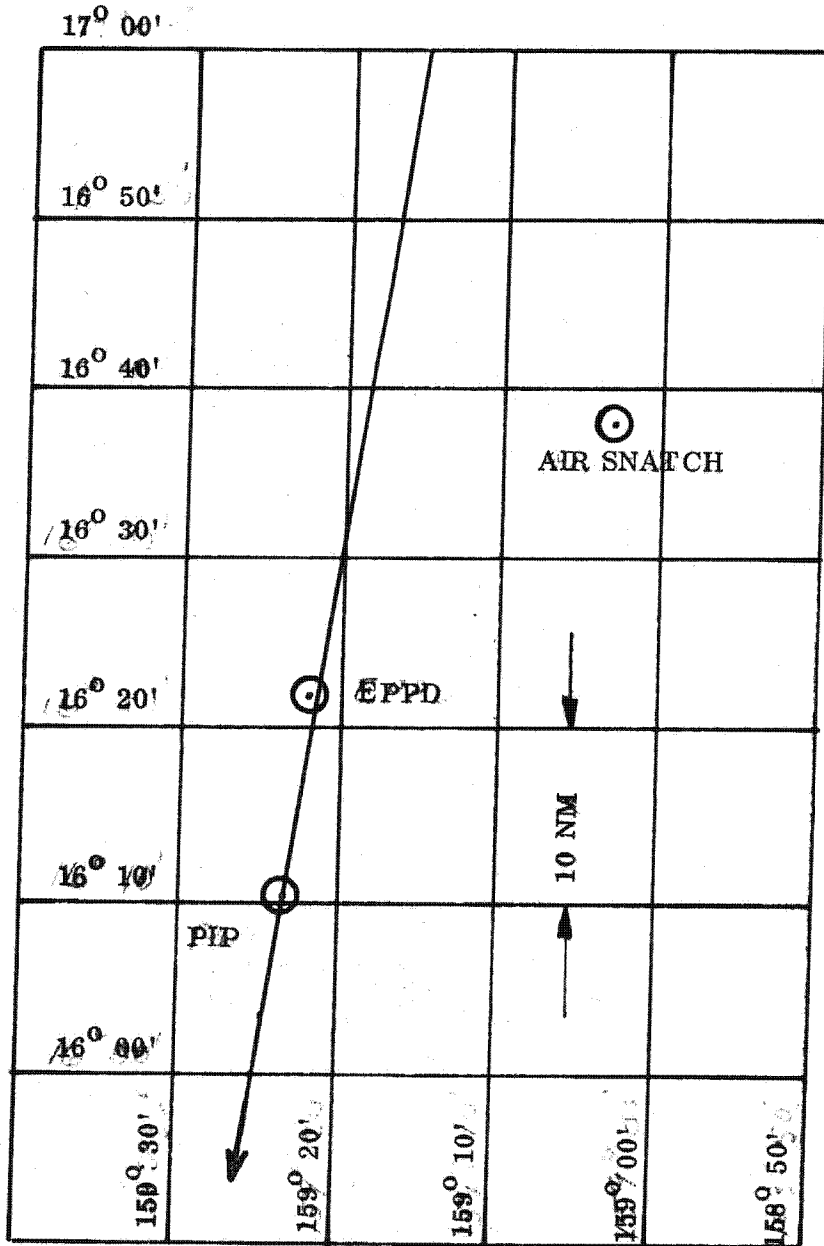
Fig. 11-1 ST-RV Recovery Locations

The predicted impact point (PIP), the estimated point of parachute deployment (EPPD) and the air snatch point are shown in Figure 11-1. The miss distance between the PIP and EPPD was calculated to be 11.68 nm short and 1.46 nm west of the ground track. The capsule was affected by a 125 KTS jet stream and was blown 16 nm from the EPPD by a 105 KTS wind from 250 degrees.

The capsule was recovered at 12,400 ft on the first pass with no damage to the chute or capsule.

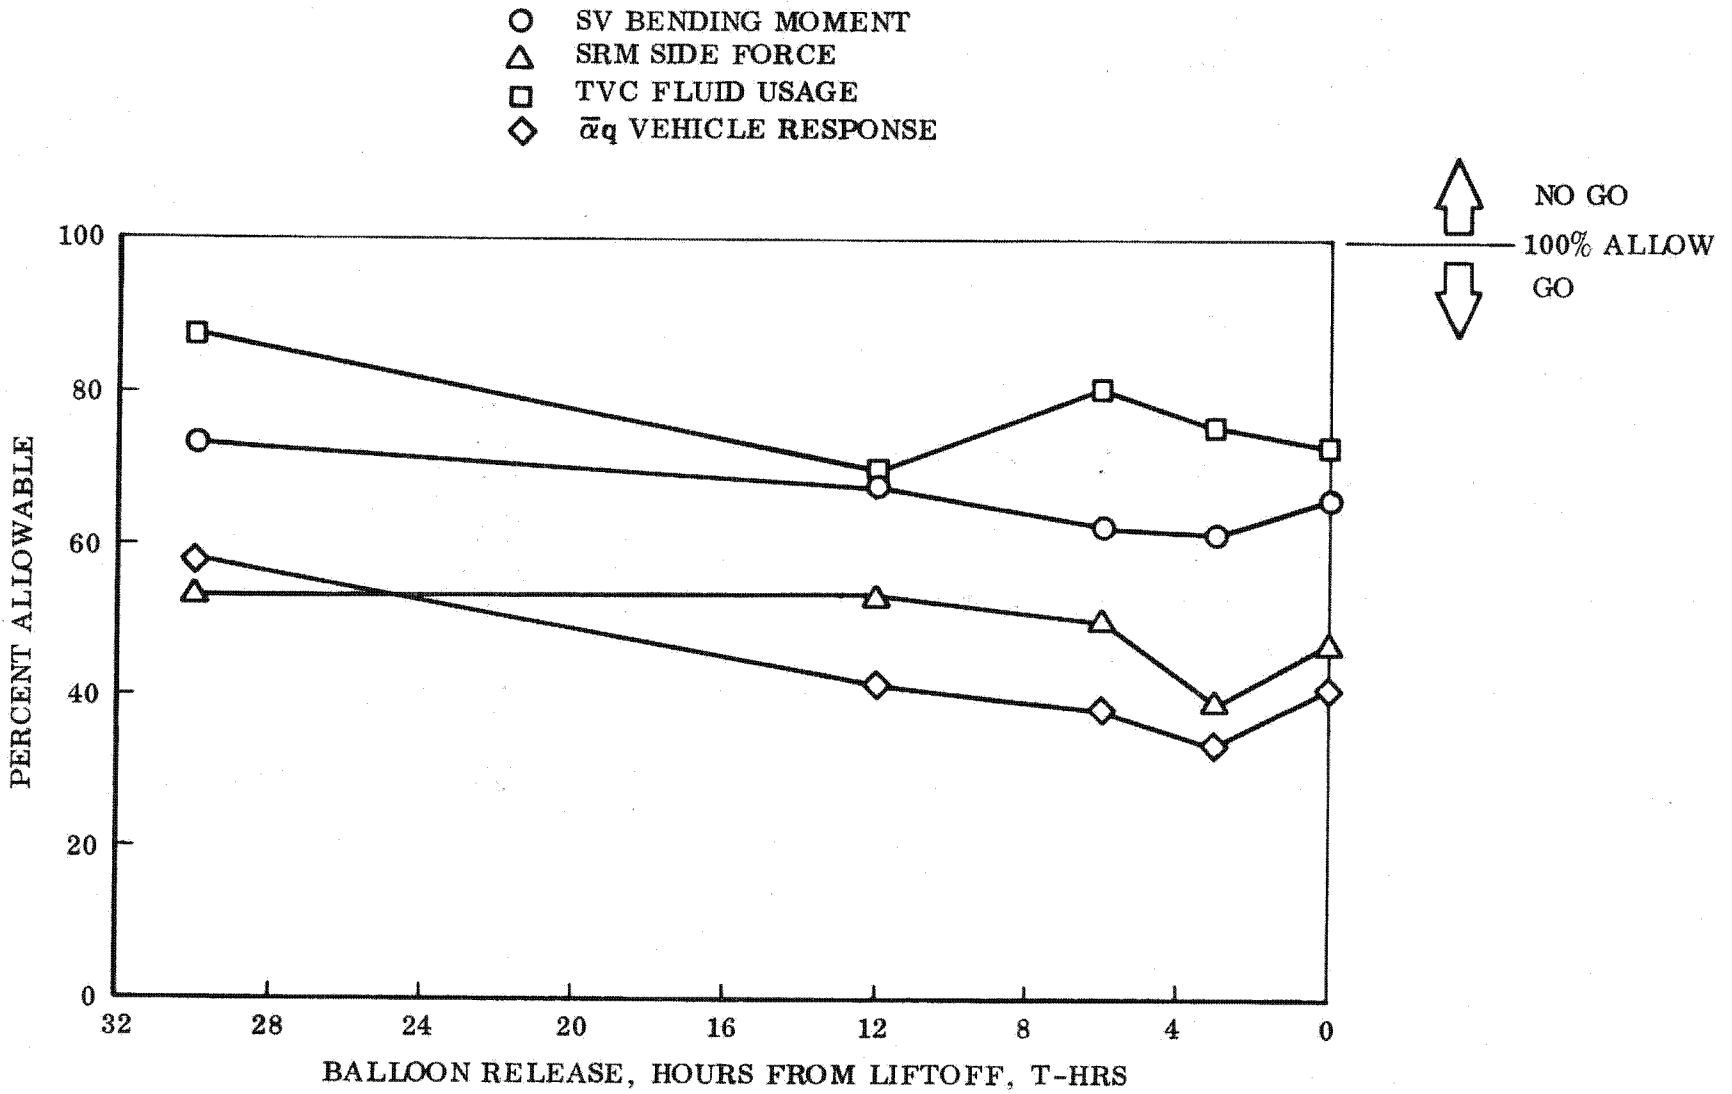
Fig. 14-1 Critical Launch Parameter Summary

Table 14-1 presents a chronological tabulation of the winds aloft computer runs for SV-5. The results are plotted on Fig. 14-1.

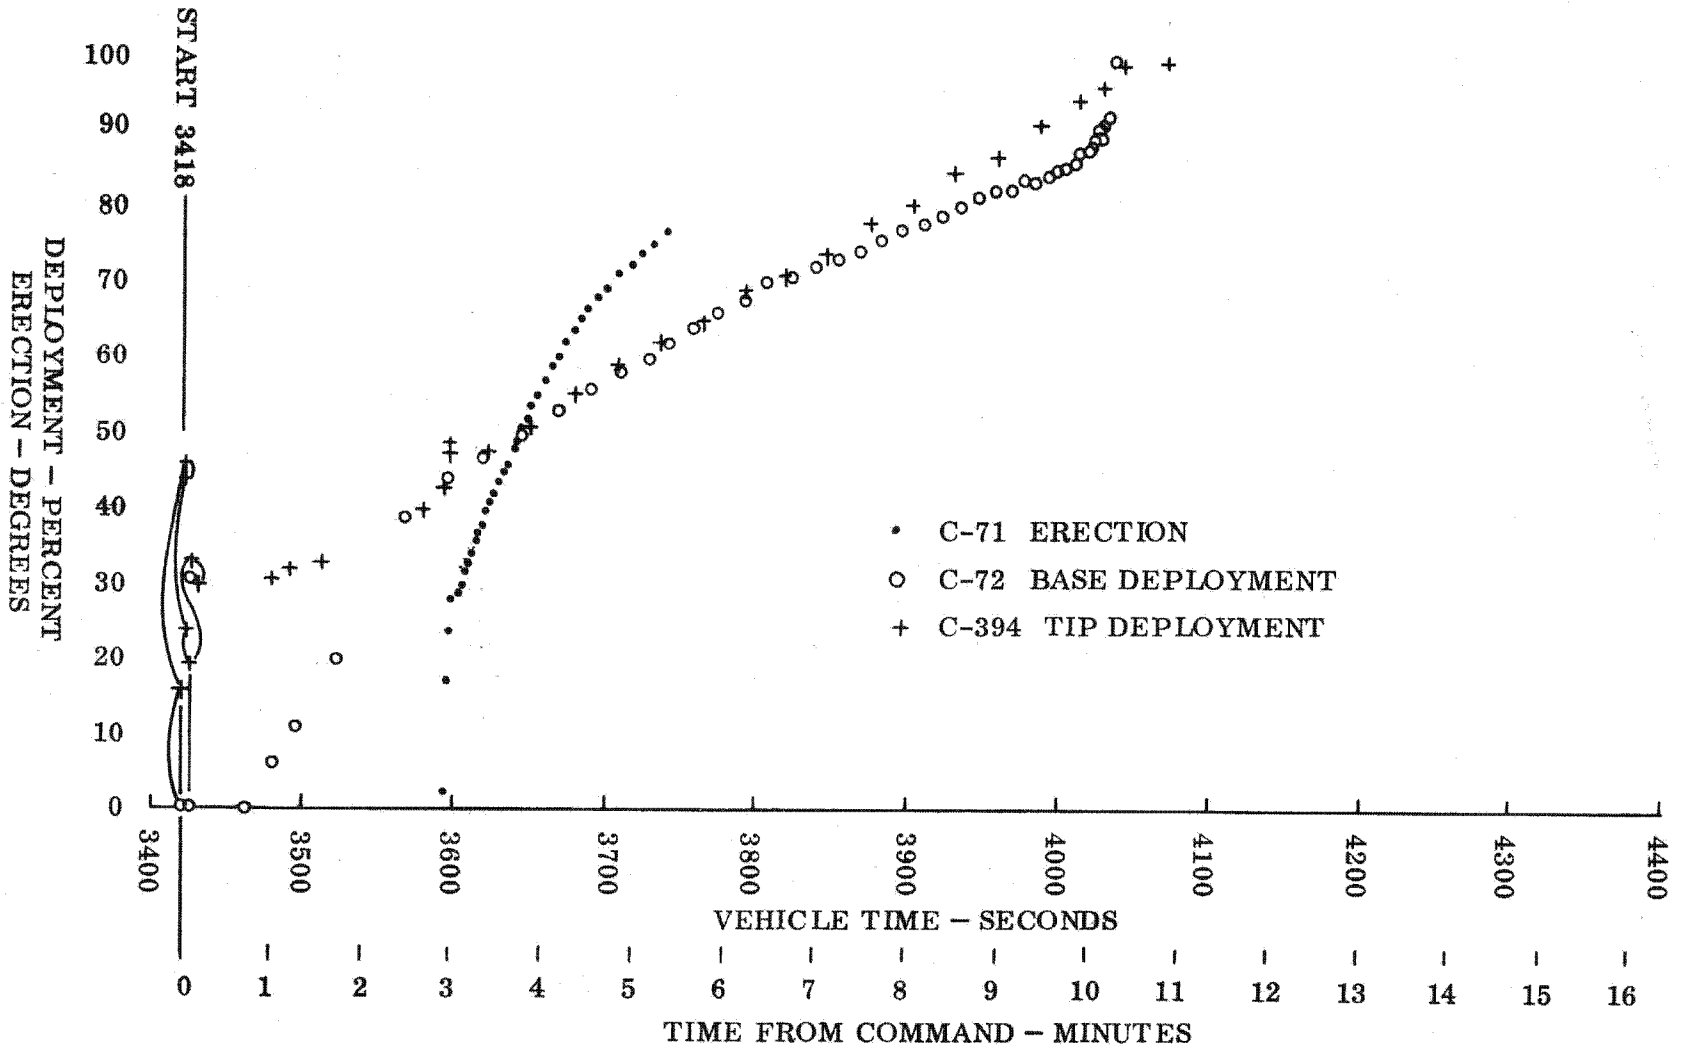
Fig. 14-2 Left-Hand Solar Array Erection and Deployment Time Histories

The erections and deployment time history for the left (-Y) solar array is shown in Fig. 14-2 and for the right (+Y) solar array in Fig. 14-3. It should be noted that the arrays were deployed at the first station pass, INDI. The arrays were fully deployed and erected by the next station, POGO, and they were then repositioned from +18 deg to 0 deg and then to -18 deg for maximum output at the flight beta angle of -7.8 deg. Deployment potentiometers have been added on the outboard solar panels which more accurately show the initial motion of the arrays (C-393 and C-394) and these are shown together with the potentiometers common to this and preceding vehicles.

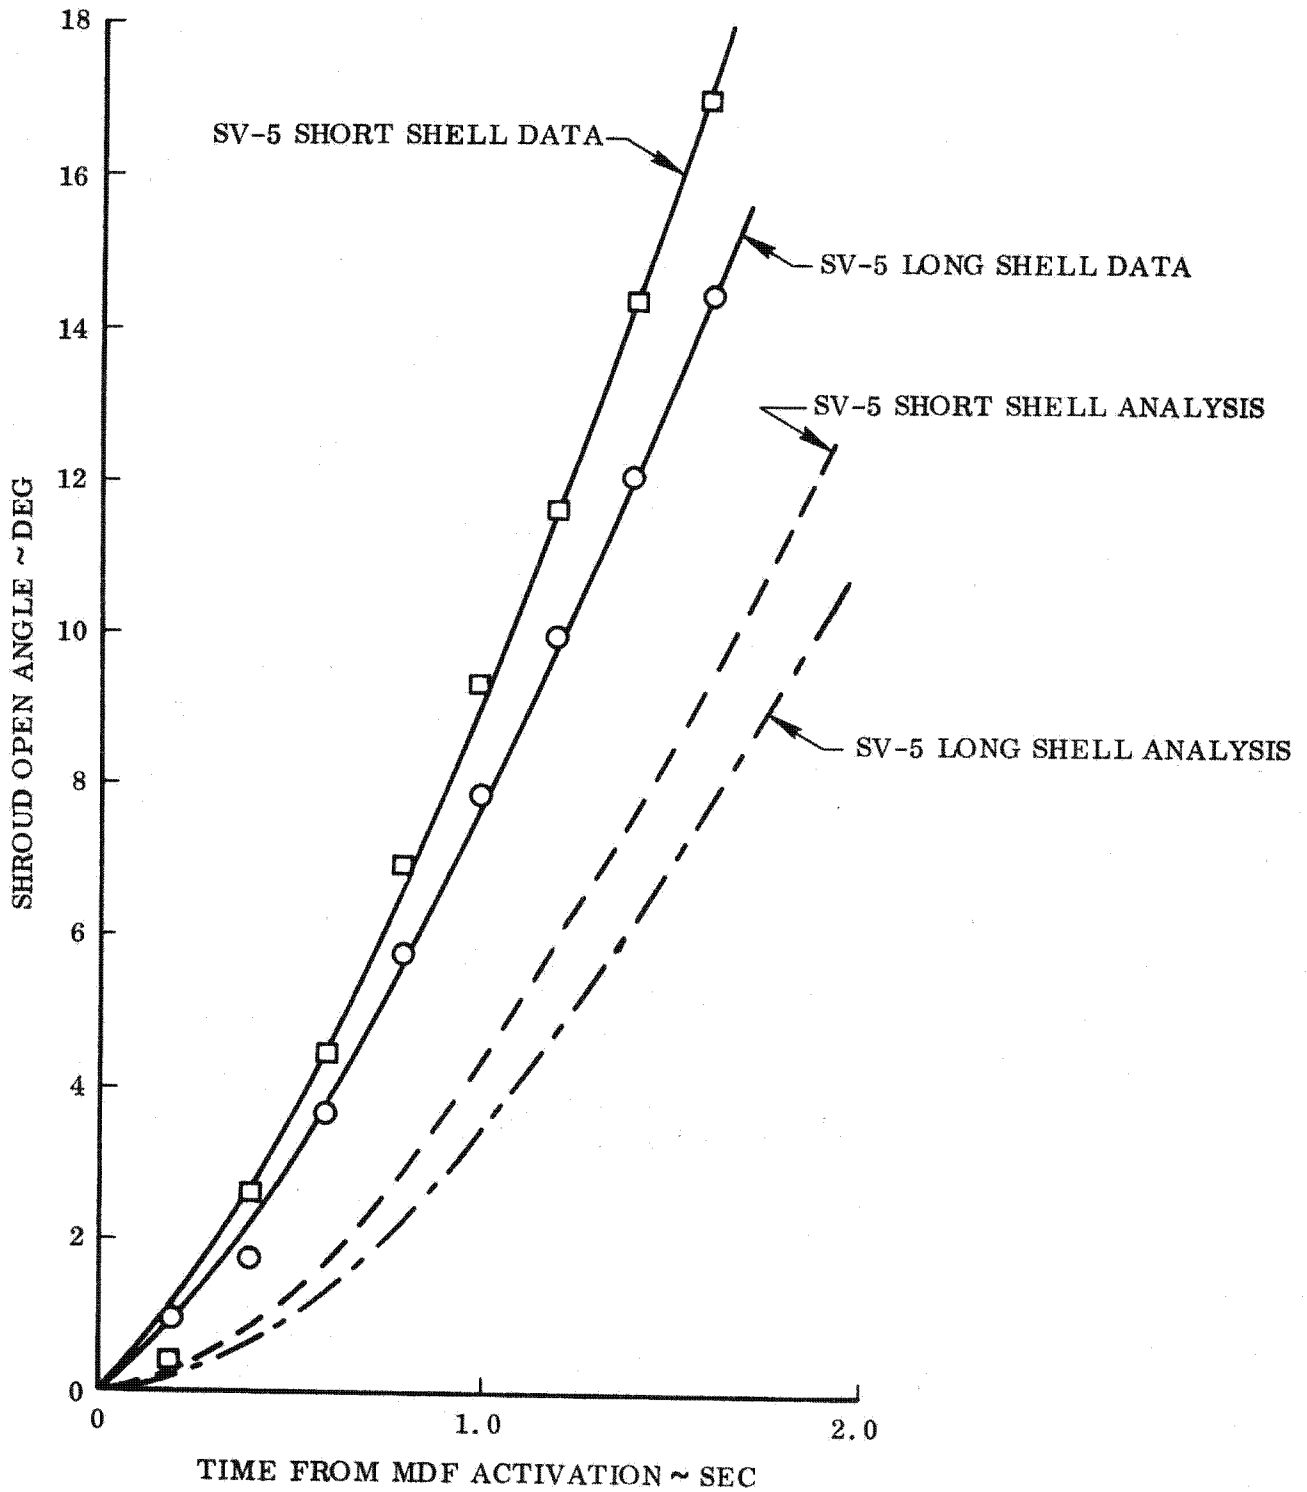
Fig. 14-4 Shroud Separation History

Previous flights have indicated the shroud separates faster than predicted. The potentiometer end was relocated on SV-5 to more accurately measure the initial 10 deg of shroud rotation by measuring only 18 deg rather than the full rotation (approximately 60 deg) before separation. The measured initial rates are shown in Fig. 14-4 to be 5 deg/sec faster than accounted for in pre-flight analysis. Two possible contributors to this initial velocity are being investigated:
