BIF003W/2-068875-73
HEXAGON Cy /
5 February 1973
Sheet Count: 73

FLIGHT TEST ENGINEERING ANALYSIS REPORT
FOR
THE HEXAGON PROGRAM SATELLITE VEHICLE NUMBER FOUR (S)

This report describes the performance of the fourth HEXAGON Program Satellite Vehicle (SV-4). The vehicle was launched on 10 October 1972 and after a 69 day primary mission and a 22 day SOLO mission was deboosted on Rev 1463 on 8 January 1973.

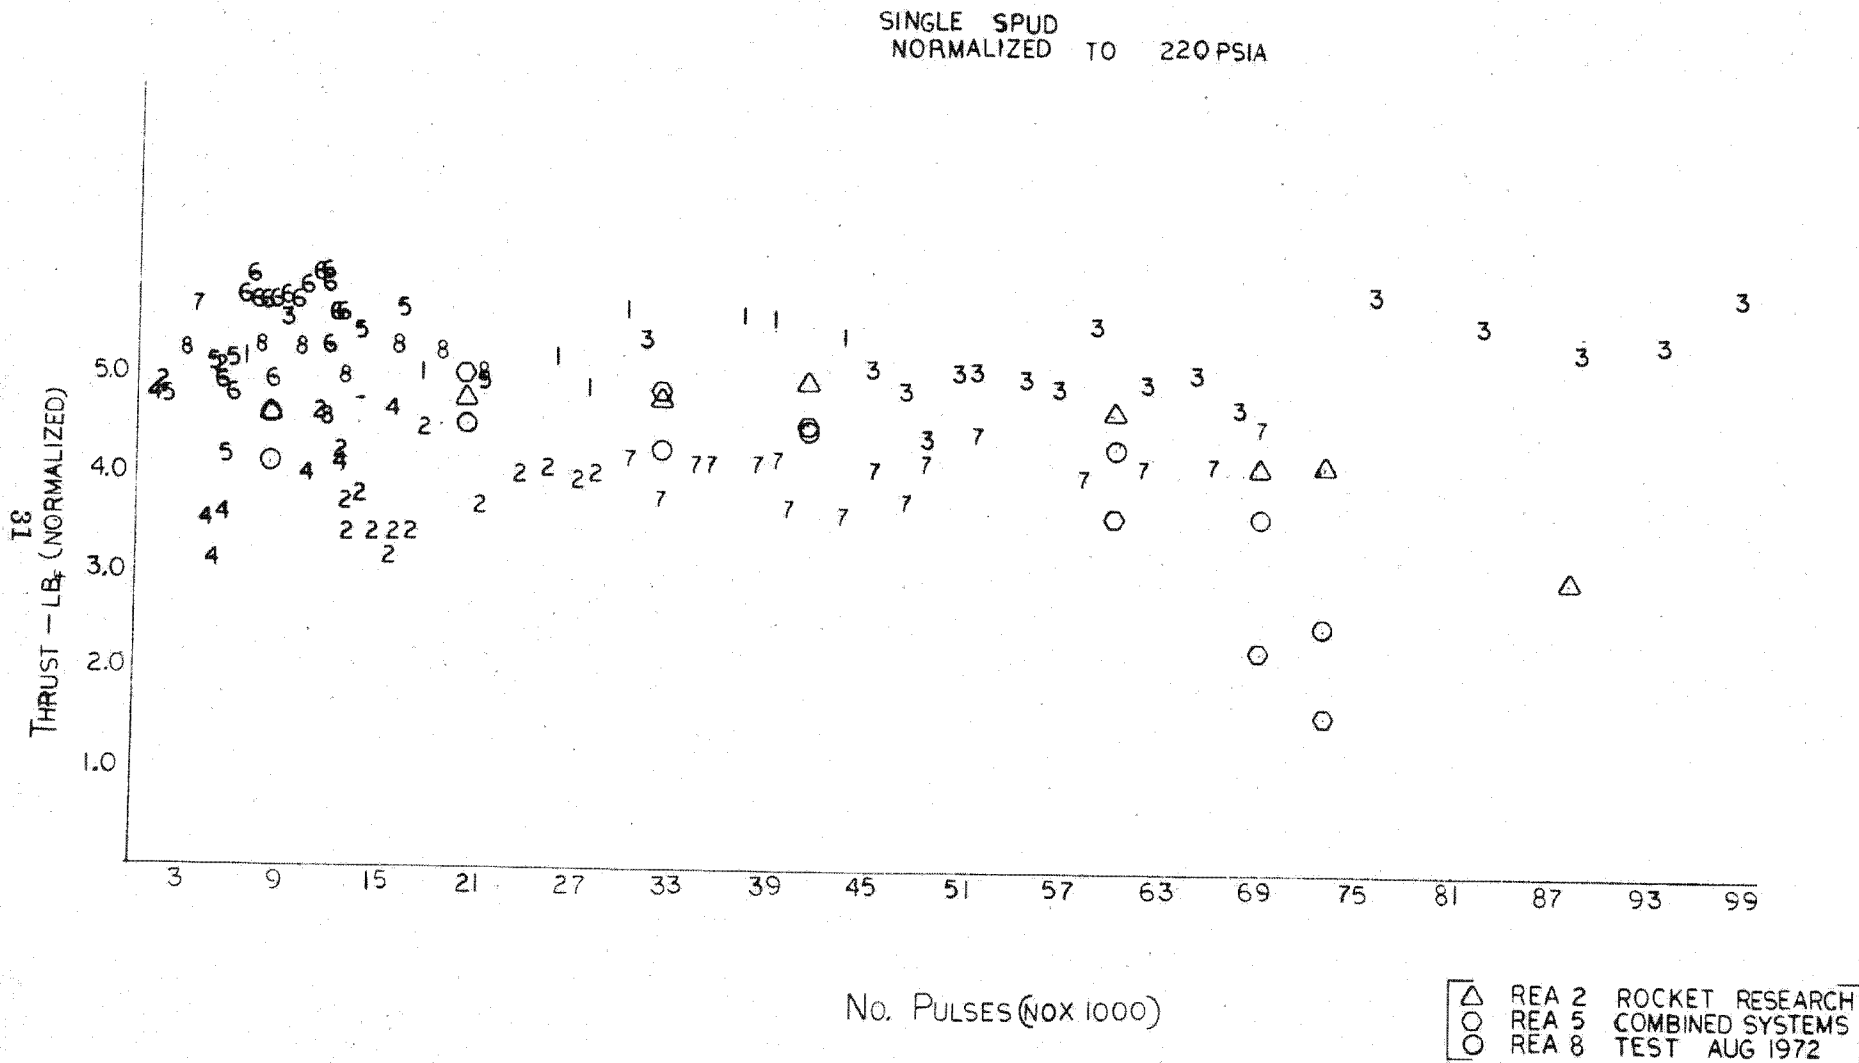
Fig. 2-4 RCS Thruster Health

producing steady state thrust were commanded and are noted on Fig. 2-2. Mini-pitch consisted of pitching the vehicle down 14° and then flying for 3.5 minutes prior to reconnecting the Horizon Sensors which allowed the vehicle to reattain the proper flight attitude without additional commanding. The mini-yaw was a 14° yaw and then a commanded return to the zero yaw position. Results obtained are shown in Fig. 2-3, and Fig. 2-4. Figure 2-3 is a non-normalized plot and shows the method of determining the thrust is accurate enough to follow the normal blow down curve. Figure 2-4 presents the REA thrusts normalized to a 220 psi feed pressure plotted against pulse count. Included on Fig. 2-4 are the results of the combined system ground test at Rocket Research. The thrust degradation at 60-70,000 pulses seen in the ground test did not materialize in flight. It can be seen that only one thruster significantly exceeded the ground test pulse life; however, the more important parameter, mission days, was more than doubled.

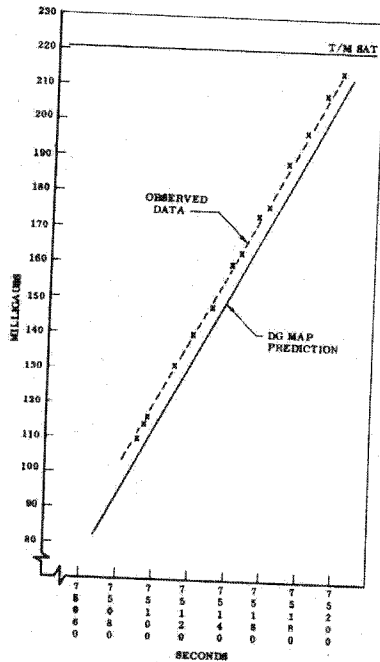
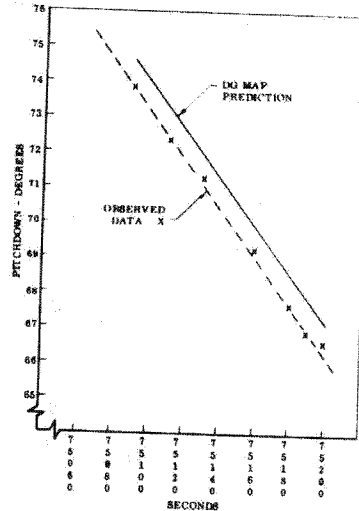
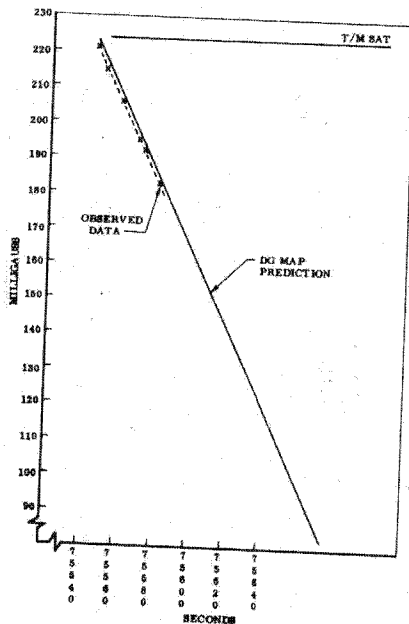
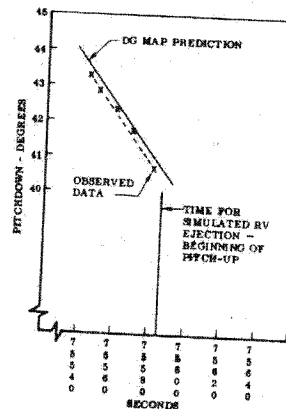
Fig. 6-1a

The vehicle was inertially flown so as to be in an RV recovery attitude with a pitchdown of -40.7 degrees at KOD1 at System Time 75785.6 on Rev 813. Based on the observed position of the vehicle after the ACS programmed pitchup, the actual pitchdown at separation was 0.22 degrees greater than desired.

DGMAP using the inertial stabilization option was used to predict the theoretical P, Q and R magnetometer readings to be expected at POGO and KODI for the predicted inertial position of the vehicle. The predicted and observed sensor readings and the predicted and observed pitch angles are shown in Fig. 6-1. It can be seen that the R sensor reading at POGO established the attitude to be about one degree less than the true position of the vehicle if the 0.22 degree error is added to the difference on the graph. The P sensor is above the saturation level of the TM at POGO. At KODI the R sensor saturates the TM but the P sensor established the pitch attitude to be about 0.4 degrees less than the actual.

R Sensor in N-S RV Recovery Mode Over POGO (P Sensor Saturates TM)

P Sensor in S-N Deboost Mode Over KODI (R Sensor Saturates TM)

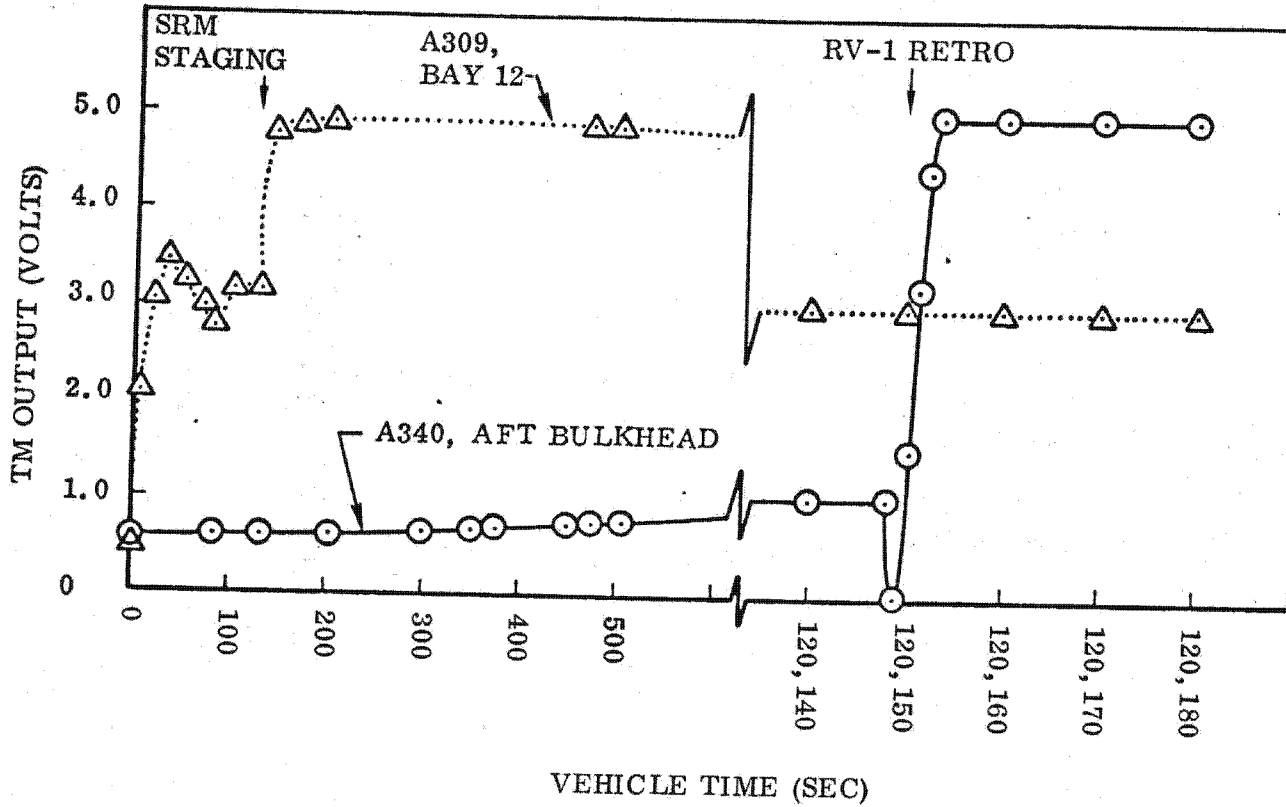
Fig. 12-3 8004 QCM Data

The mass deposition measured during ascent by the QCM's is shown in Fig. 12-3. The results are shown in TM volts, but the calibration curves for the QCM's indicate that the actual mass deposit during ascent was 3.8×10^{-5} g/cm².

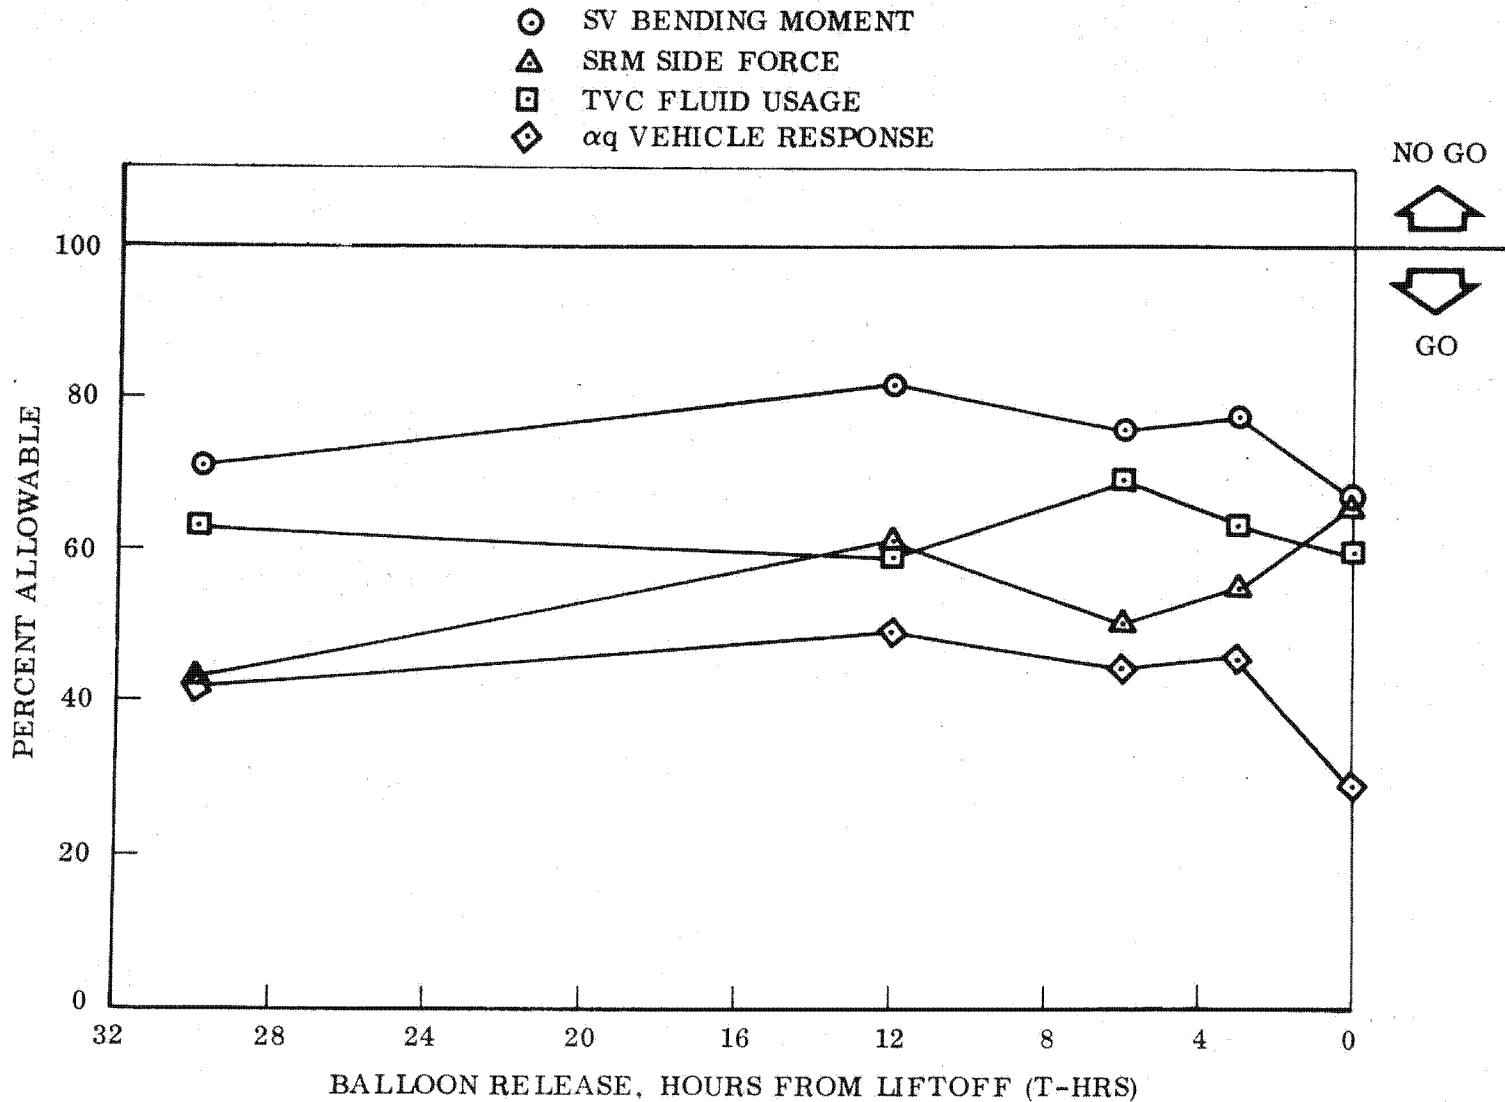
Fig. 14-1 Critical Parameter Summary

Table 14-1 presents a chronological tabulation of the winds aloft computer runs for SV-4. The results are plotted on Fig. 14-1.
