25 August 1971

FLIGHT TEST ENGINEERING ANALYSIS REPORT  
FOR  
THE HEXAGON PROGRAM SATELLITE VEHICLE NUMBER ONE (S)

Prepared and Submitted by the  
Satellite Vehicle Integrating Contractor

This report describes the performance of the first HEXAGON Program Satellite Vehicle (SV-1). The vehicle was launched on 15 June 1971 and completed its primary mission with the recovery of RV number four on 16 July 1971. This report encompasses only these 31 days.

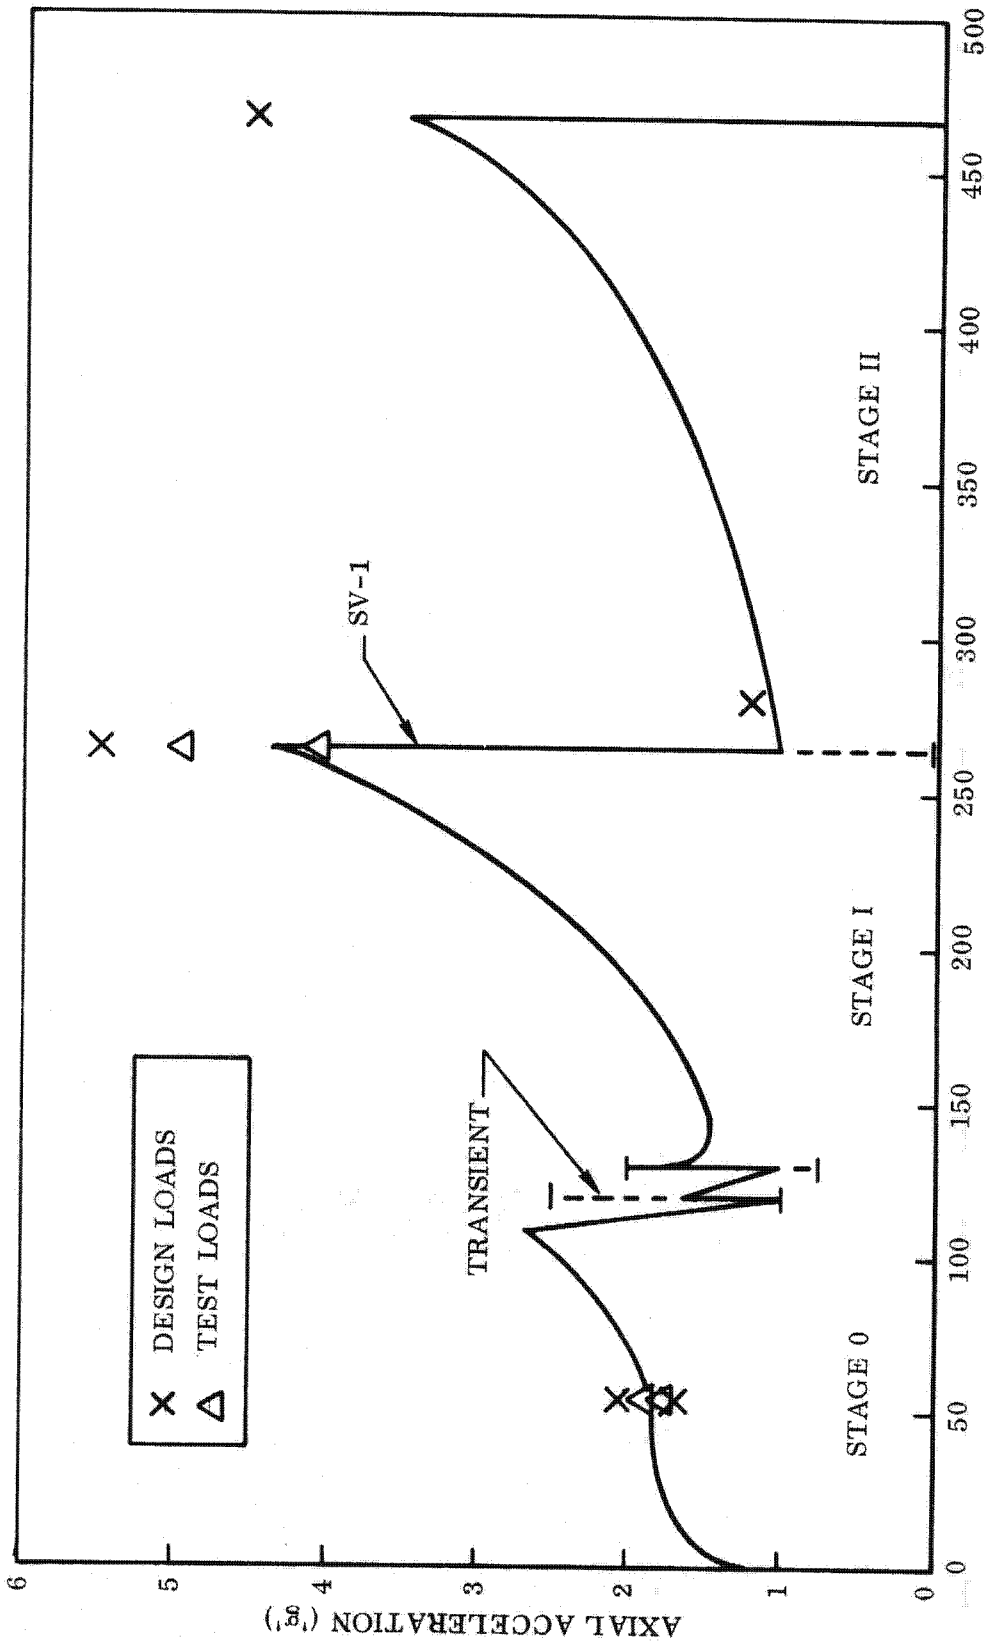
Fig. 14-1 Axial Acceleration History

The axial accelerations were measured at Station 1642 and 2180 and are shown in Fig. 14-1 along with the design and static test levels for the complete ascent.

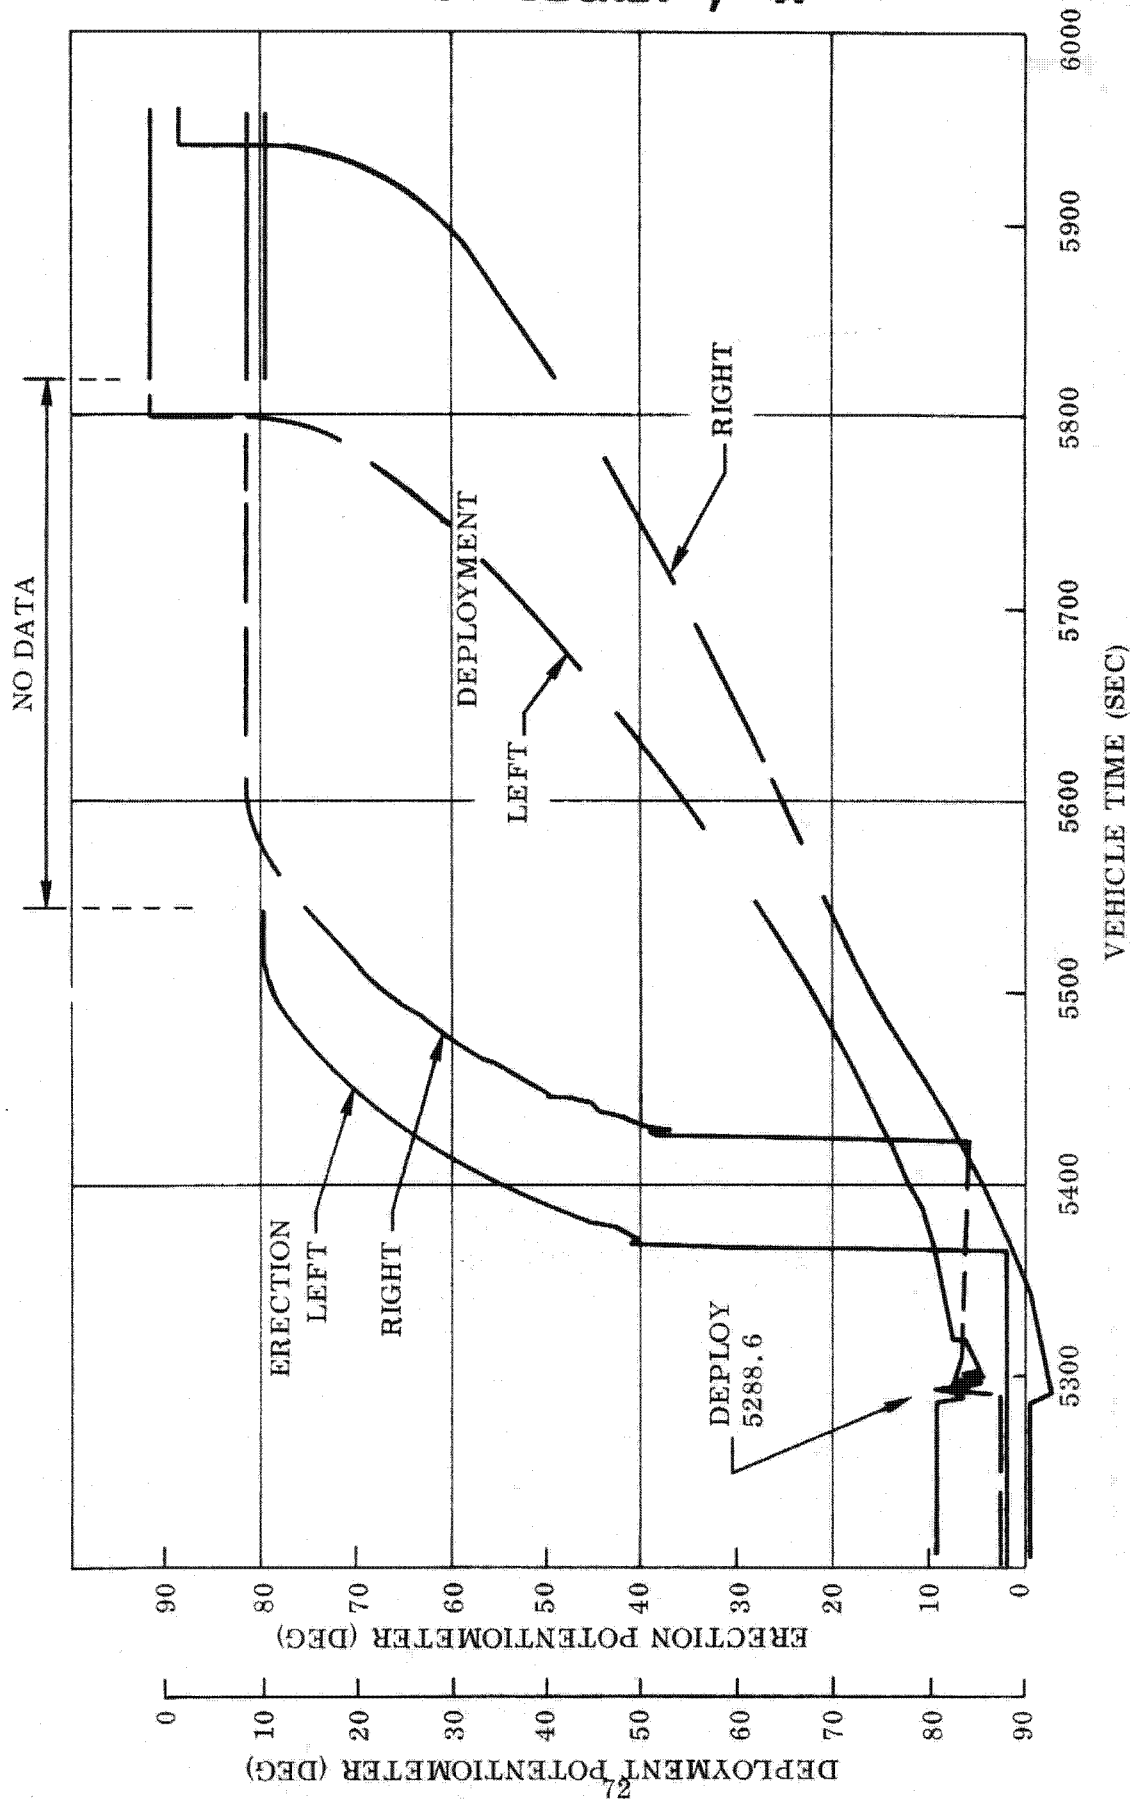
Fig. 14-3 Solar Array Erection and Deployment

The history of the solar array erection and deployment are shown in Fig. 14-3. Since the arrays were deployed and erected in the proper position for this flight's beta angle, no positioning was necessary and none was performed.

Data exists to describe completely the erection of the left solar array and it was completed 230 sec after deployment was commanded. Only partial data is available for the other motions; however, data for the final portion of the deployment of the right array permits probable histories for all the motions to be sketched in on Fig. 14-3. It is estimated that the right solar array erected in 320 sec. The time for the right deployment was 650 sec and the time for the left deployment is estimated at 510 sec. Temperatures of the left and right erection dampers were 63 and 65<sup>o</sup>F respectively. The right array also took longer to erect and deploy during ground tests.
