BIF003W/2-090260-73 HEXAGON Copy No. Sheet Count: 64 9 November 1973

FLIGHT TEST ENGINEERING ANALYSIS REPORT

THE HEXAGON PROGRAM SATELLITE VEHICLE NUMBER SIX (S)

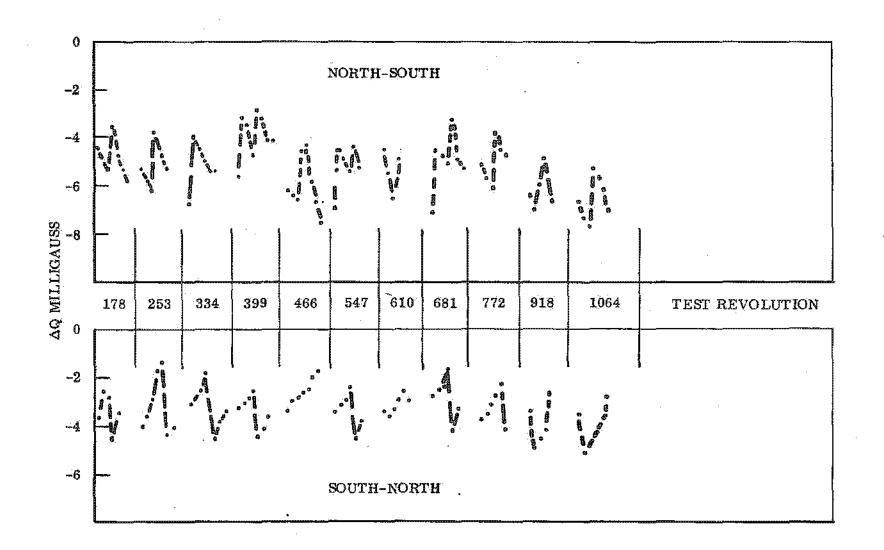
Fig. 6-1 Yaw Attitude Determination Tests

This data is shown in Figure 6-1. During these tests yaw attitude was approximately zero degrees. Since a 1 degree yaw error would result in a 6 milligauss change in the ΔQ magnetometer from DGMAP, it can be seen that such an error would be difficult to detect without the establishment of the magnetometer distortion error while ACS control is normal.

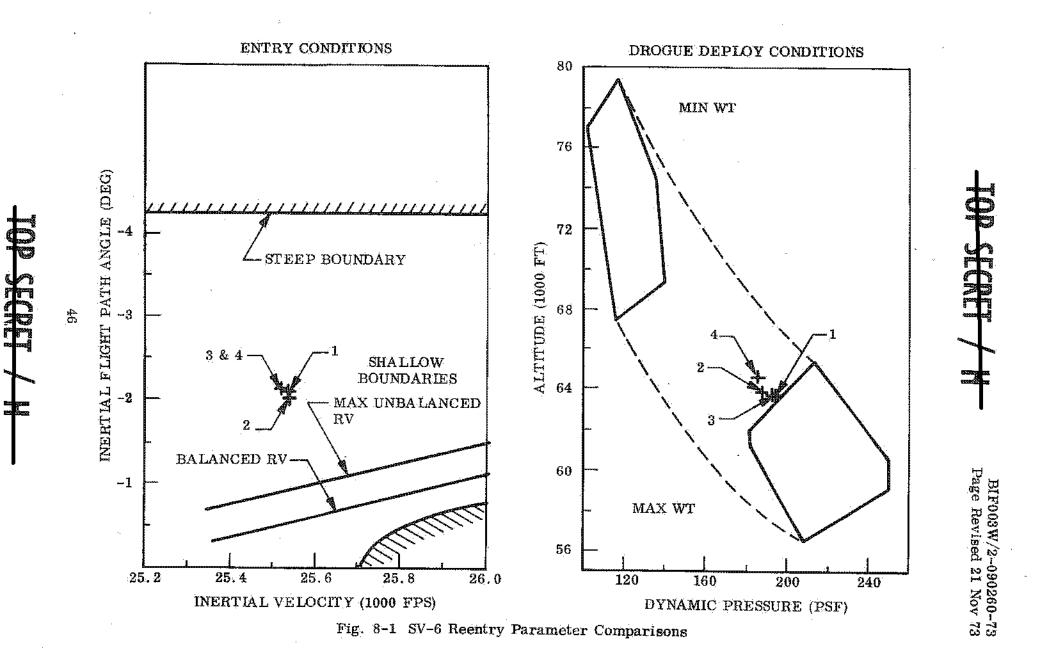
The recovery statistics are shown in Table 8-1 and Fig. 8-1. Performance of the RV subsystems is summarized in Table 8-2. Data indicate that all RV events (on-orbit, reentry and recovery) occurred as planned (except for the premature activation of the flashing recovery light during "reel-in" on all flights except RV-2) and the RV flights followed the predicted trajectories. In addition to premature activation of the flashing light, two minor anomalies occurred. On RV-4, the Recovery Light cover lanyard failed at its attach point to the drogue lazy leg. The cover was removed from the light but the cover and lanyard were not extracted from the vehicle. Also on RV-4 a heat-shield SMDC (Shielded Mild Detonating Cord) line separated from its connector with no adverse effects.

The RVs were adequately spin stabilized during the vacuum coast phase and aerodynamically stable during the atmospheric phase of the reentry trajectory. Figure 8-1 shows the entry conditions to be well within previously established entry boundaries and that the conditions at time of drogue chute deployment were within the design envelope.

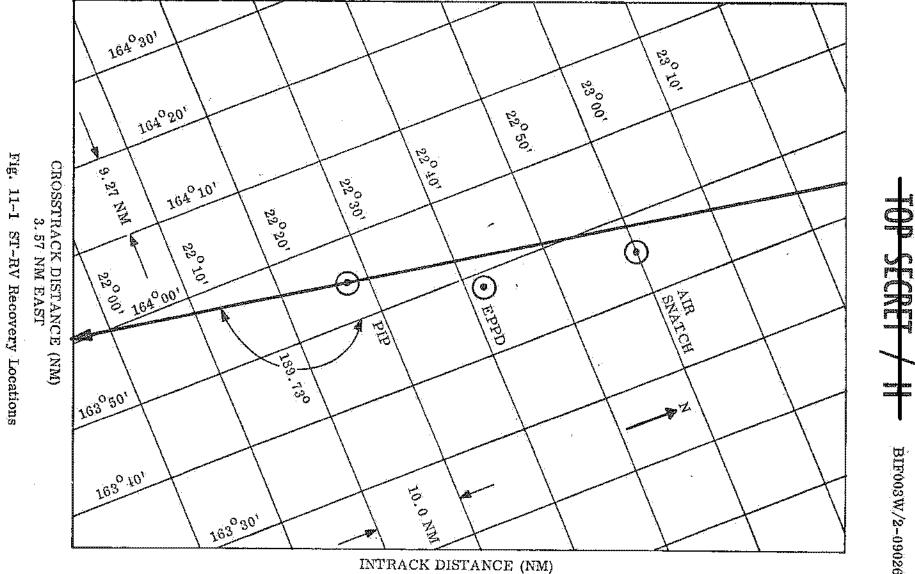
The predicted impact point (PIP), the estimated point of parachute deployment (EPPD) and the air snatch point are shown in Fig. 11-1. The miss distance between the PIP and EPPD was calculated to be 15.22 nm short and 3.57 nm East of the ground track. The offset of the pick-up point and the EPPD is attributed to wind. The capsule was recovered at 12,800 ft on the first pass with no damage to the chute or capsule.

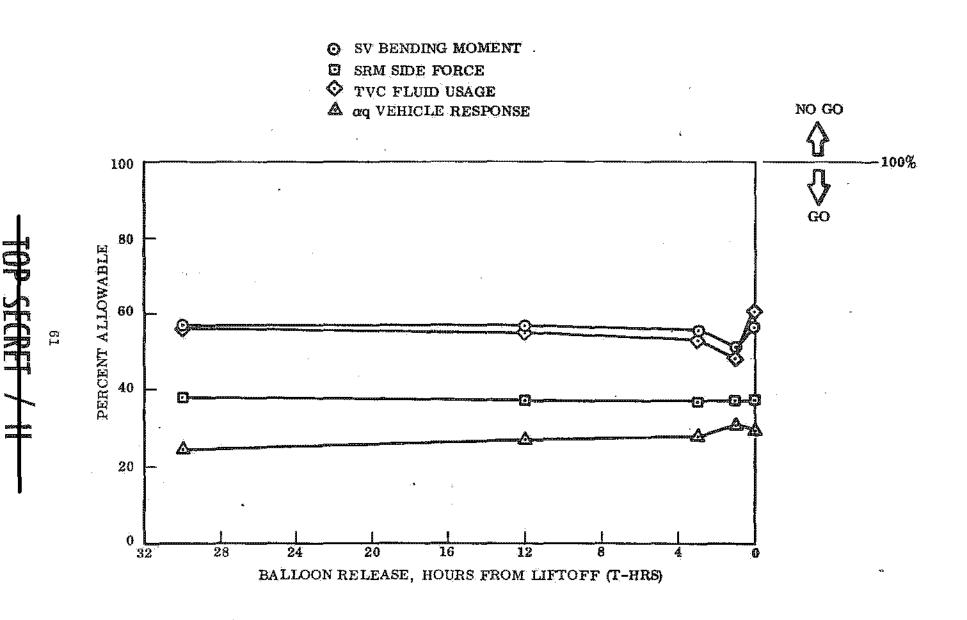
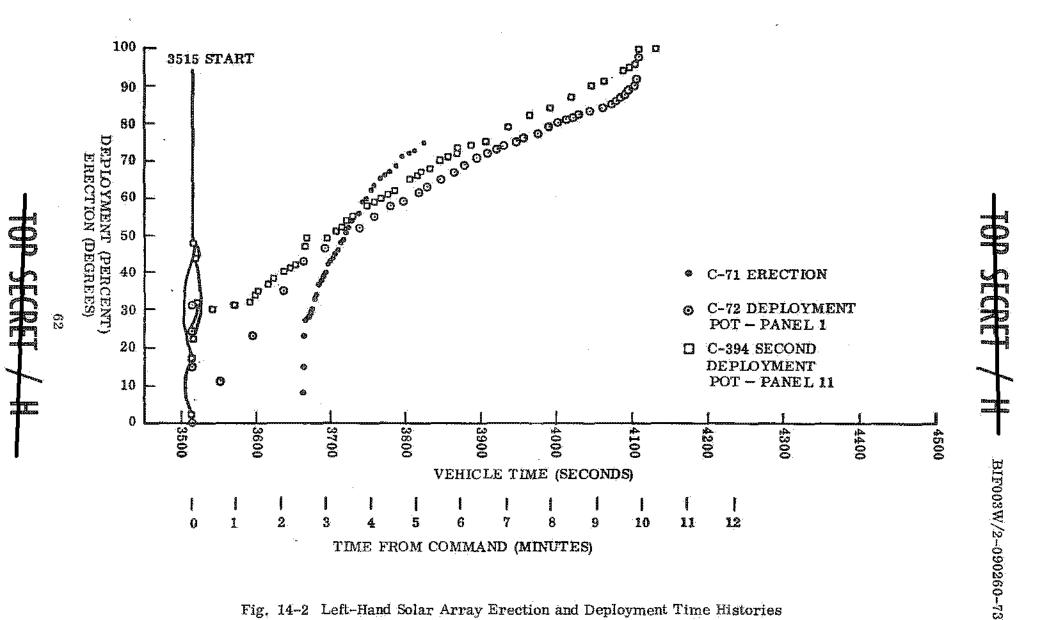
Fig. 14-2 Left-Hand Solar Array Erection and Deployment Time Histories

The erection and deployment time history for the left (-Y) solar array is shown in Fig. 14-2 and for the right (+Y) solar array in Fig. 14-3. The arrays were deployed at the first station pass, INDI, and were fully deployed and erected by the next station, POGO where they were repositioned from +18 to 0 deg for the maximum output at the flight beta angle of -1.9 deg.
