PHOTOGRAPHIC EVALUATION REPORT

MISSION 1001-1

25-29 SEPTEMBER 1963

NATIONAL PHOTOGRAPHIC INTERPRETATION CENTER

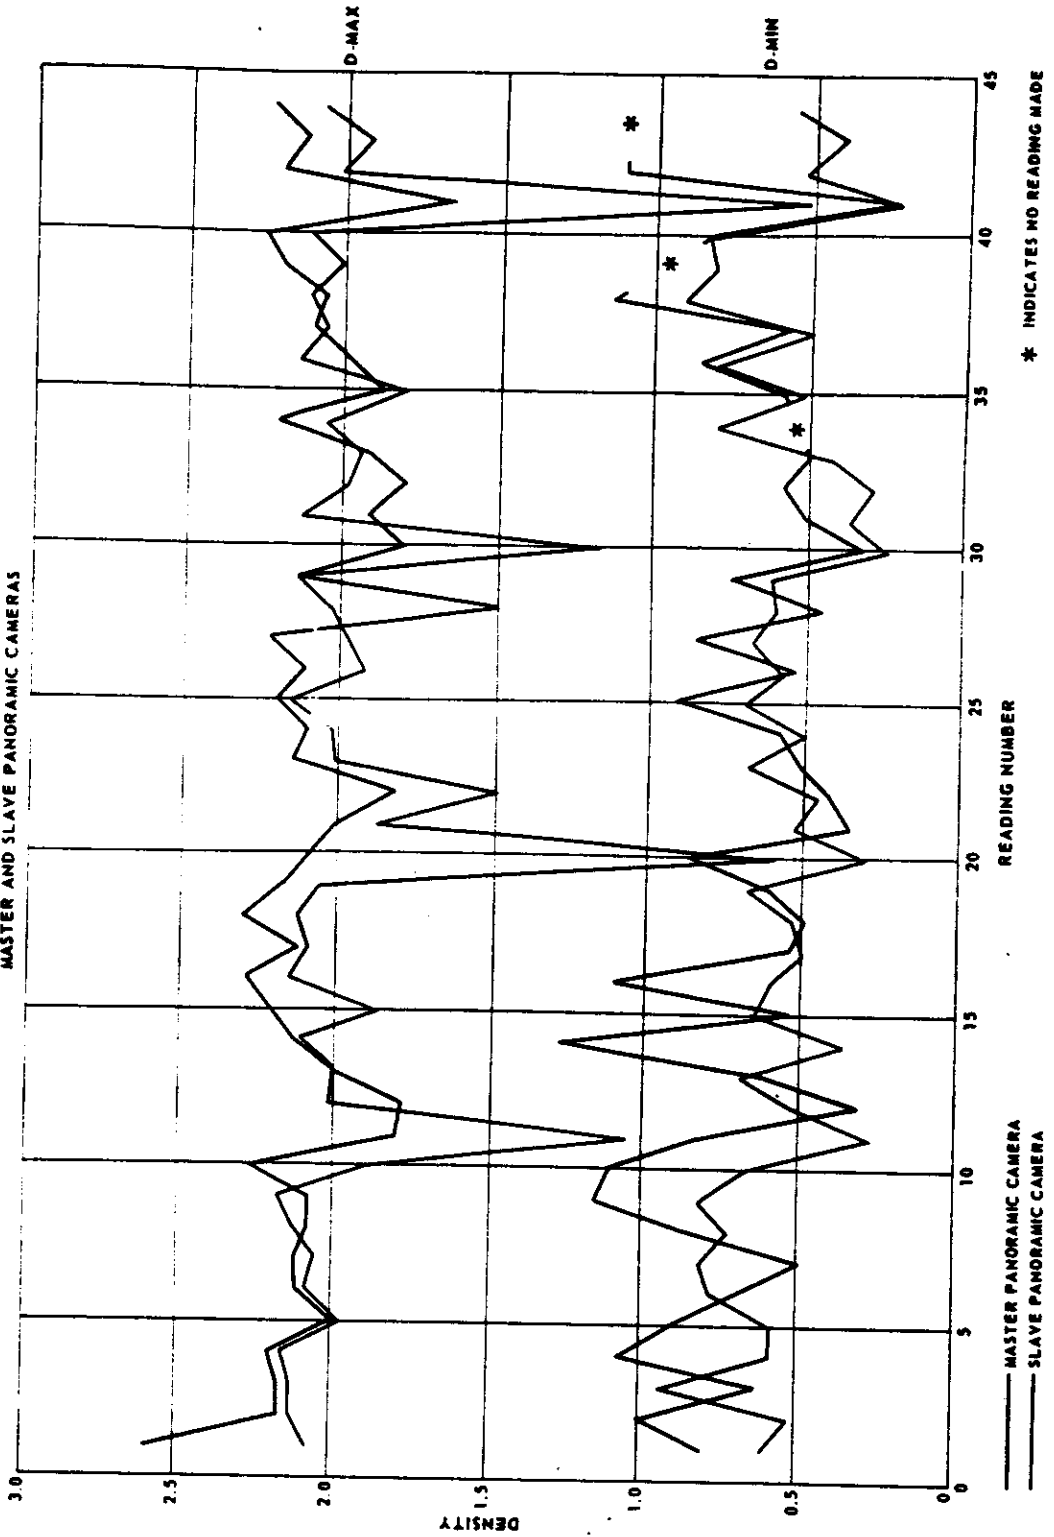
MISSION 1001-1
LIMITING DENSITIES
MASTER AND SLAVE PANORAMIC CAMERAS

* INDICATES NO READING MADE

— MASTER PANORAMIC CAMERA
- - - SLAVE PANORAMIC CAMERA

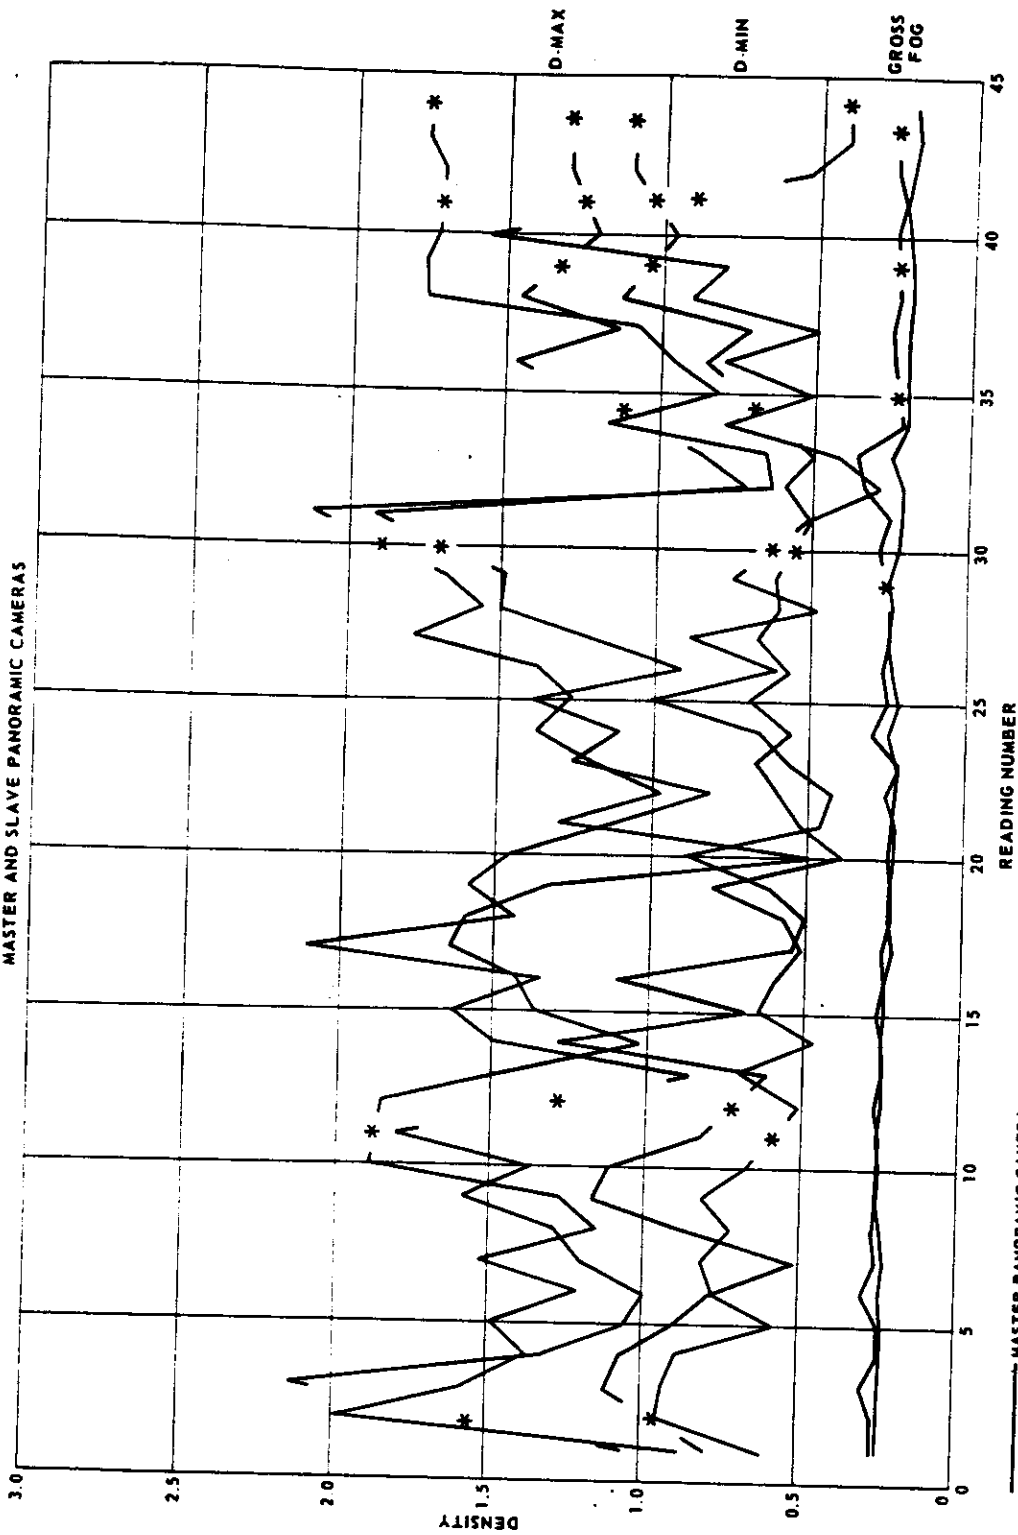
MISSION 1001-1
TERRAIN DENSITIES
MASTER AND SLAVE PANORAMIC CAMERAS

--- MASTER PANORAMIC CAMERA
--- SLAVE PANORAMIC CAMERA
* * * INDICATES NO READING MADE
NPIC H-8788 11/641
