CORONA J

PERFORMANCE EVALUATION REPORT

MISSION 1039-1 and 1039-2

PR 1635 J-39

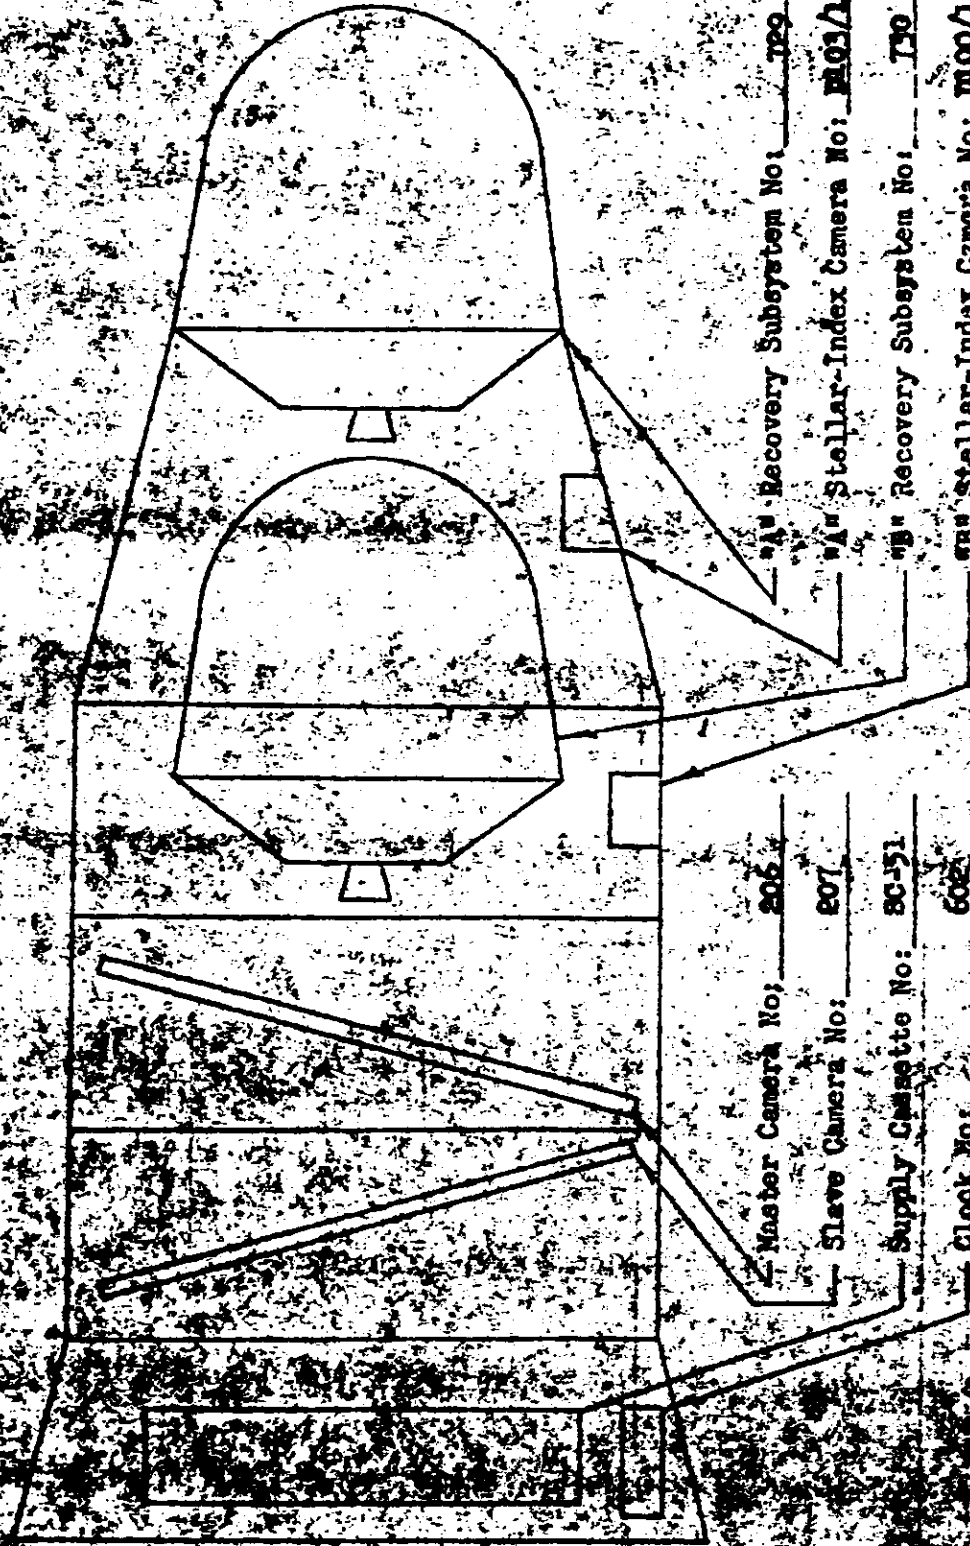
SCHEMATIC INBOARD PROFILE - CORONA J. EYSTER

MISSION 1039

Master Camera No: 206

Slave Camera No: 207
