CORONA J

PERFORMANCE EVALUATION REPORT

MISSION 1101

VEHICLE 1641

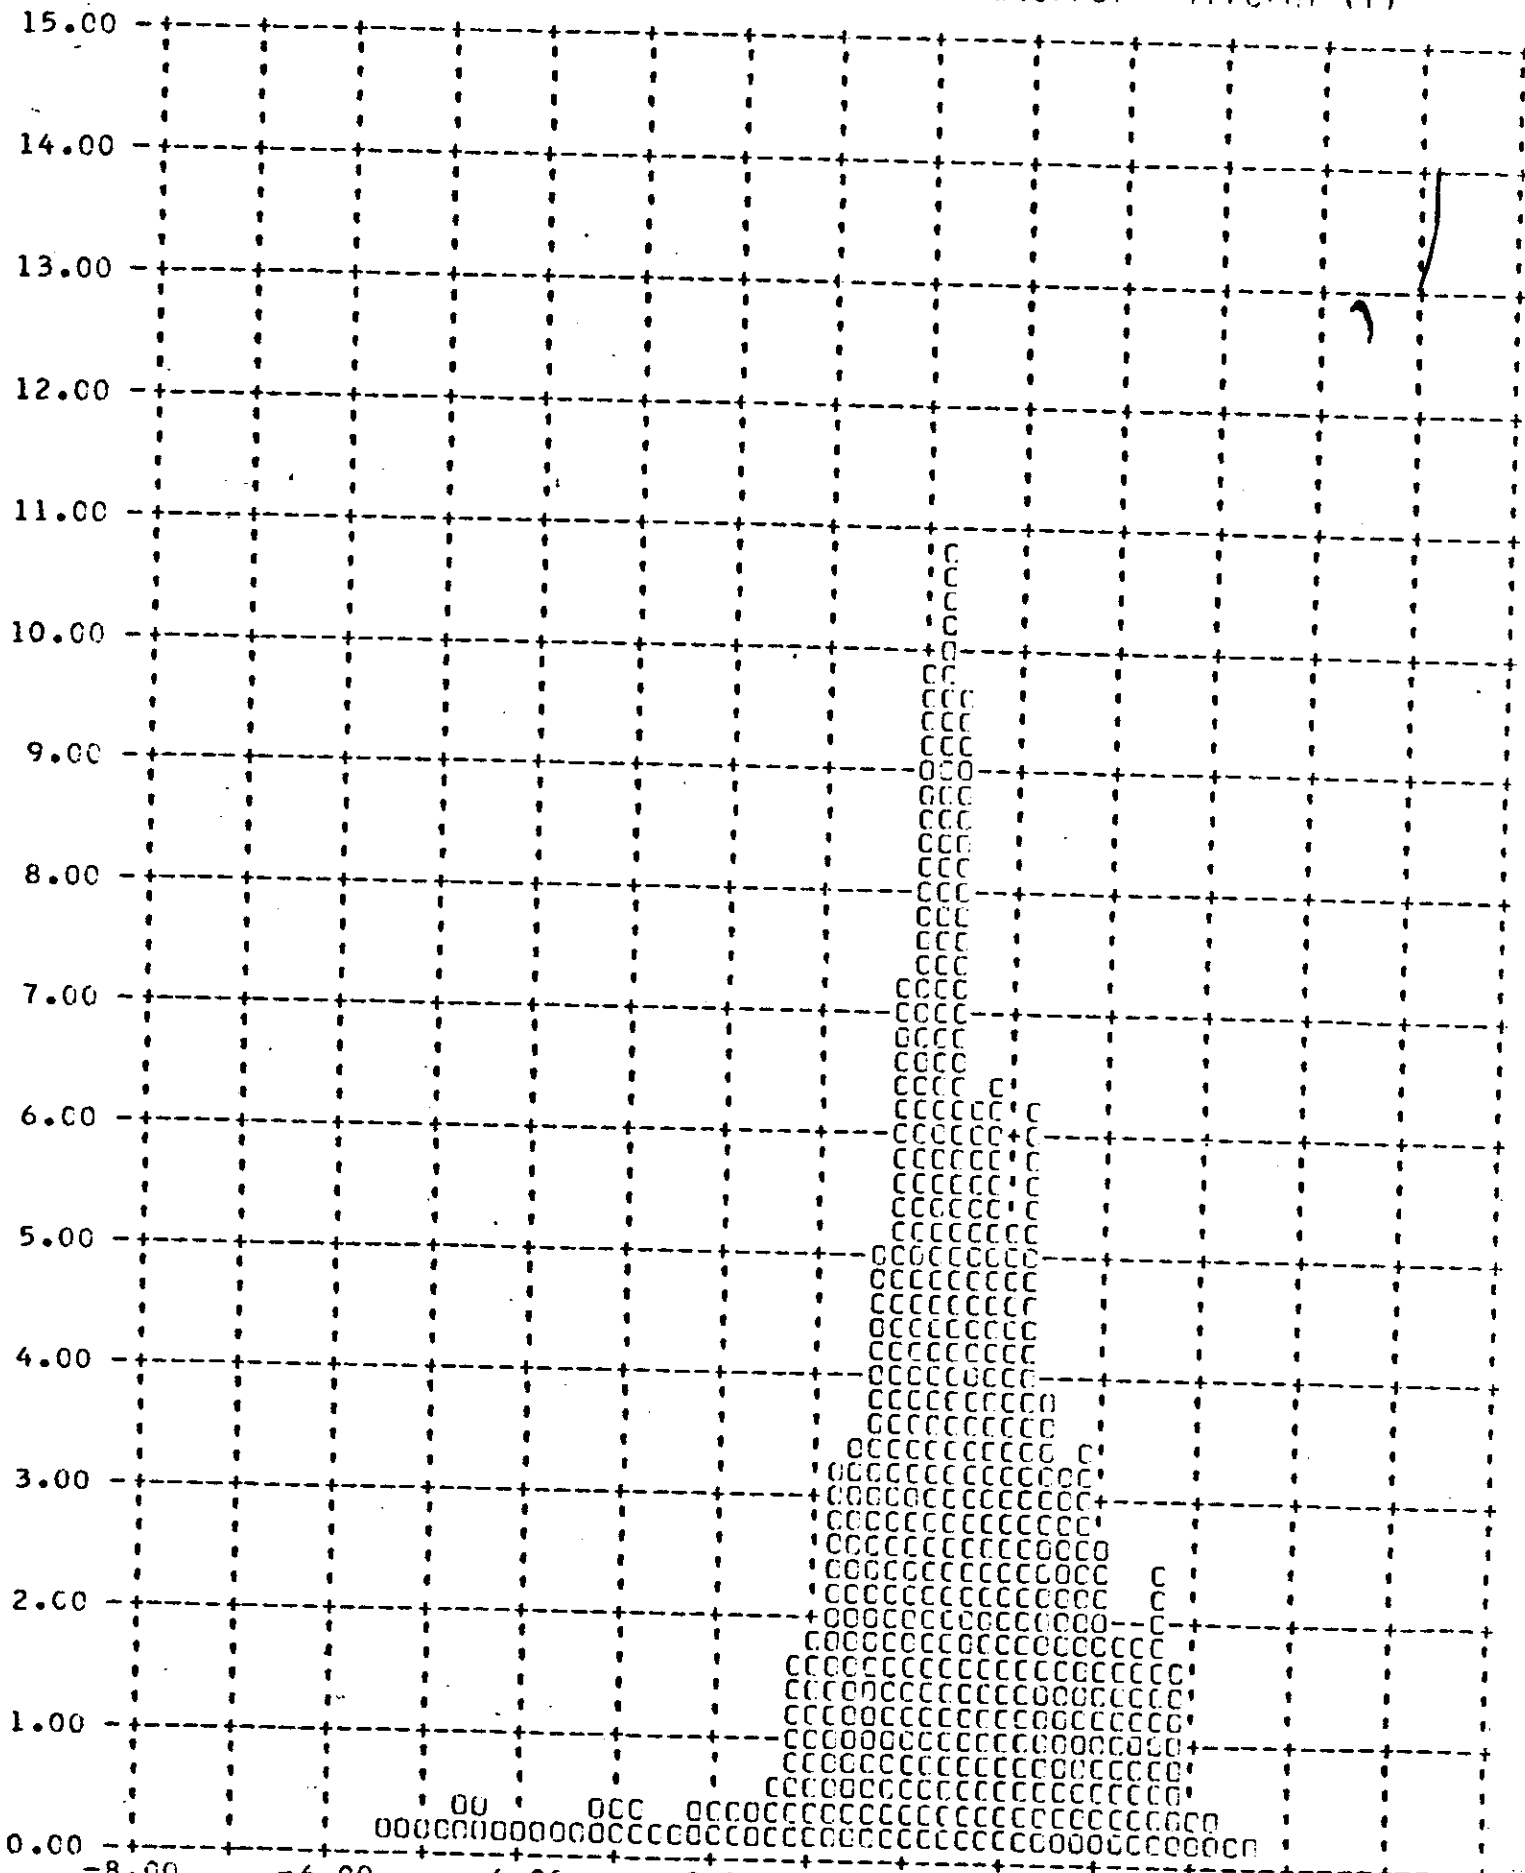
Y V/H RATIO ERROR - PERCENT (X) VERSUS FREQUENCY - PERCENT (Y)
