CORONA J
PERFORMANCE EVALUATION REPORT
MISSION 1105-1 AND 1105-2
FTV 1646, CR-5

SUBJECT: MISSION 1105 FINAL REPORT (CR-5)

This document constitutes the final payload test and performance evaluation report for Mission 1105 which was launched on 3 November 1968.

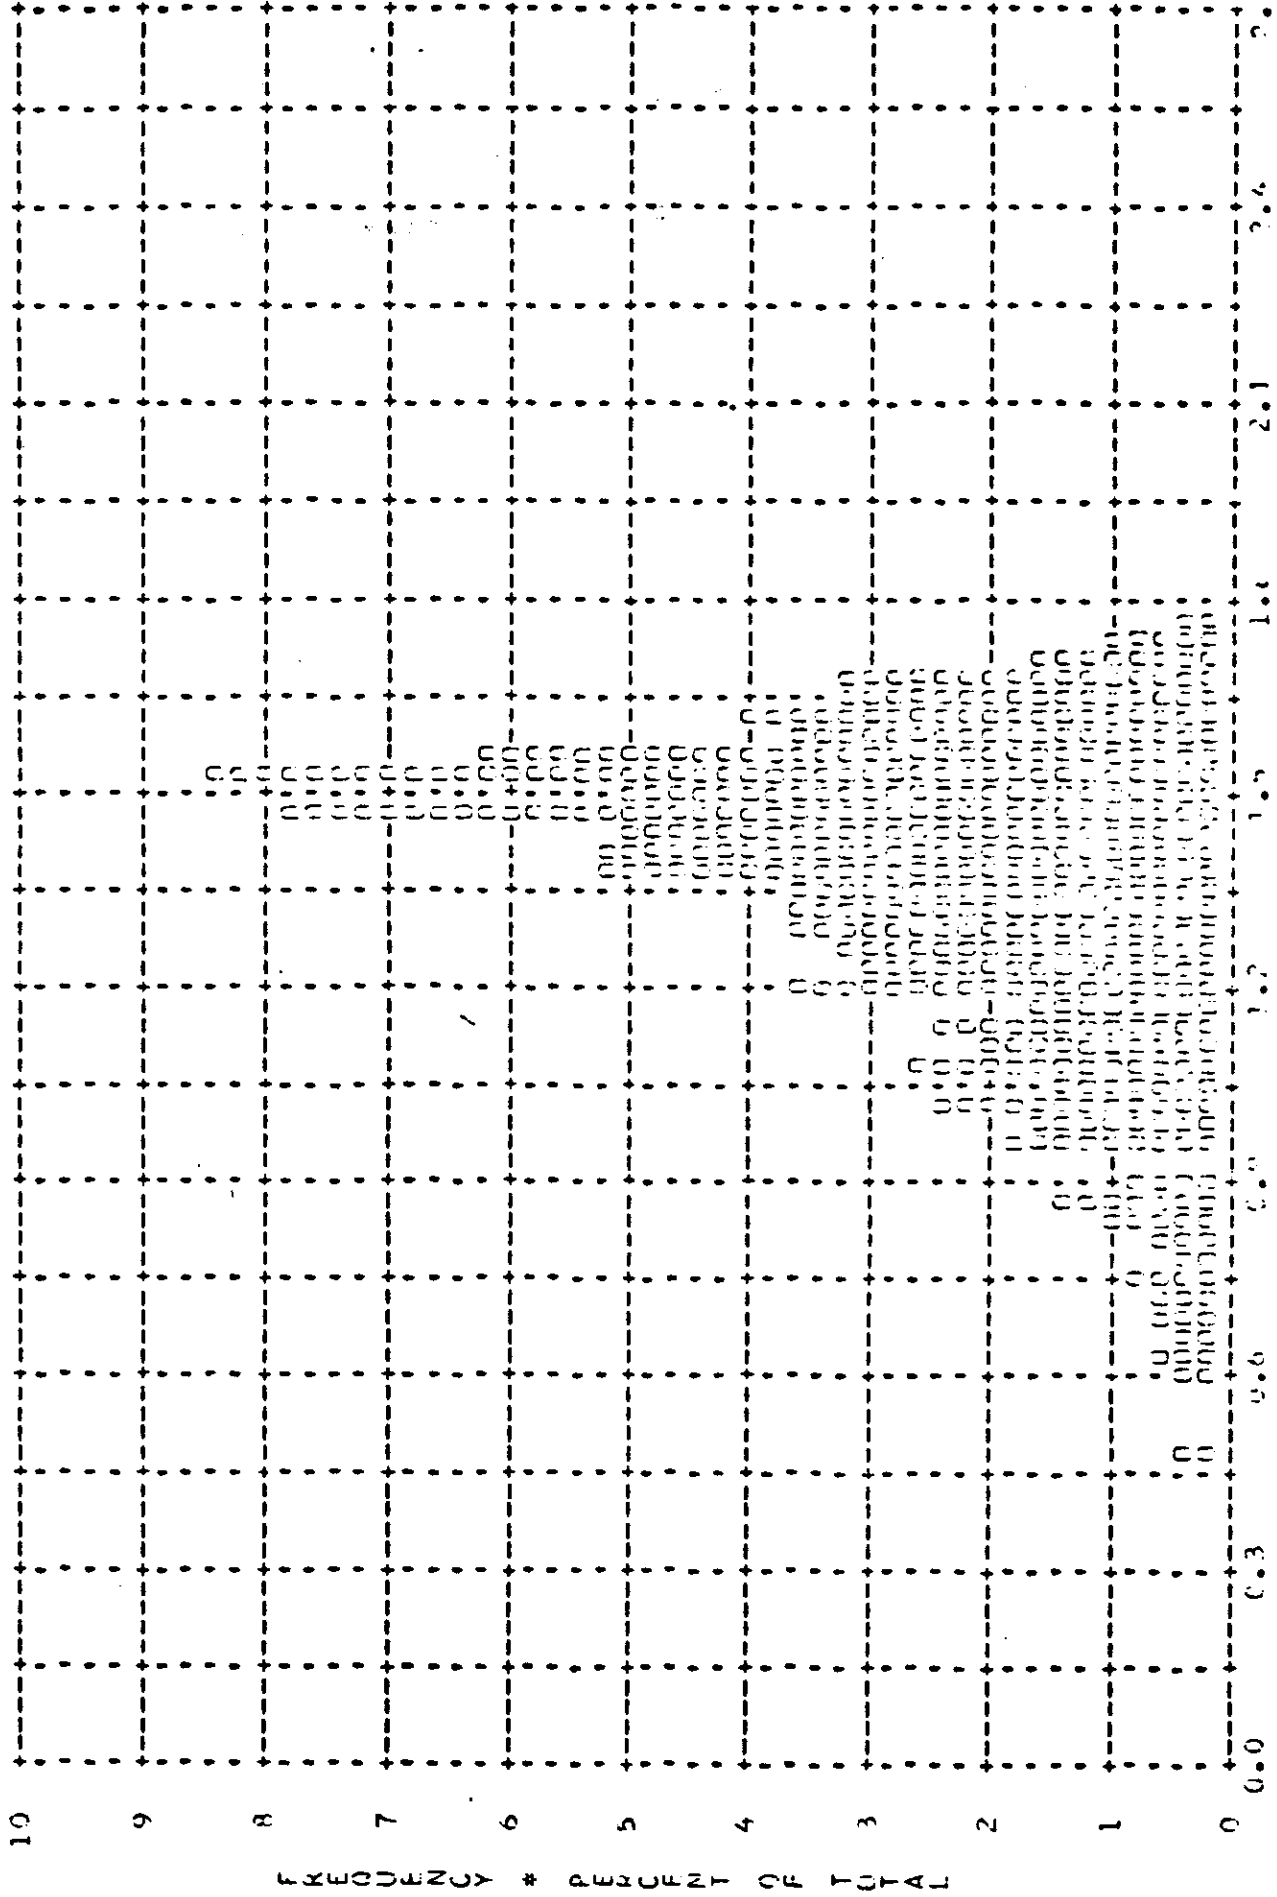
MISSION # 1105-2 * INSTK * AFT * PLOT OF D MAX * TERRAIN * PROCESSING * DUAL GAMMA
ARITH MEAN # 1.35 * MEDIAN # 1.40 * STD DEV # 0.46 TO 1.76 WITH 407 SAMPLES

FIGURE 5-14 * SECURITY *

Representative terrain diffuse D-min, D-max values for Missions 1105-1 and -2, FWD and AFT cameras, are shown in Figures 5-7 to 5-14. These macro-density measurements (500 μ spot) were supplied by AFSPFF. The film was dual gamma processed using the Yardleigh processor. Figures 5-15 and 5-16 show the process control standard and actual process for the FWD camera flight record, Mission 1105-1, respectively. Figure 5-17 shows the characteristic curve for the FWD camera flight film sampled on R-2 day.

The terrain D-min, D-max data in Figures 5-7 to 5-14 may be compared with Figure 5-17 to show the distribution of terrain density data relative to the R-2 day characteristic curve for film type SO-380.
