PHOTOGRAPHIC EVALUATION REPORT

Mission 9045
30 September 1962
1, 2 October 1962 Z

FE No. 38-52

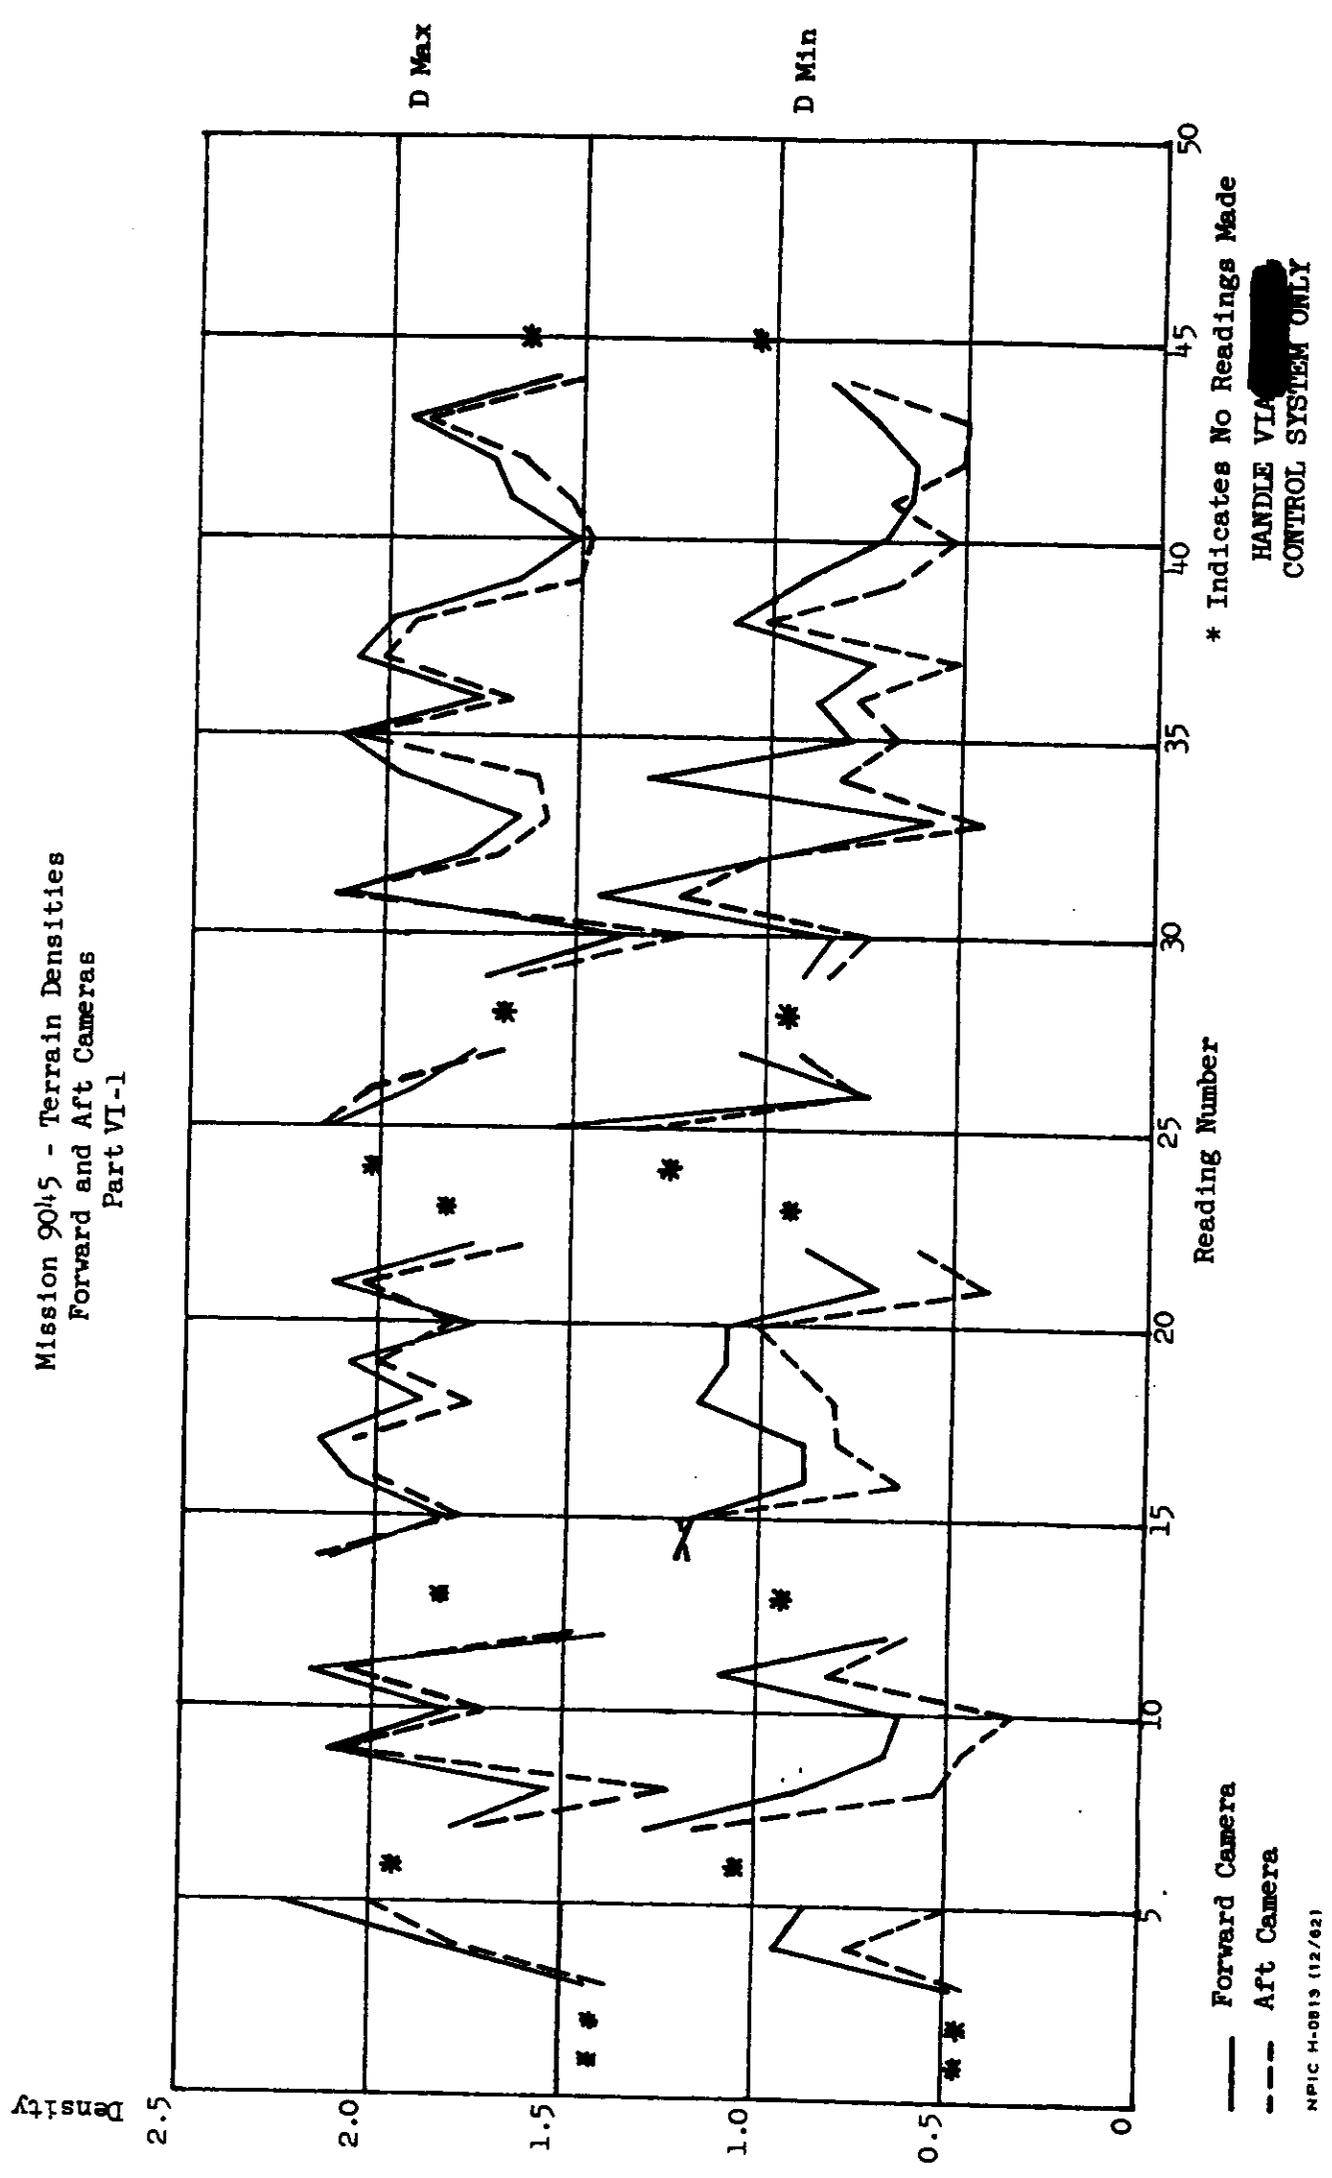
Mission 9045 - Terrain Densities
Forward and Aft Cameras
Part VI-1

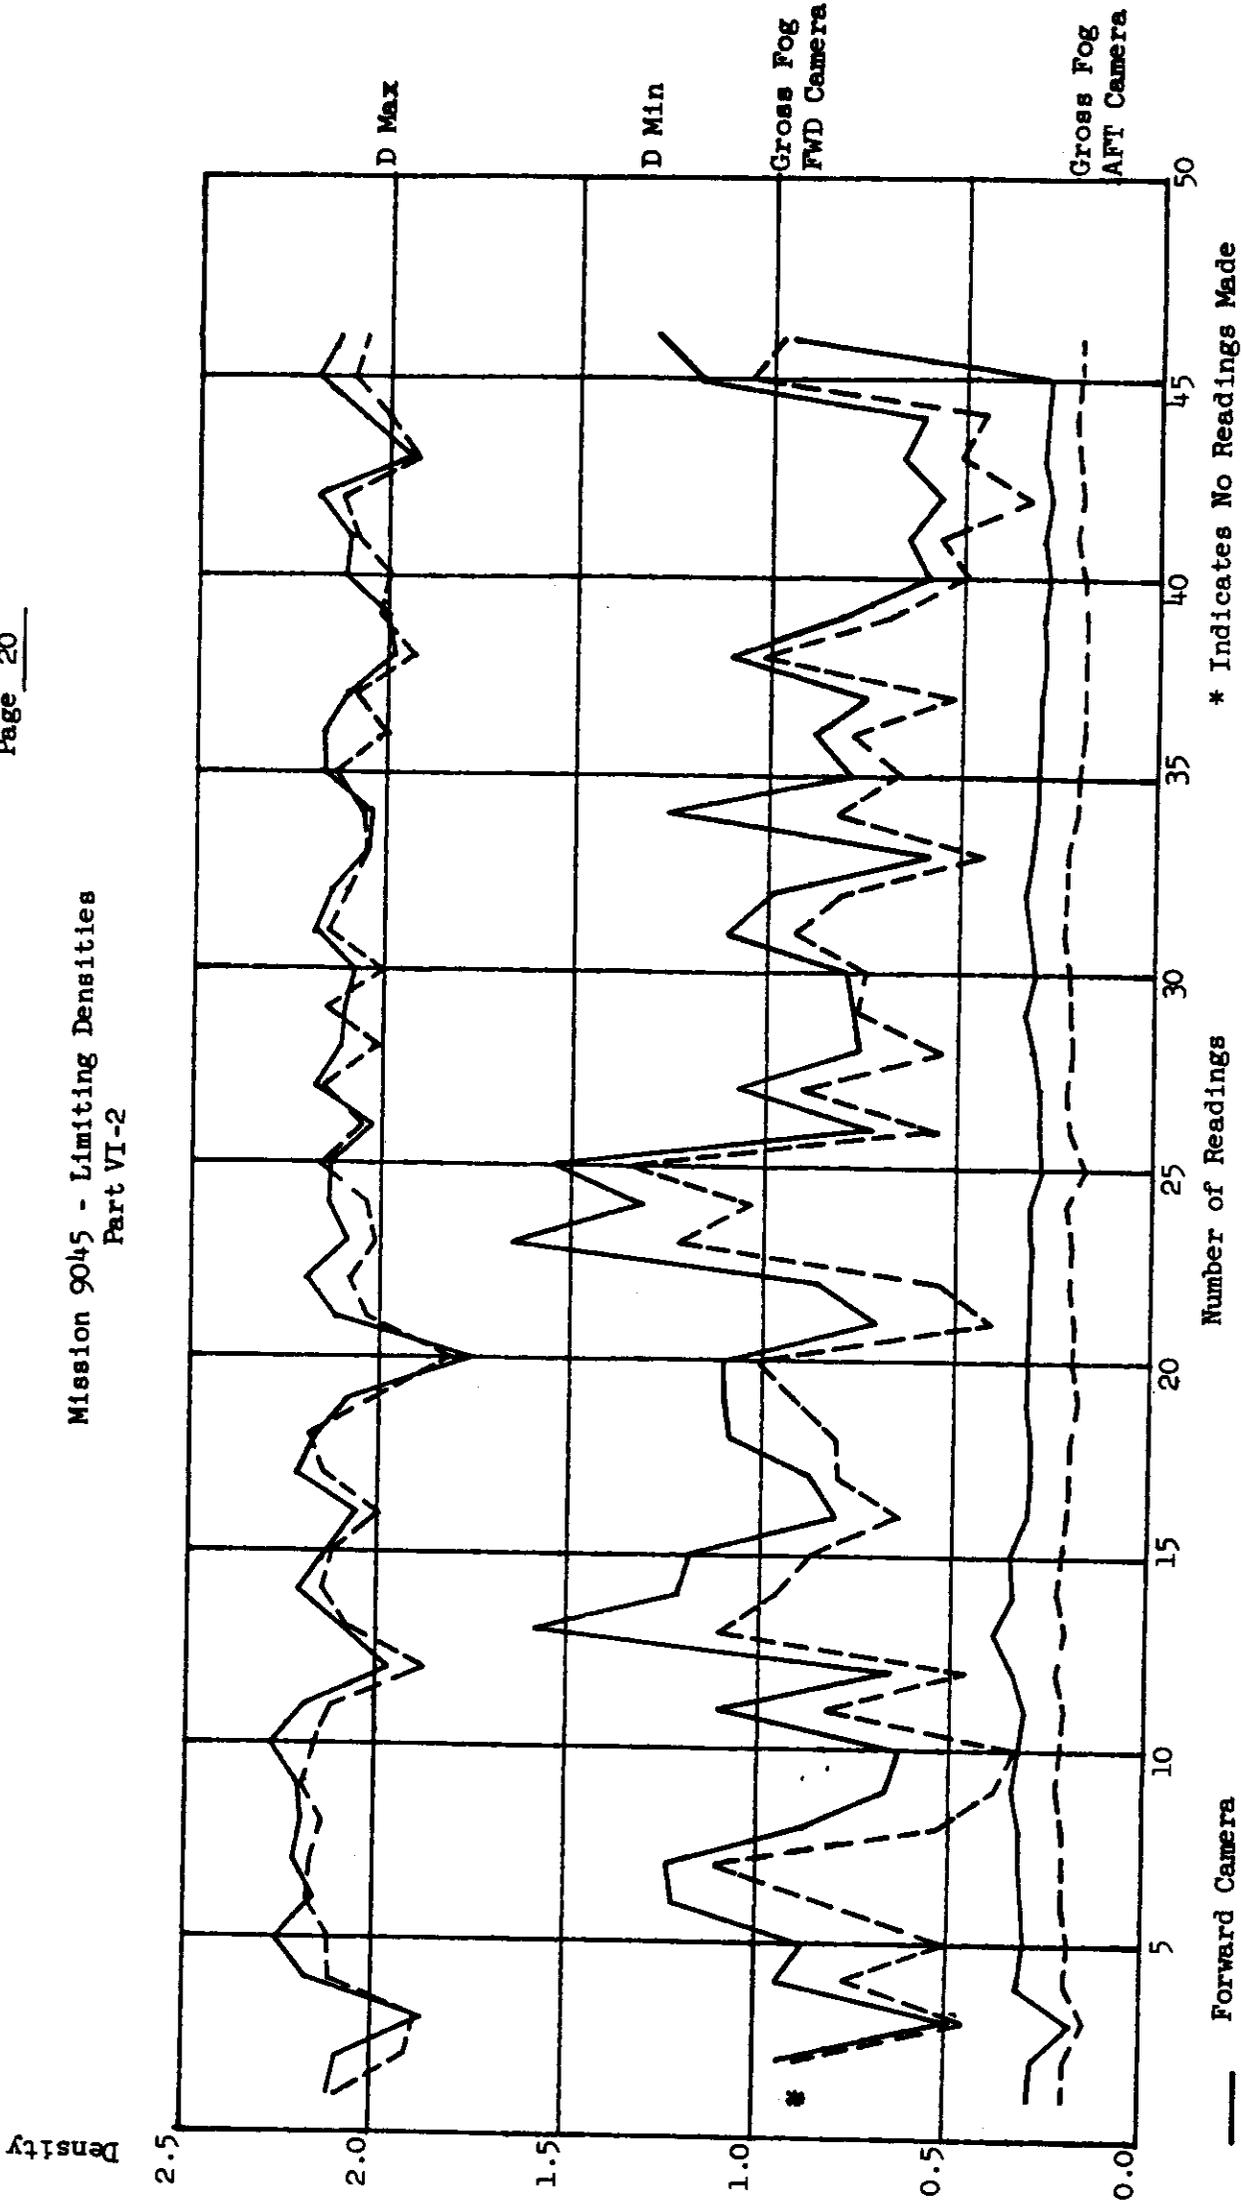
Mission 9045 - Limiting Densities
Part VI-2

* Indicates No Readings Made

1. No uniform radiation fogging is present on this mission.
2. Overlap is normal, 55 to 60% for all frames.
3. Transfer of opaquing material used in titling appears on most frames.
4. Vignetting causes a serious drop in contrast and density in the corners of the format.
5. A processing stain occurs on frames 144-149 and appears intermittently throughout the film.
6. Small bits of emulsion are displaced on frames 165, 275, 277, 289, and 317.
7. The correlation marker to indicate firing of the stellar camera did not function.
8. Density readings were taken from selected frames using the MacBeth Quantalog Densitometer Model EP 1000, with an EP 20 attachment and a 0.5 mm aperture. Terrain and Limiting density readings for D Max, D Min and Gross Fog are given below.

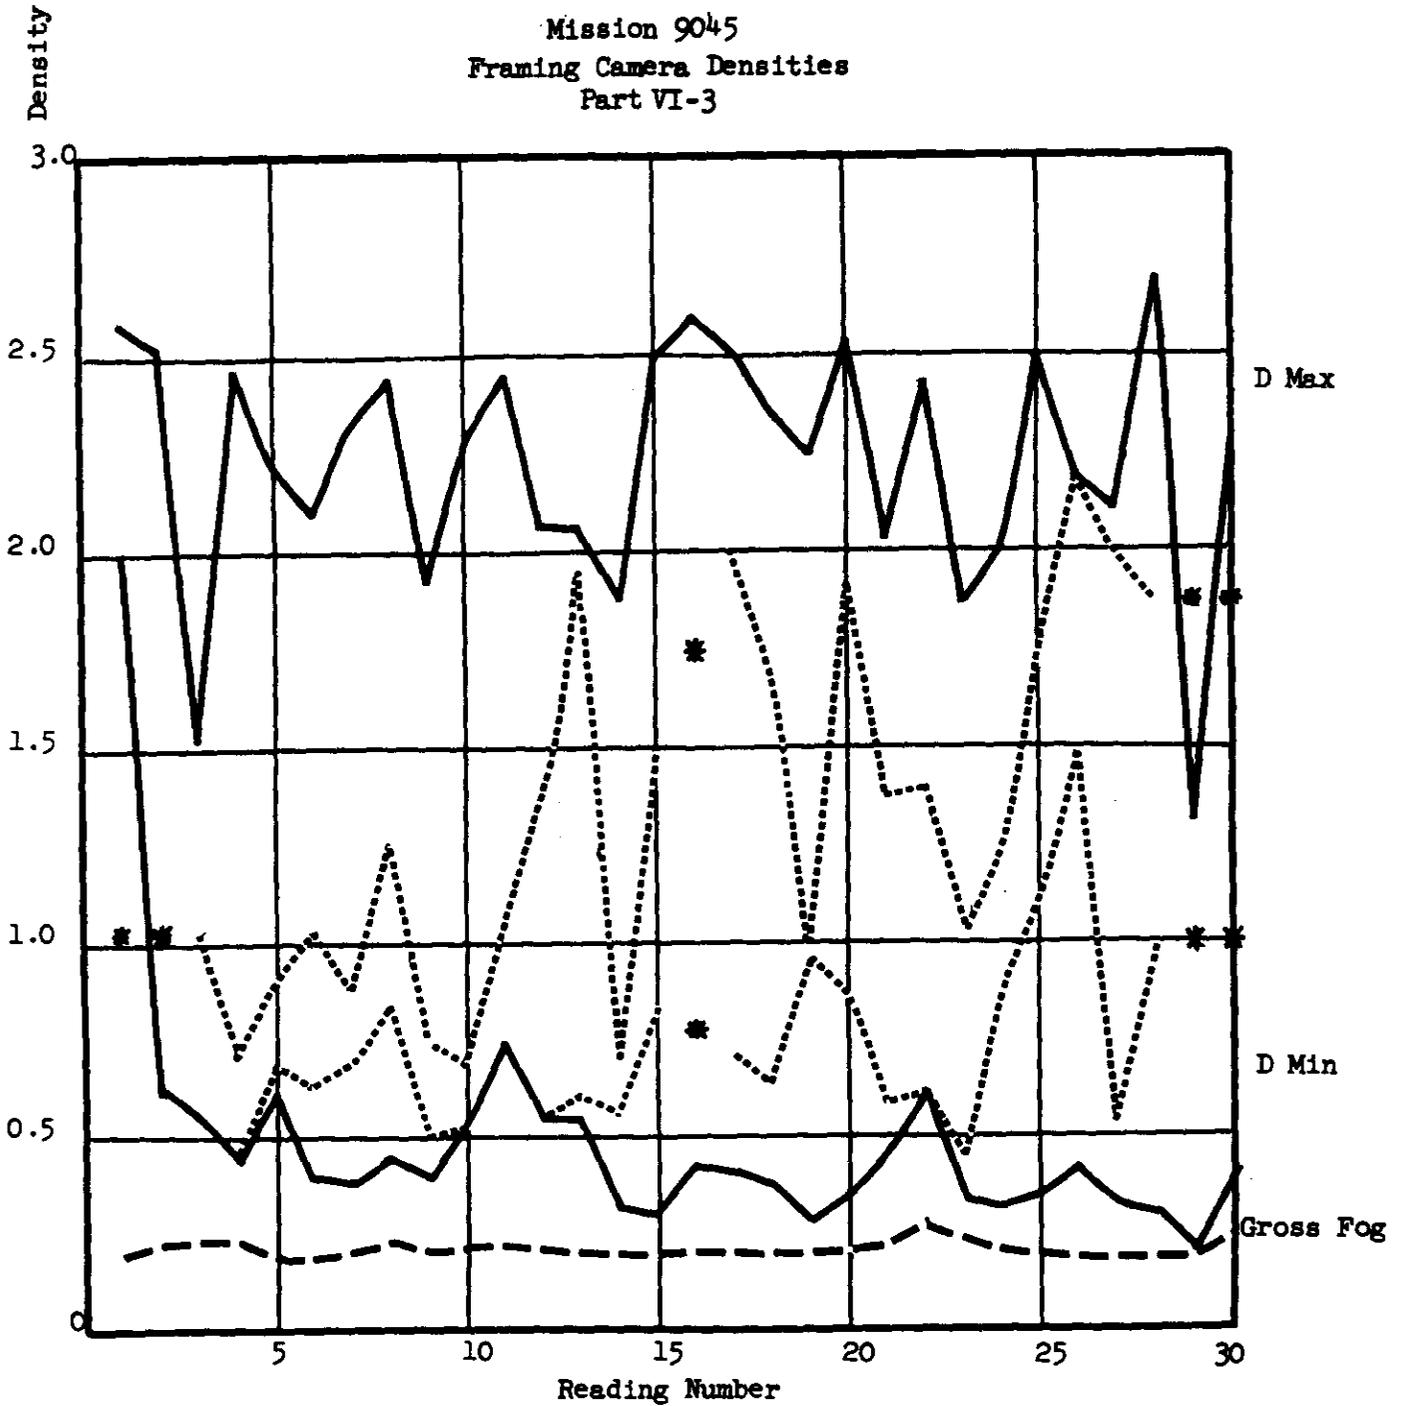
Mission 9045
Framing Camera Densities
Part VI-3

— Limiting Densities
..... Terrain Densities
- - - Gross Fog

* Indicates No Readings Made
