CORONA J

PERFORMANCE EVALUATION REPORT

MISSION 1045

25 JUNE 1968

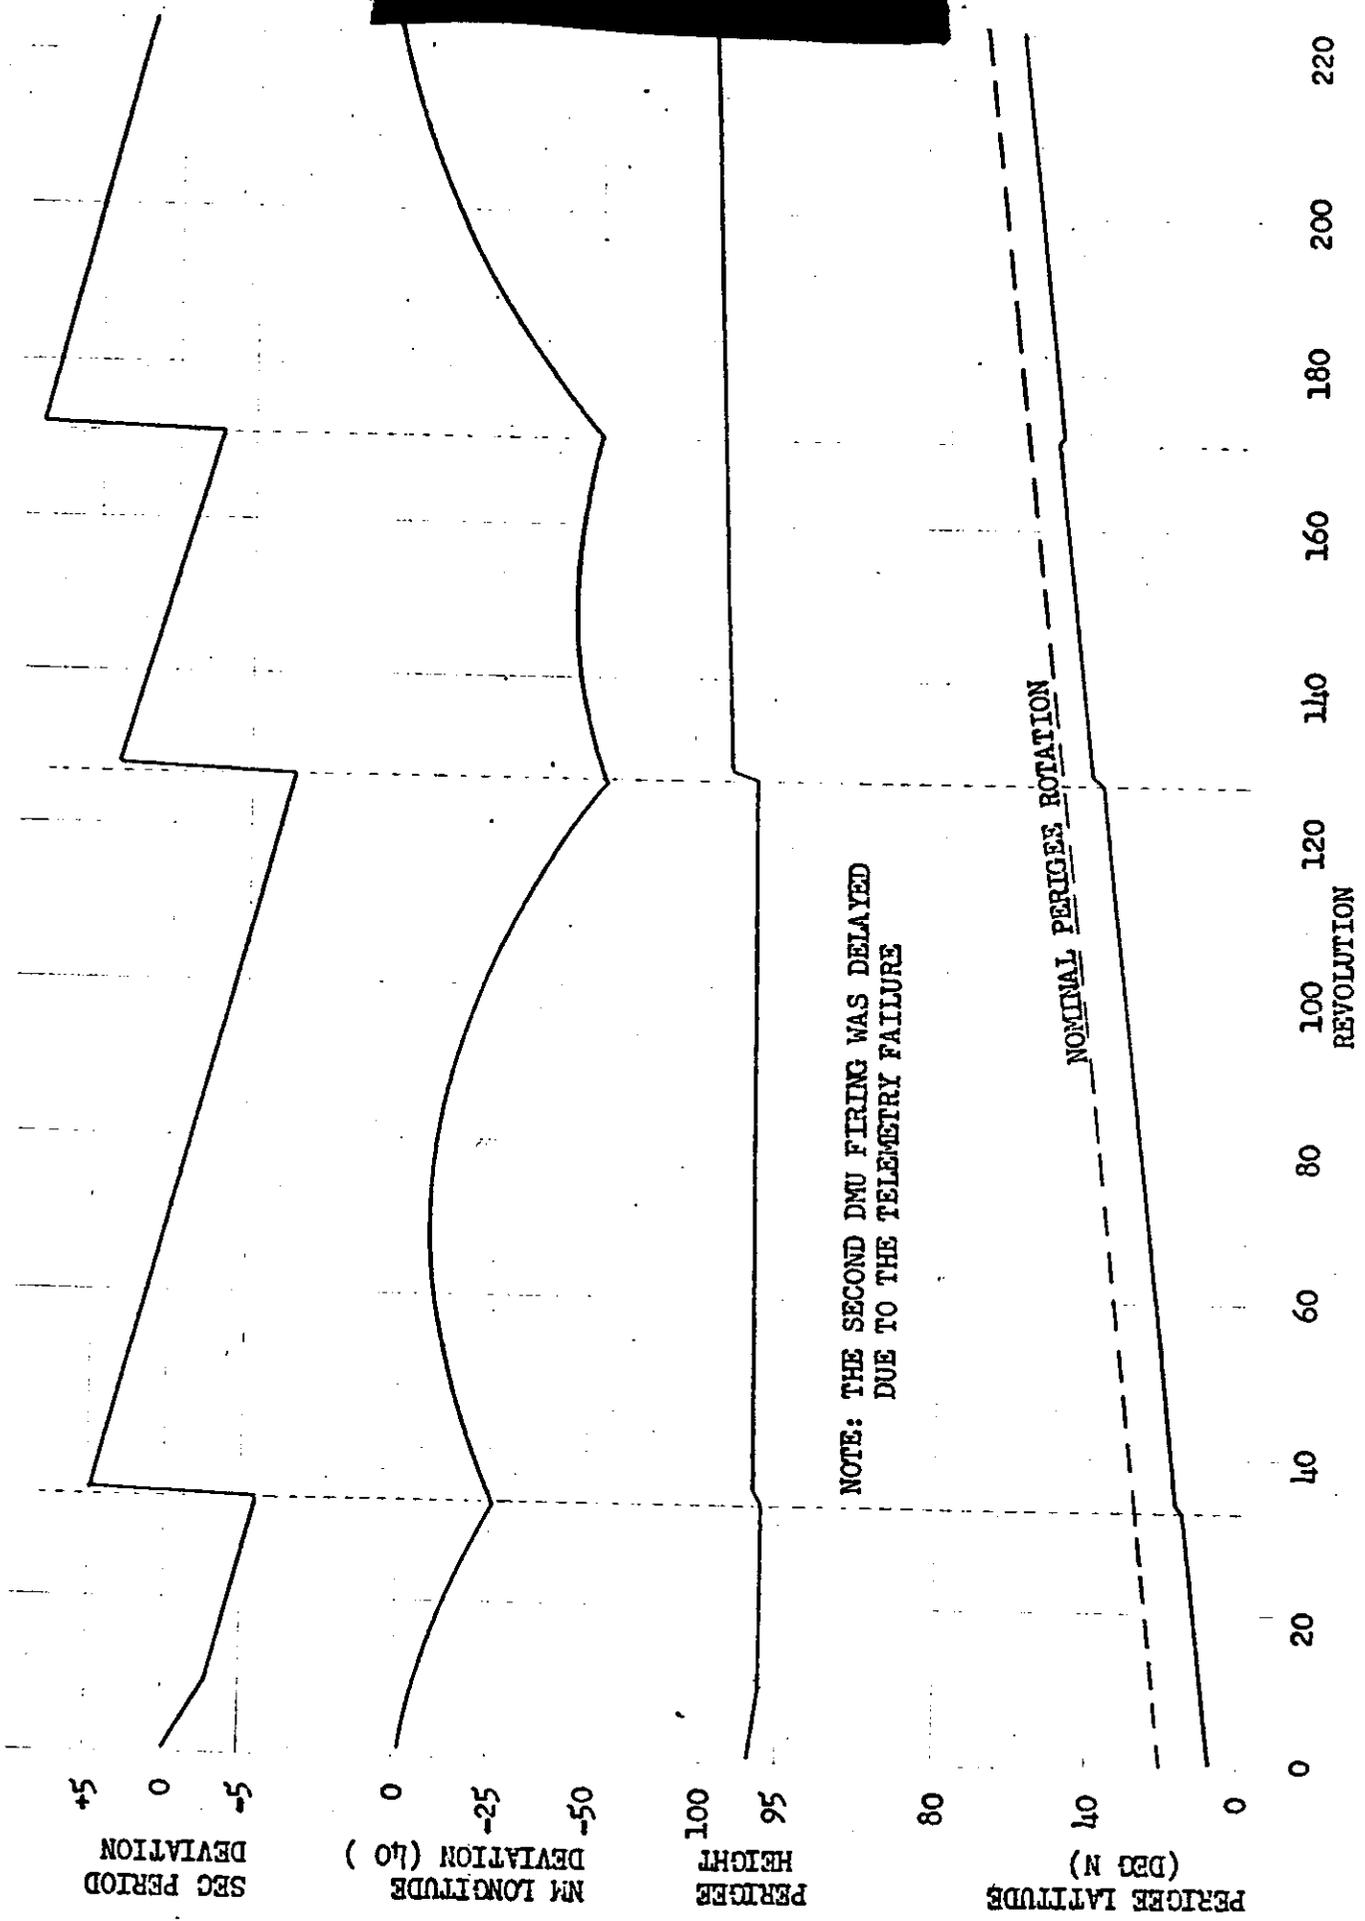
The chart on the following page summarizes deviations from the nominal orbit.

NOTE: THE SECOND DMU FIRING WAS DELAYED
DUE TO THE TELEMETRY FAILURE

NOMINAL PERIGEE ROTATION
