BIF-107-50299-68
Total Pages:105
Page 1
Copy 2 of 2
19 December 1968

MOL MONTHLY PROGRESS REPORT

1 November 1968 through 30 November 1968

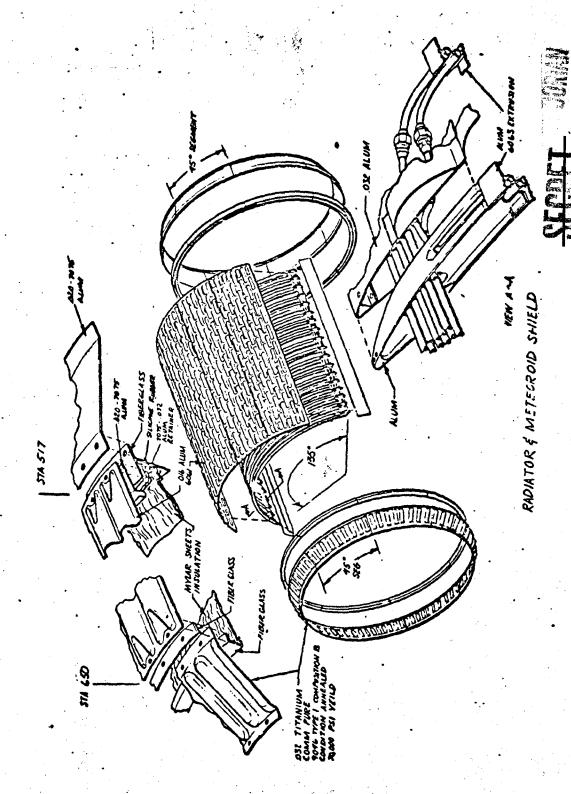
The final, supersonic phase of the Meteoroid Shroud Flutter Model Test (1A35) (see Figure 2) has been completed in the period. Prior to the supersonic tunnel runs, tests and analyses were performed to resolve the apparent discrepancy in model dynamic similarity. The discrepancy was found in the predicted characteristics of the prototype rather than in the fabrication of the model. Flutter was not observed in either the transonic or the supersonic runs. Quicklook data also indicates lower than predicted buffet loads. Remaining areas of concern in the meteoroid shroud design are being listed for review by MDAC-WD management.
