DISCOVERER XIV

(AGENA 1056 / THOR 237)

SYSTEM TEST EVALUATION AND PERFORMANCE ANALYSIS REPORT

(35 - DAY REPORT)

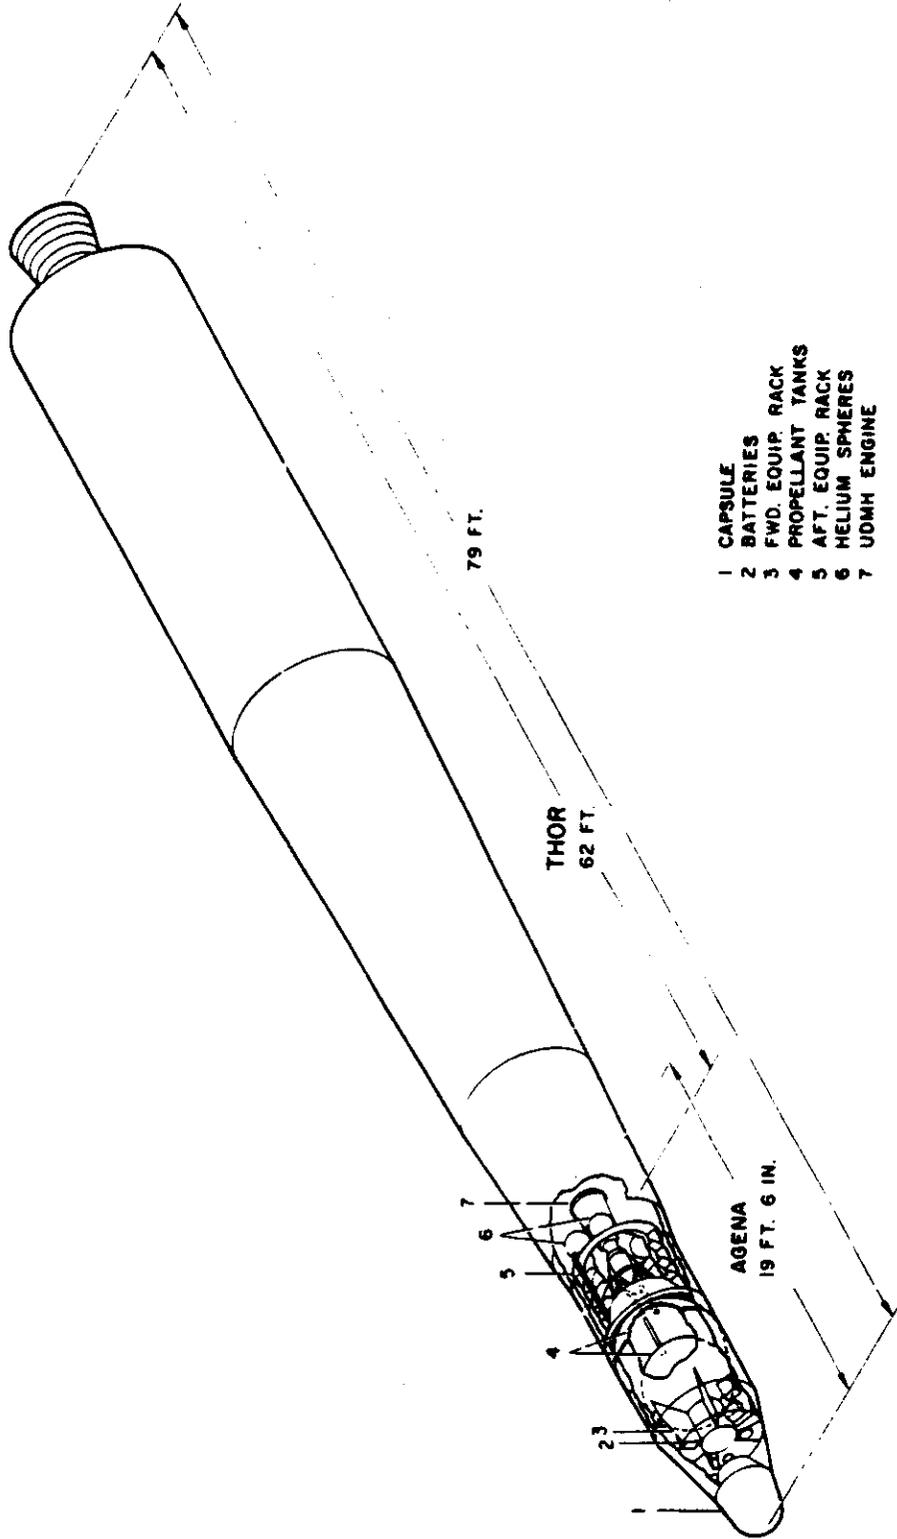
Figure 2-2 Agena 1056-Thor 237 Configuration

- 1 CAPSULE
- 2 BATTERIES
- 3 FWD. EQUIP. RACK
- 4 PROPELLANT TANKS
- 5 AFT. EQUIP. RACK
- 6 HELIUM SPHERES
- 7 JDMH ENGINE

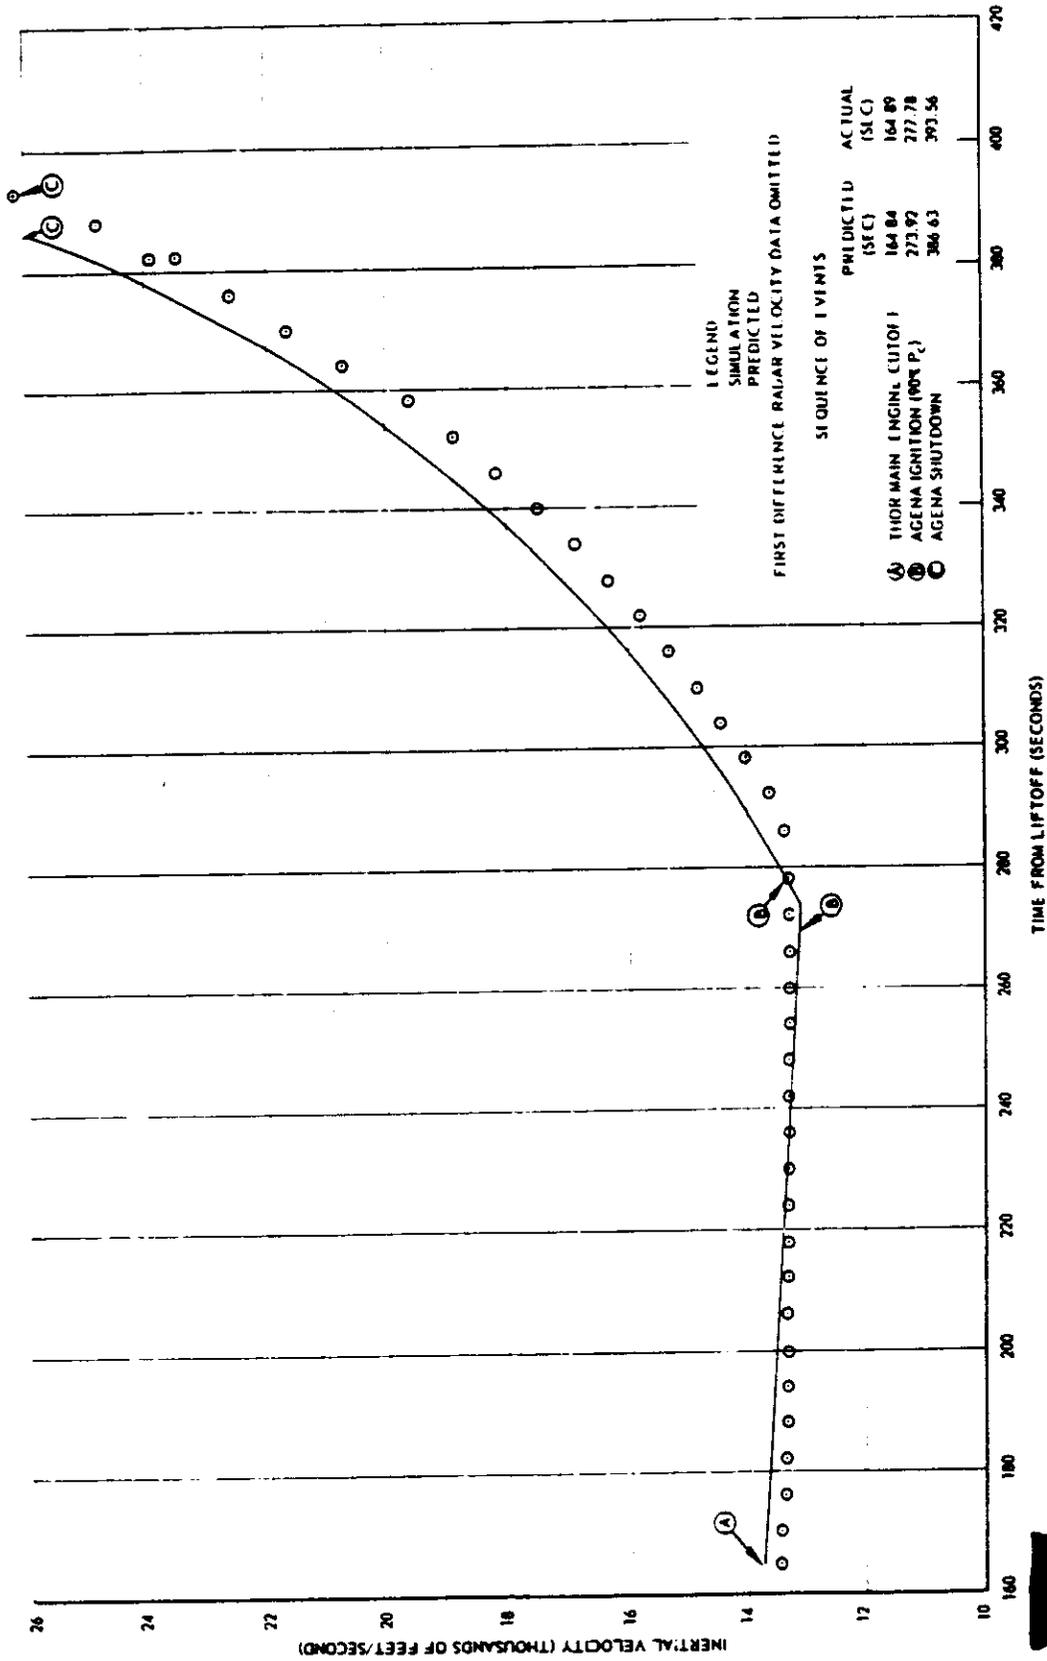
Figure 5-2 Inertial Velocity Related to Time

At first-stage burnout, the velocity was approximately 304 ft/sec lower than predicted, with a flight-path angle approximately 0.7 degree higher than nominal. The altitude and burning time were approximately nominal. At the time of main-engine cutoff, the azimuth heading was about 0.4 degree west of nominal.

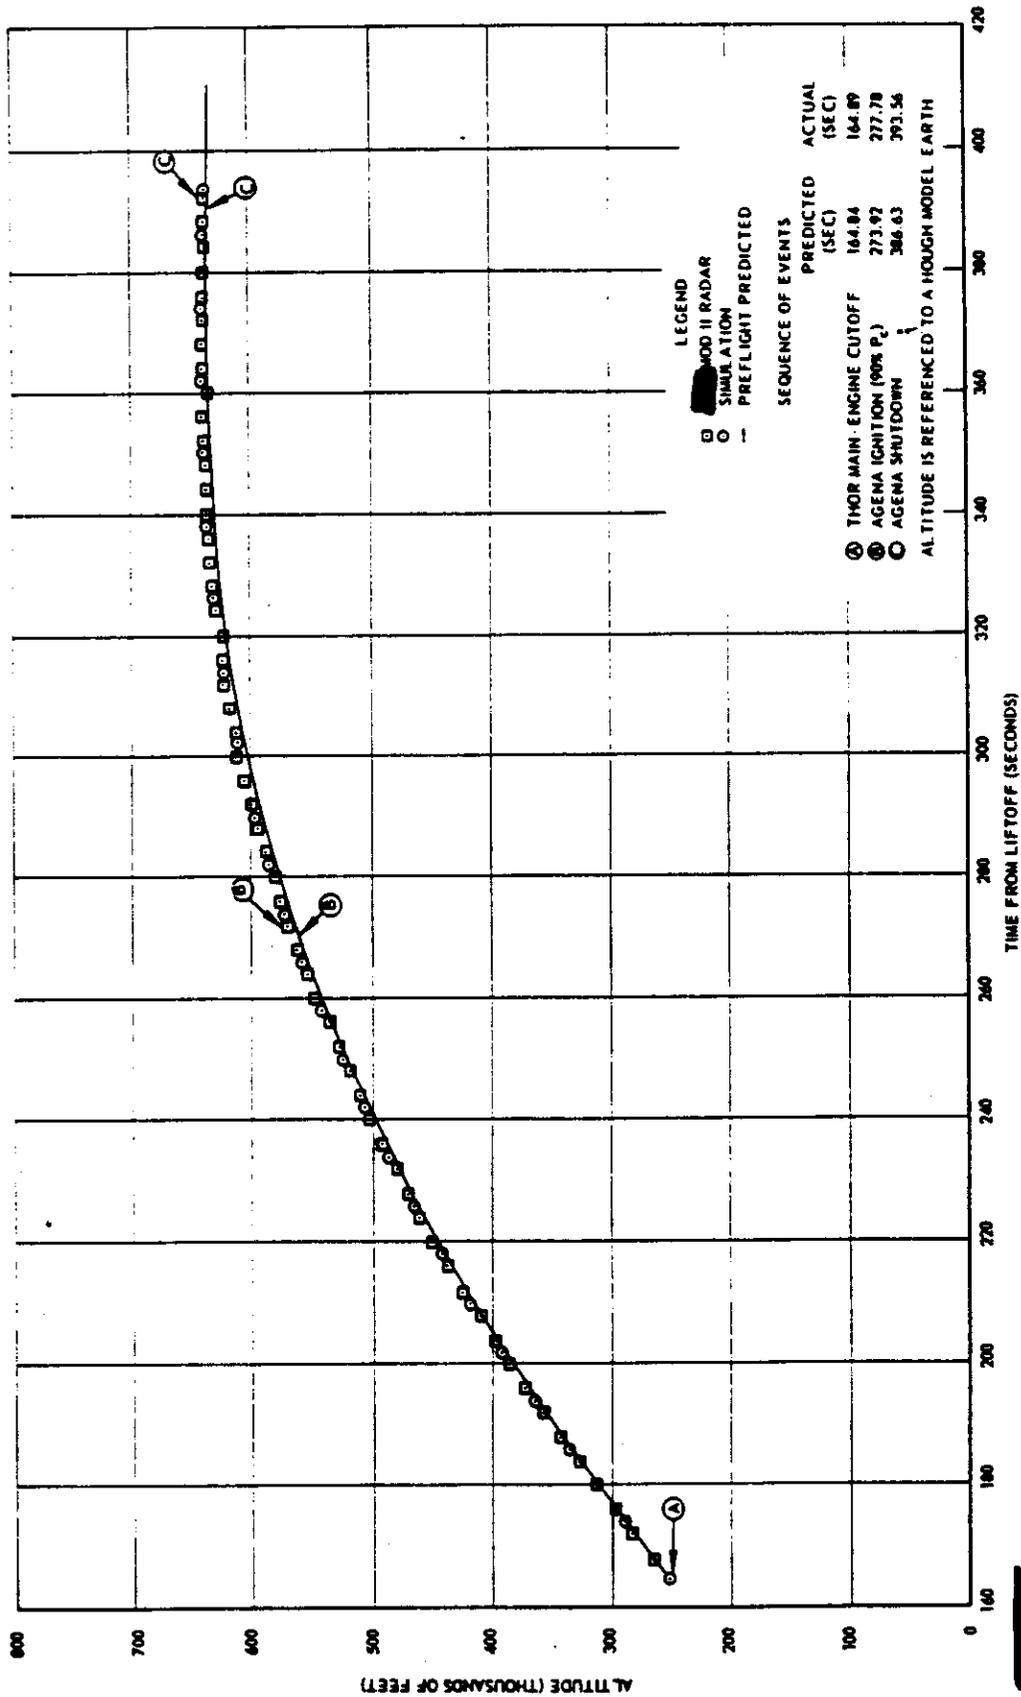
Figure 5-3 Altitude in Relation to Time

The combination of conditions at main-engine cutoff resulted in a flight which closely paralleled the predicted altitude trajectory during the coast phase. Thor apogee was 2.04 nautical miles higher and velocity was 371 ft/sec lower than the predicted coast apogee conditions.

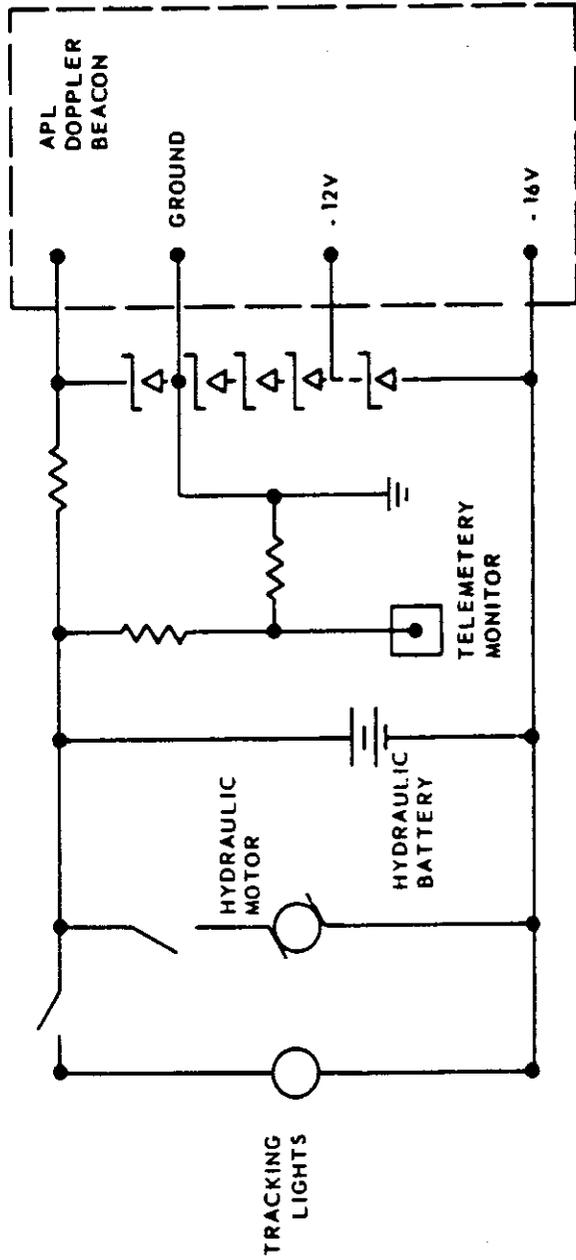
Figure 5-7 Hydraulic-Motor Battery System

Environmental and power measurements made during orbit were normal (Tables 5-2 and 5-3). The JUH/APL beacon failed to operate. Since the monitor of the hydraulic battery which powers this beacon in orbit was open, the indication of proper battery operation was the fact that the optical tracking lights, also operated from this battery, functioned properly. Examination of the associated circuitry (Fig. 5-7), shows that a ground on the negative side of the battery could have caused this failure. This circuit will not be used on future flights.

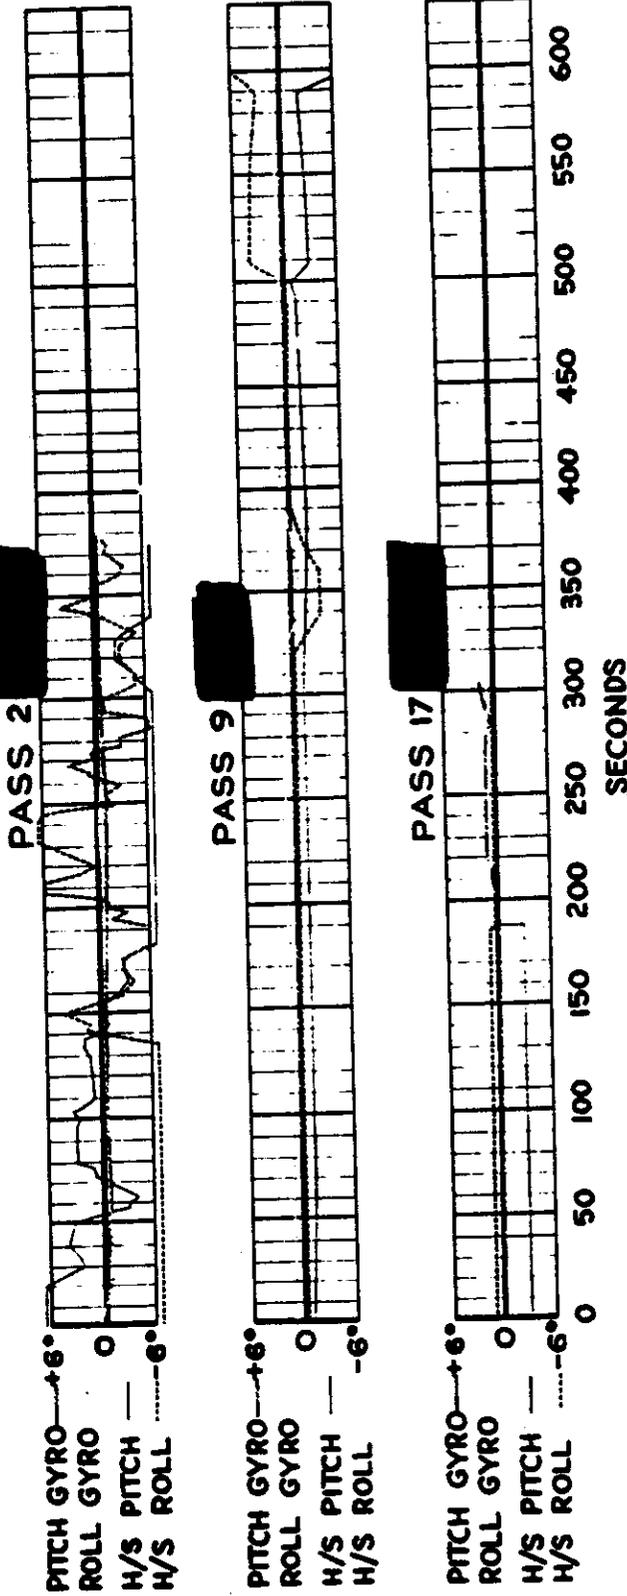
Figure 5-8 Orbital-Attitude Control Performance

Orbital guidance and control was not correct during Passes 1 and 2 but became normal following Passes 1 and 2. Control-gas expenditure was normal after Pass 2 following abnormally high use during Passes 1 and 2. The only performance variance indicated subsequent to Pass 2 was the higher-than-normal pitch-horizon-scanner offset (Fig. 5-8).

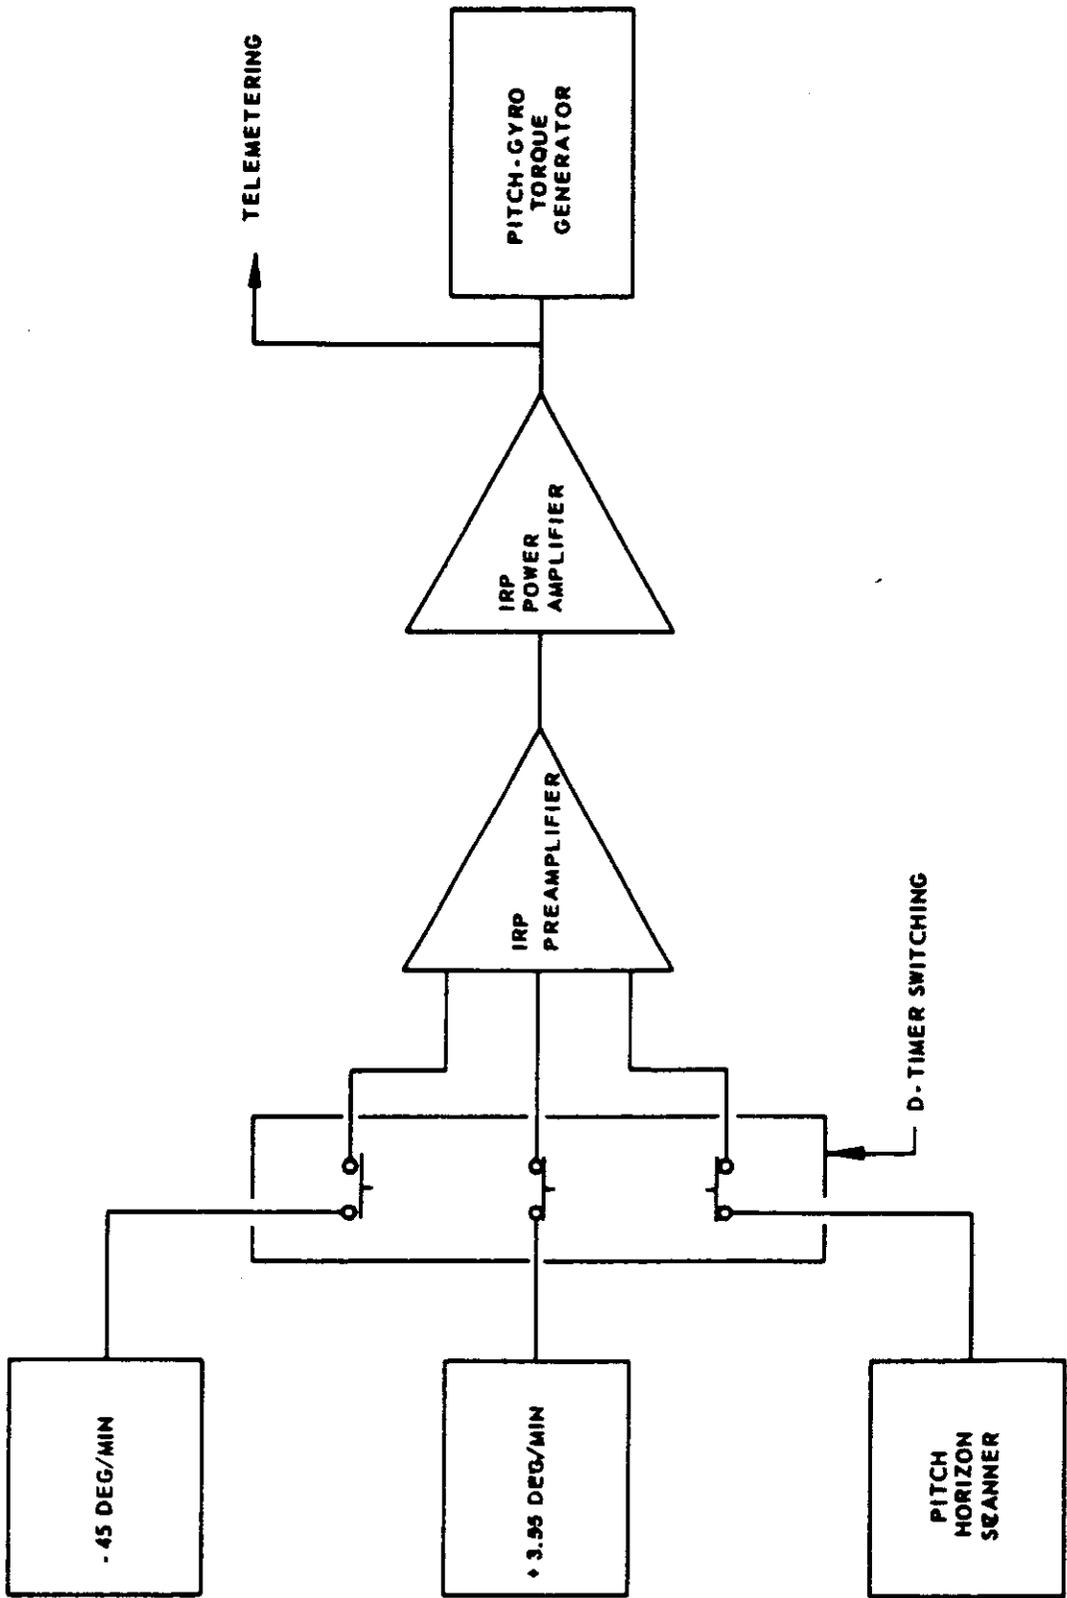
Figure 5-9 Torquing Circuitry

All flight data were reviewed in detail, and it was concluded that the failure occurred in an active element of the pitch-torquer circuit, specifically in either of the two inertial reference package (IRP) amplifiers (Fig. 5-9). Of the two possibilities, the power amplifier was most suspect since the pre-amplifier operates at a relatively low-power level and could not have produced the effects indicated.

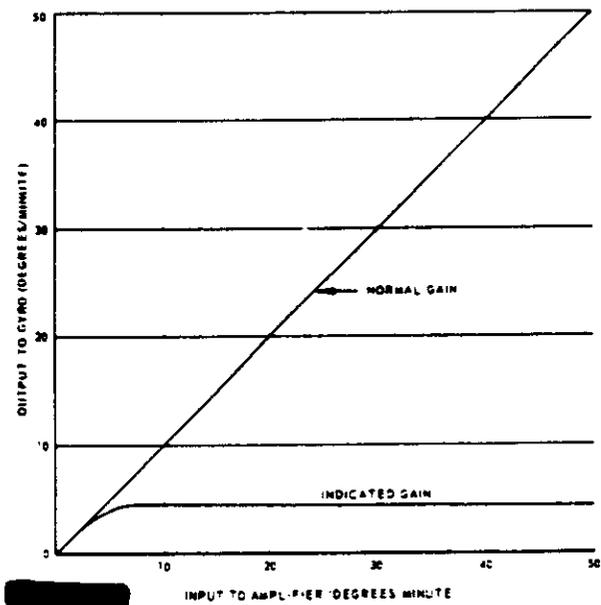
Figure 5-10 Amplifier Gain Characteristics

Tests were conducted at the guidance laboratory in an effort to duplicate the apparent gain variance indicated in flight and shown in Figure 5-10. By simulating a power-transistor failure in the final stage of the test amplifier, its gain characteristics showed close correlation with that indicated. This appears to be the reason for failure to pitch down properly. Further, this mode-of-failure, if initially intermittent, would draw high currents from the power supply and explain the anomalies indicated by the Pass 1 data. Therefore, conclusions are that the transistor failed during Pass 2, and the mode-to-failure was intermittent, starting early in Pass 1 and terminating during Pass 2.

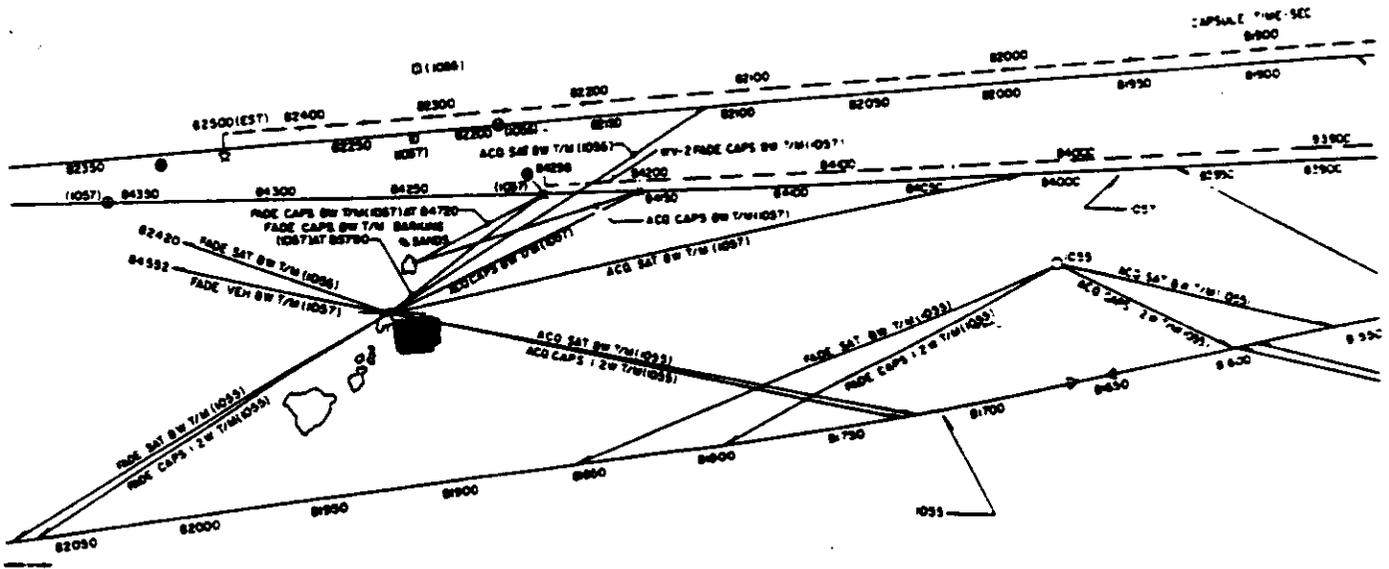
Figure 6-1 Agena 1055, 1056 and 1057 Recovery Telemetry Coverage

Failure to obtain capsule telemetry data was attributed to malfunction of the circuitry which applies power to the transmitter. In spite of the complete absence of telemetry signals, the time that the events of the retro phase occurred was accurately determined from data. This was possible because the small explosions resulting from the firing of squibs caused ionized gas to surround the VHF-beacon antenna, producing severe drops in the beacon signal strength. Further, the retrorocket firing caused ionized gases to surround the Agena telemetry antenna resulting in a severe drop in

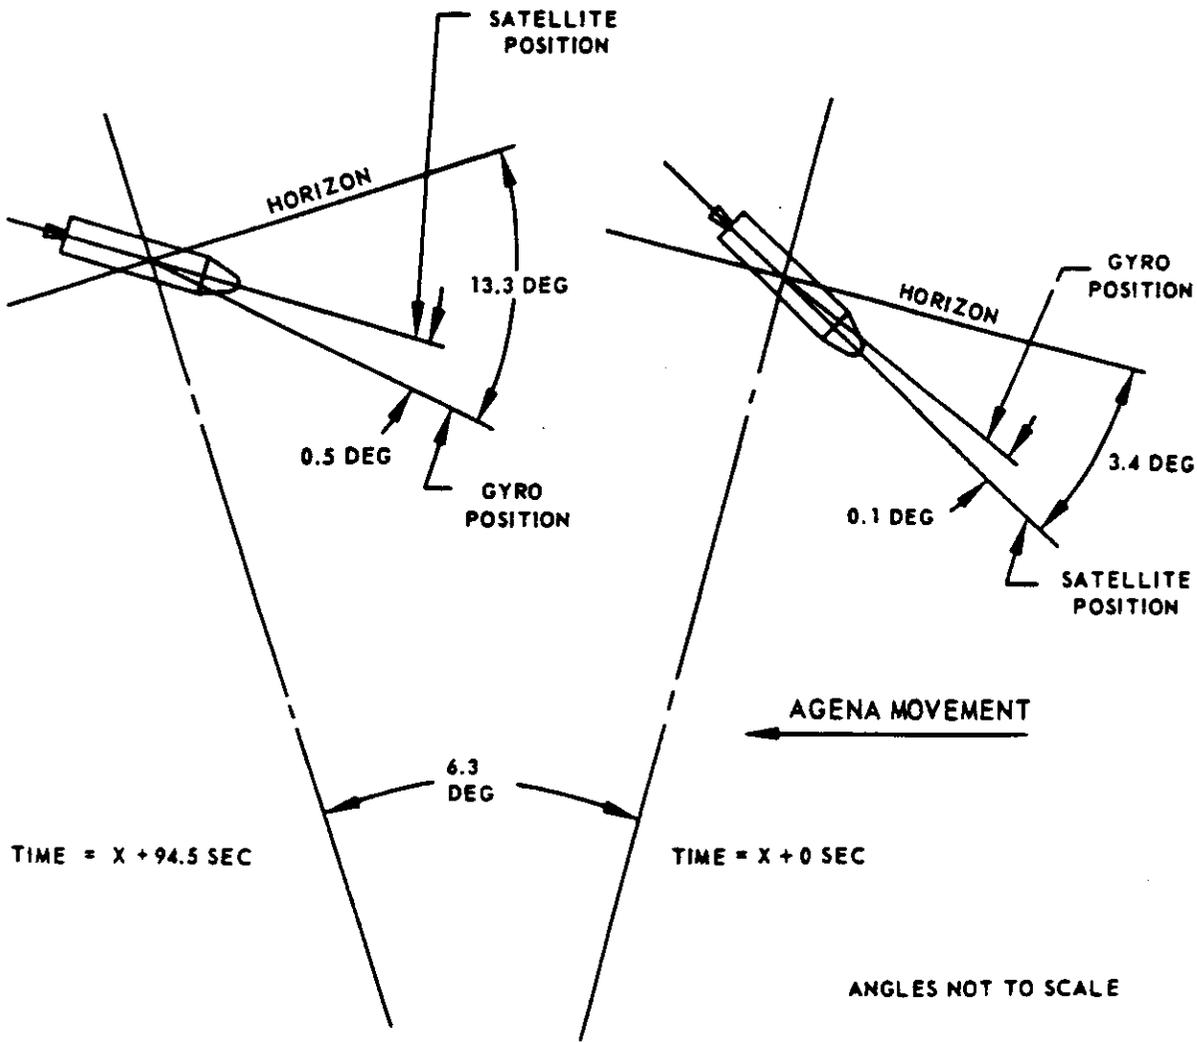
Figure 7-1 Pitchdown Performance

The pitchdown rate as determined from Agena telemetry was considerably less than the required 45 deg/min, resulting in a significant error in pitch attitude at capsule ejection. Computations based on the actual data indicate a probable pitch attitude of minus 13. 3 degrees with respect to the local horizontal at time of the capsule separation (Fig. 7-1). Pitchdown was determined in the following manner:

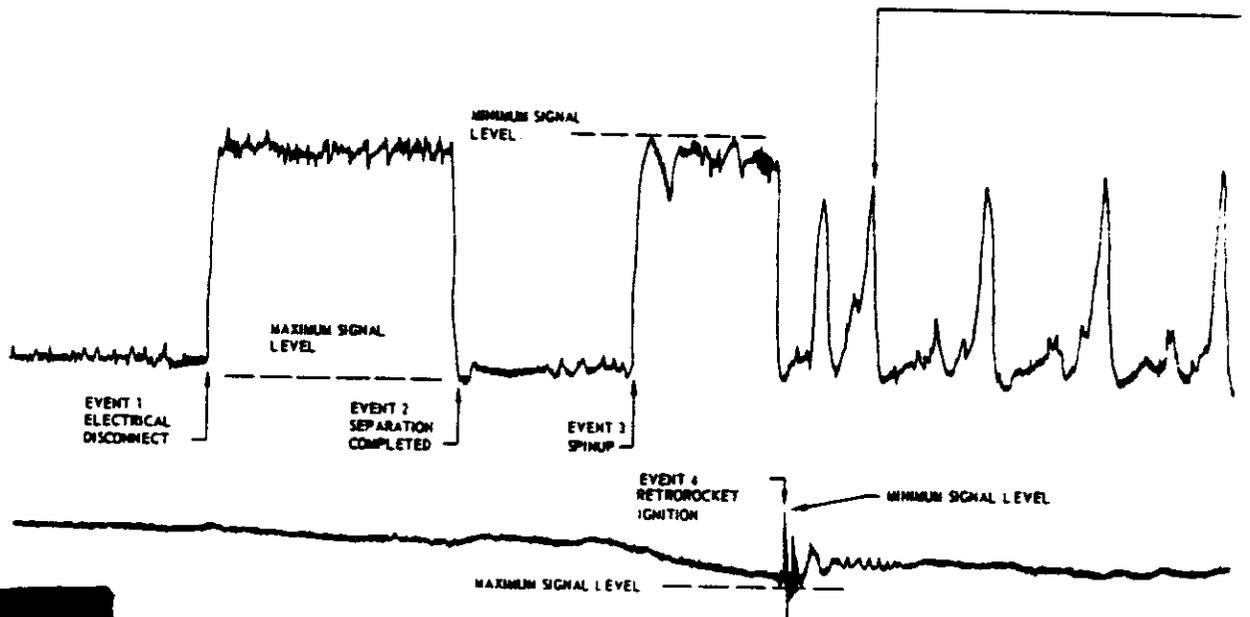
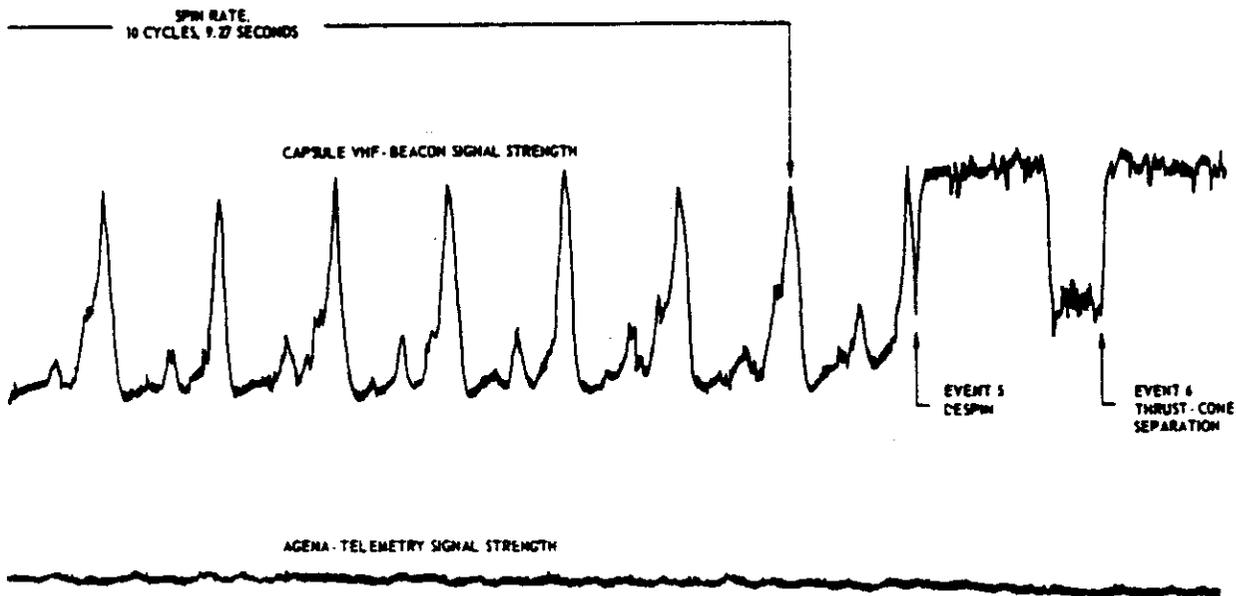
Figure 7-3

Capsule telemetry did not function on this flight, hence proper analysis of retro performance can only be accomplished by a study of VHF-beacon signal strength (Fig. 7-3, page 7-6), coupled with the knowledge that all events

VHF-Beacon and Agena-Telemetry Signal-Strength Records

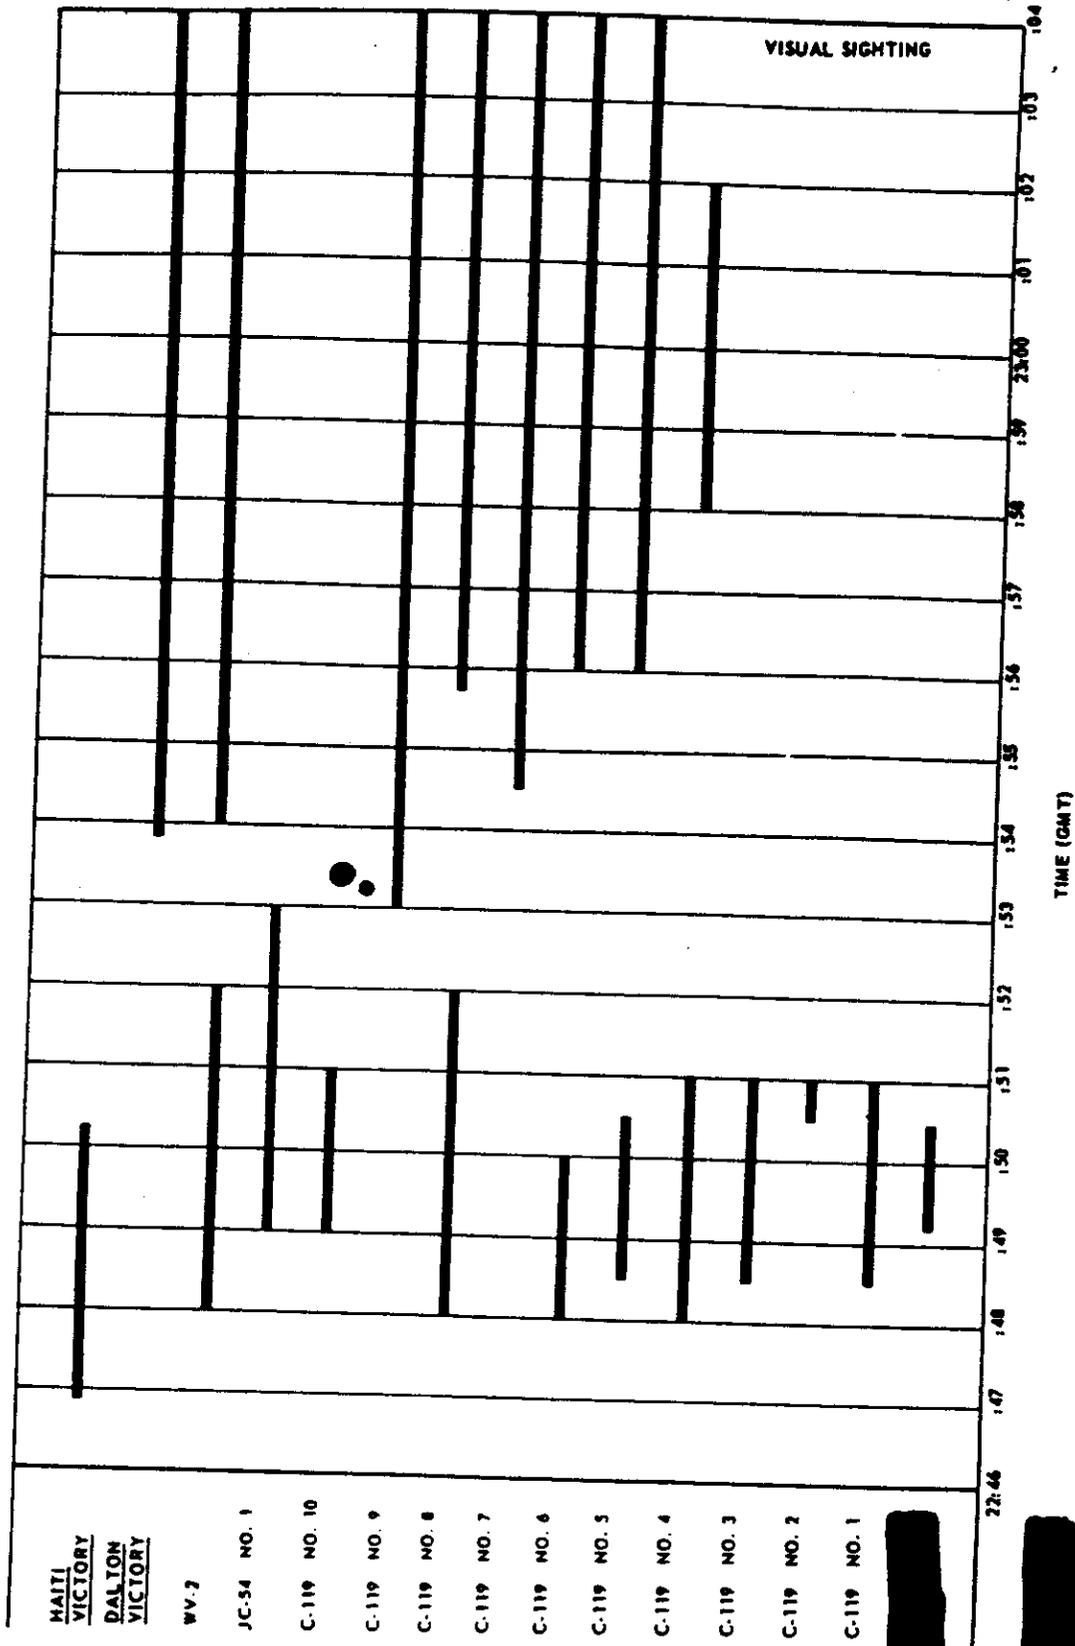
Figure 8-1 Recovery-Force VHF-Beacon Acquisition History

The capsule VHF-beacon signals were received by 12 aircraft of the recovery force, by the USS Haiti Victory, the USS Dalton Victory, [redacted] and the South Point tracking station. Barking Sands and Christmas Island stations reported no contacts. The first unit of the recovery force which reported reception of the beacon signal was the USS Haiti Victory at 82010 seconds system time. The longest contact was reported by the USS Dalton Victory which tracked the beacon for a total of approximately 30 minutes.

The VHF-beacon frequency was sufficiently stable for tracking purposes. [redacted] reported that the frequency was 0.1 megacycle low at the time of fade. The recovery force reported various changes or drifts in frequency which ranged from 2 megacycles below nominal to 3 megacycles above nominal. The USS Dalton Victory, having the longest period of reception, reported variations of 0.2 to 0.5 megacycles below nominal.

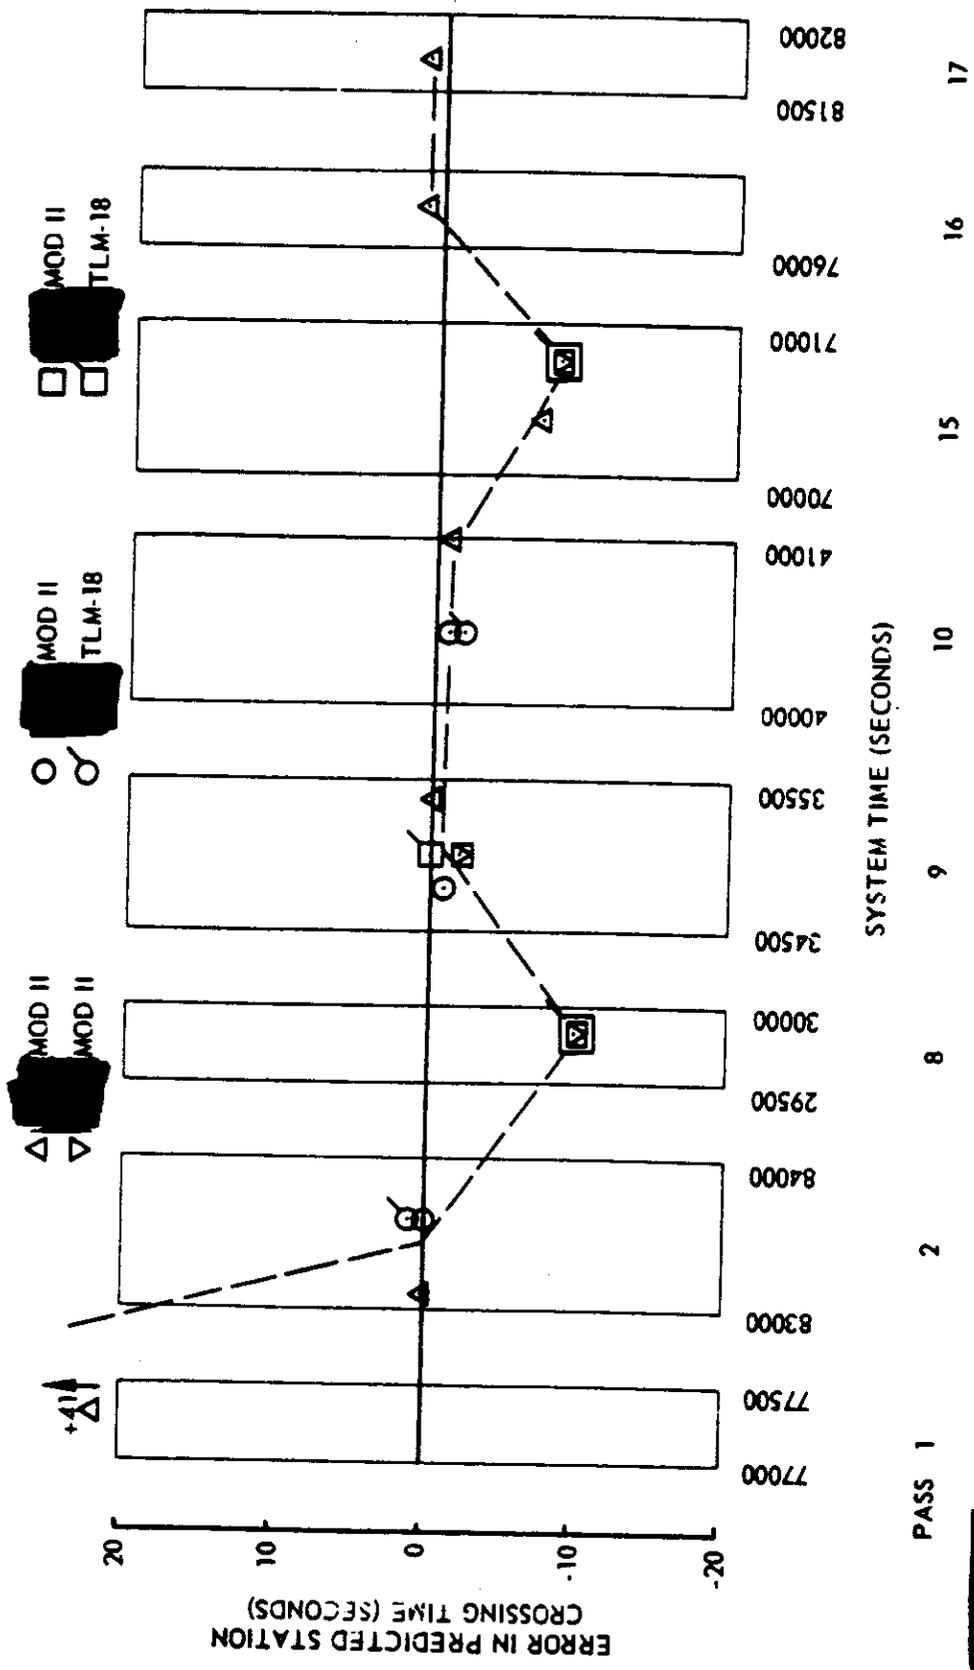
Figure 9-1 Errors in Predicted Time of Station Crossing

Predictions and acquisition messages were sent to the tracking stations from 50 to 60 minutes prior to station acquisition. Figure 9-1 shows the error in
