CORONA Program History

Volume I Program Overview

CORONA PROGRAM HISTORY

PROGRAM OVERVIEW

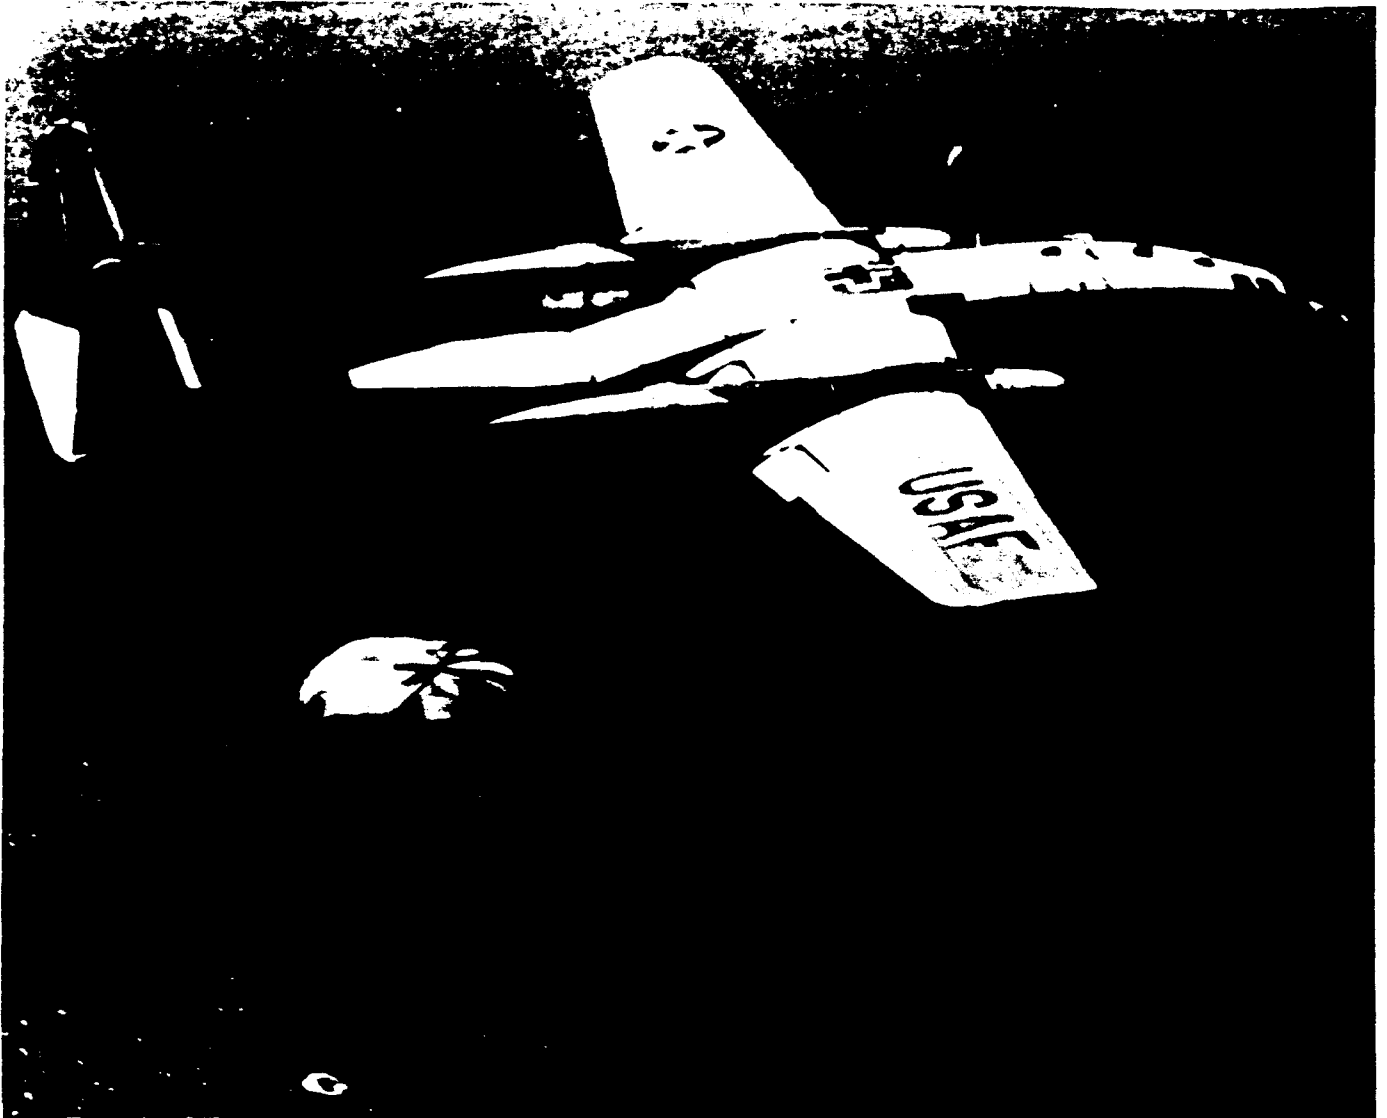
Figure 4-2

AN EARLY CORONA RECOVERY BY A C-119

Recovery presented problems in the early development period and throughout the early operational period. The planned recovery sequence involved a series of maneuvers, each of which had to be executed to near-perfection or recovery would fail. Immediately after injection into orbit, the AGENA vehicle was yawed 180° such that the recovery vehicle faced to the rear. This maneuver minimized the control gas which would be required for re-entry orientation at the end of the mission and protected the heat shield from what at that time was a deep concern for molecular heating. (Later in the J-3 design when these concerns had diminished, the vehicle was flown forward until re-entry.) When re-entry was to take place, the AGENA would then be pitched down through 60 degrees to position the satellite recovery vehicle (SRV) for retrofiring. Then the SRV would be separated from the AGENA and spin-stabilized by firing the spin rockets to maintain it in the attitude given it by the AGENA. Next, the retrorocket would be fired slowing down the SRV into a descent trajectory, and the spin of the SRV would be cancelled by firing the despin rockets. The retrorocket thrust cone was then separated, followed by the heat shield and the parachute cover. The drogue (or deceleration) chute would then deploy, and finally the main chute would open to lower the capsule gently into the recovery area. The primary recovery technique involved flying an airplane across the top of the descending parachute, catching the chute or its shrouds in a trapeze-like hook suspended beneath the airplane, and then winching the recovery vehicle aboard. Initially, C-119 Aircraft were used, but C-130 Aircraft replaced them later in the program. If the air catch failed, the recovery vehicle was designed to float long enough for a water recovery by a helicopter launched from a surface ship. Illustrations showing the recovery sequence and the aerial recovery of the capsule are provided as Figures 4-1 thru 4-3.

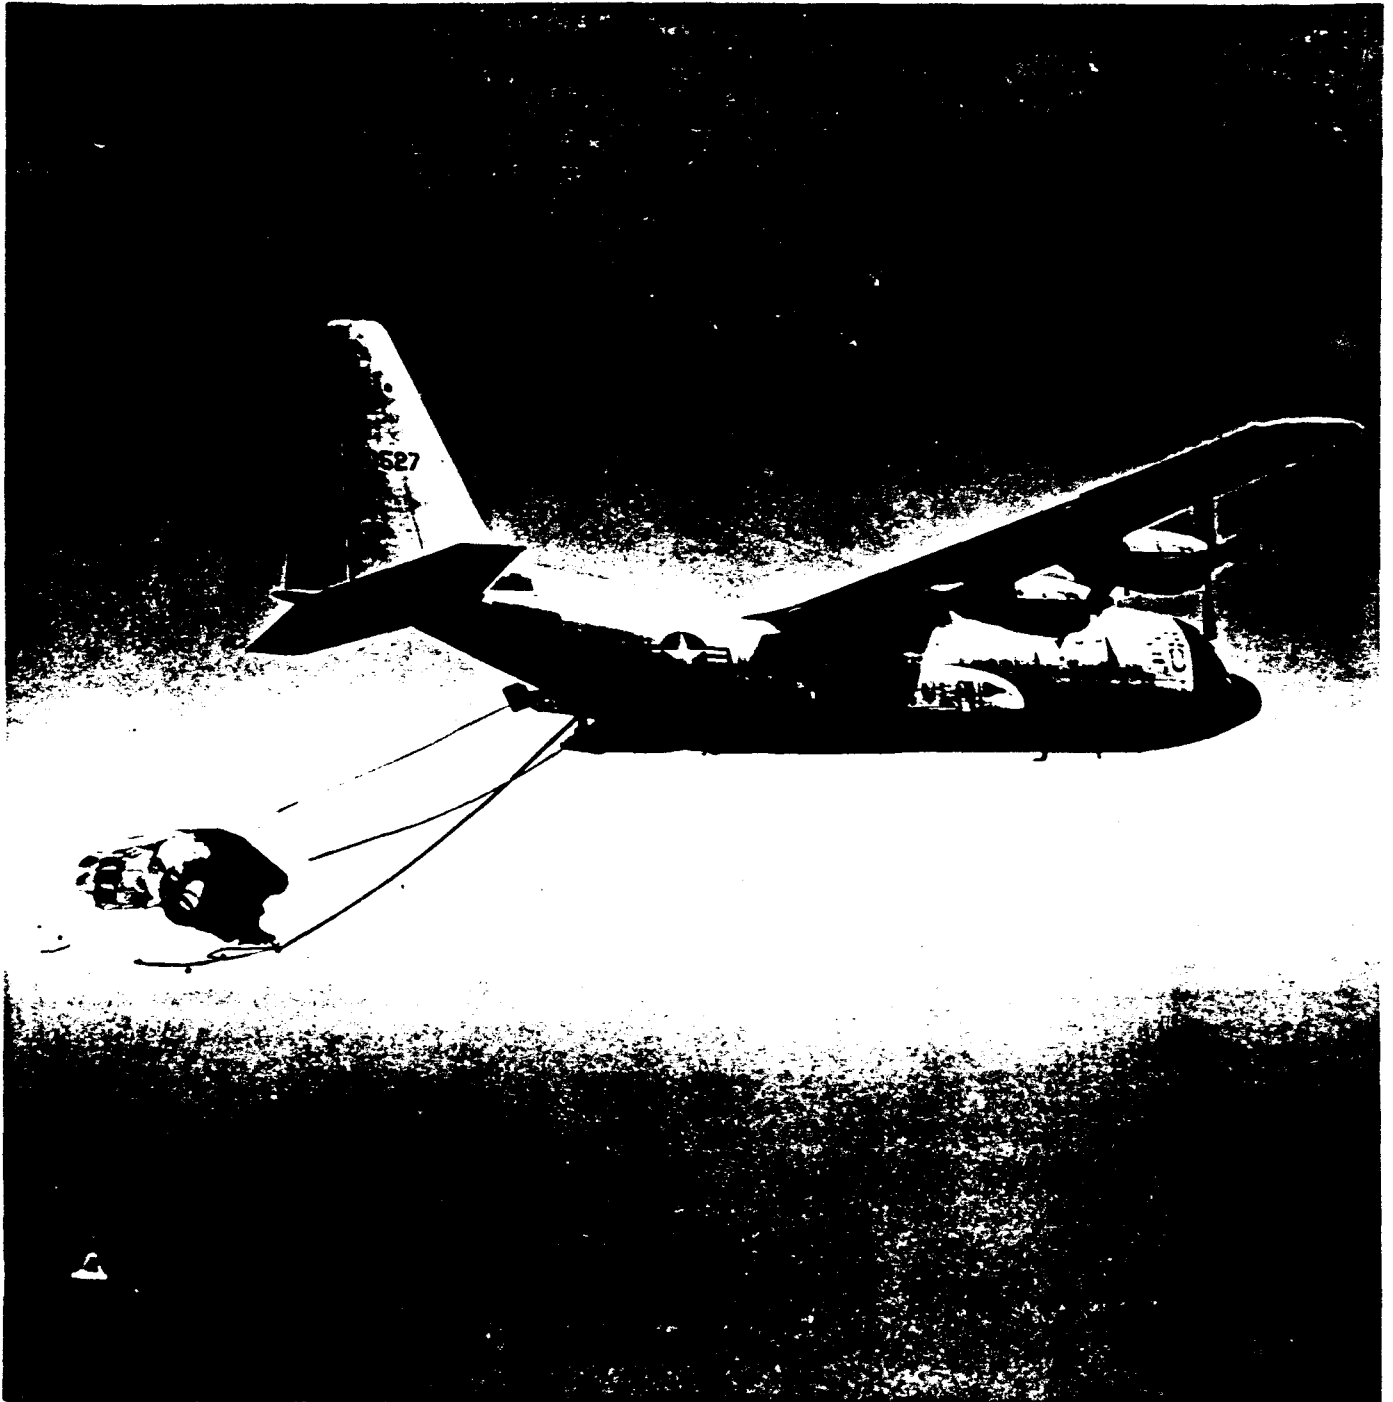
Figure 4-3

A CORONA J SYSTEM RECOVERY BY A C-130

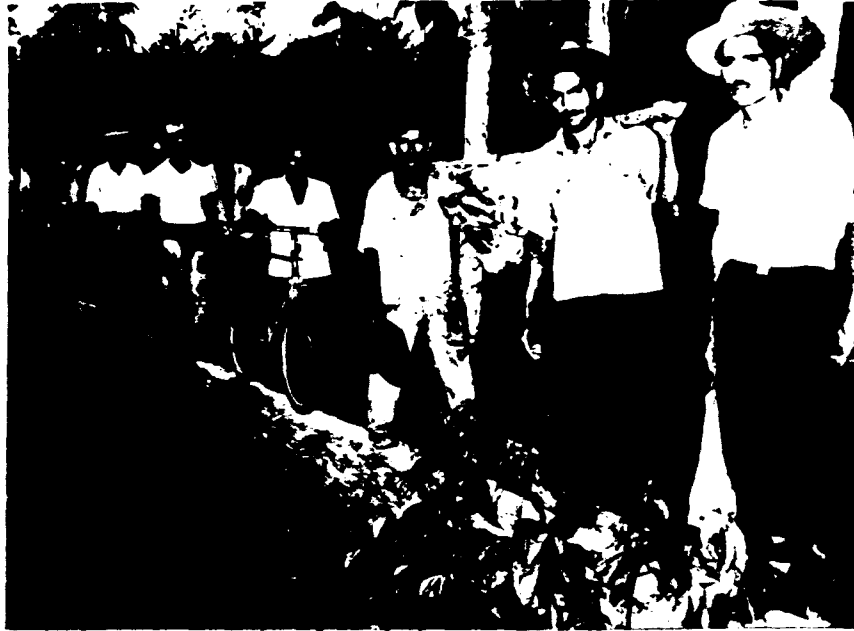
Figure 8-1

SRV being carried out of La Fria on foot by Campesinos.

Before long, word of the find reached the city of Cristobal, and people began visiting La Fria to examine the curious object from space. It was the first bucket from Mission 1005 with one full spool of well charred film clearly visible. One of the visitors was the photographer, Davila, who passed the word to the American Embassy. Military attachees were called in and a team of CORONA Program officers flew to Caracas to direct the recovery operation and to ship the capsule and any other fragments that could be found back to the United States for detailed examination. The capsule was carried out part way by campesinos on foot and then was taken over by the Venezuelan Defense Ministry and flown to Caracas. The USAF bought the crumpled specimen from the Venezuelan Government and quietly dismissed the event as an unimportant NASA space experiment that had gone astray.

The CORONA technicians who examined the capsule after its arrival back in the U. S. concluded that the re-entry of the SRV came as a result of normal orbit degeneration with separation from the instrument fairing being caused by re-entry forces. The thrust cone was sheared during separation but was retained by its harness long enough to act as a drogue chute, thus preventing the capsule from burning up during re-entry and stabilizing it for a hard, nose-down landing.

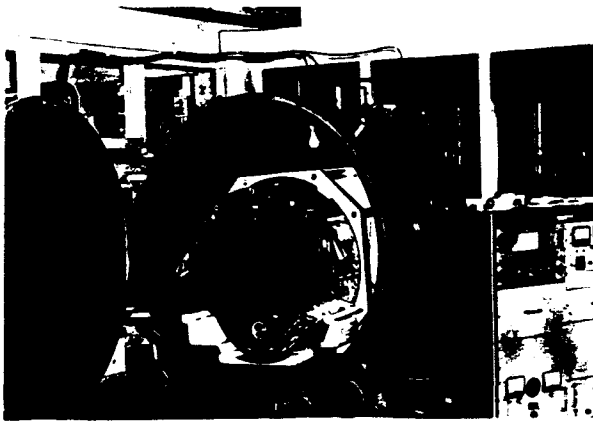
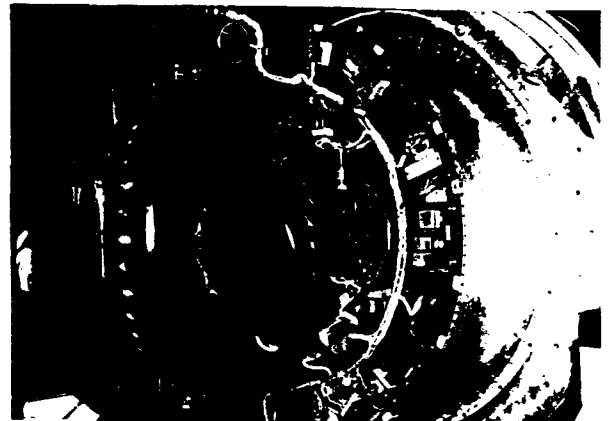
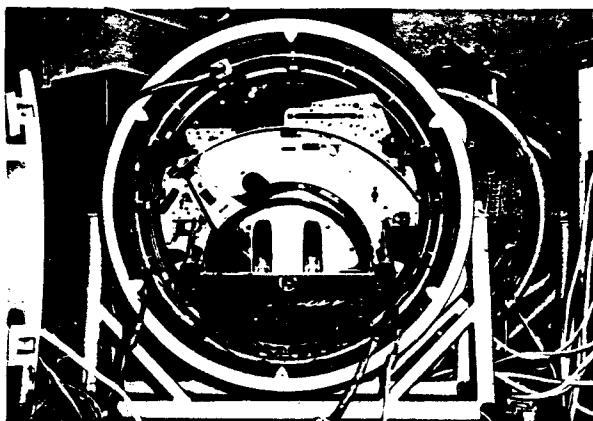
Figure 8-3

THE CORONA CAMERAS

The Original CORONA (C)

The ARGON (A)

The MURAL (M)

The LANYARD (L)

The J-1

The Constant Rotator or J-3

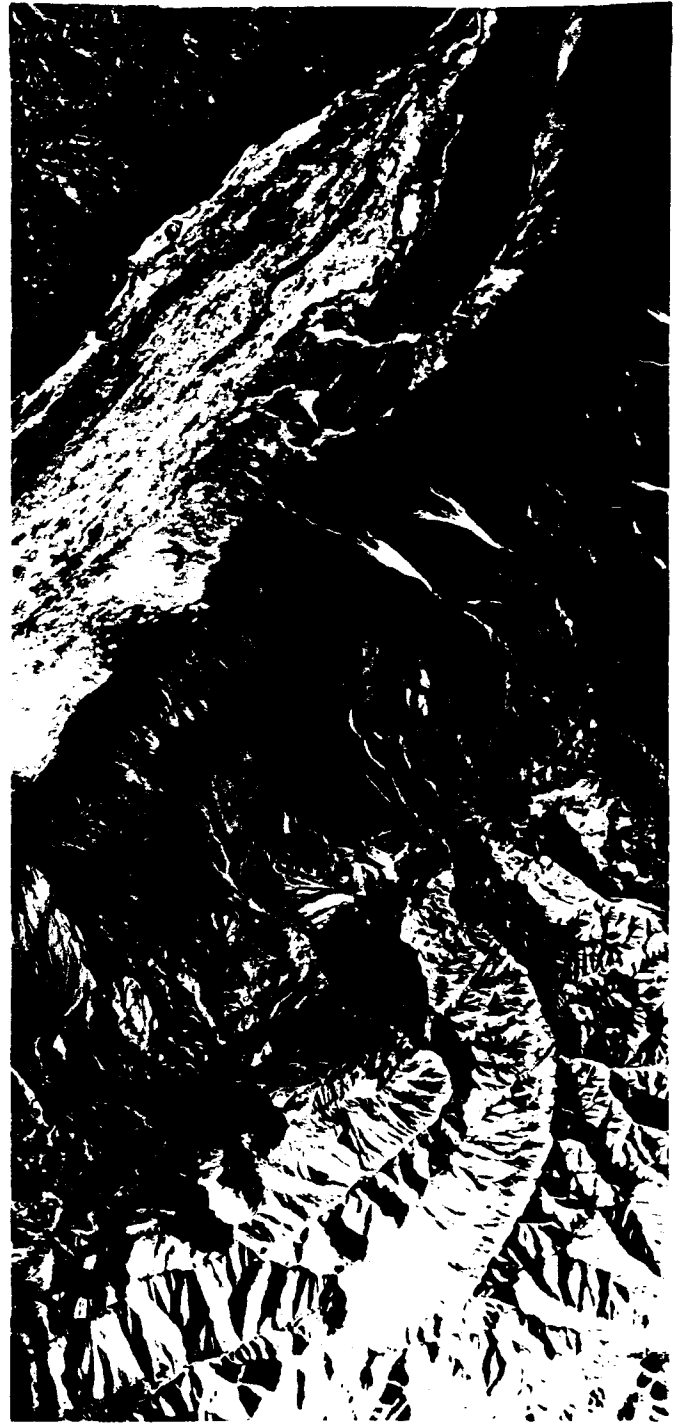
STEREO PAIR ILLUSTRATING PHOTOGEOLOGIC VALUE OF CORONA IMAGERY

While the primary objective of the CORONA Program was the search and surveillance of denied territories, the high quality of the photography permitted even further exploitation of the film. For example, an effort at Itek was undertaken by the Government and private agencies to achieve photogeological mapping from the satellite photography. Through stereoscopic viewing of the high definition black and white and color films, these studies at Itek did lead to successful geological mapping. In March 1971, Itek published [REDACTED] final report, Appraisal of Geologic Value for Mineral Resources Exploitation, which concluded that CORONA system image quality was sufficient for most photogeologic mapping projects, and that the film could be used in determining the geological, economical, and political potential of a photographed area. Figure 8-4 provides a stereo pair (one black and white record and one color record) from a mission showing apparent mineralization. Figure 8-5 is a photogeologic evaluation map produced from CORONA imagery.
