CORONA CR

MISSION SUMMARY

TELEMETRY ANALYSIS

MISSION 1114

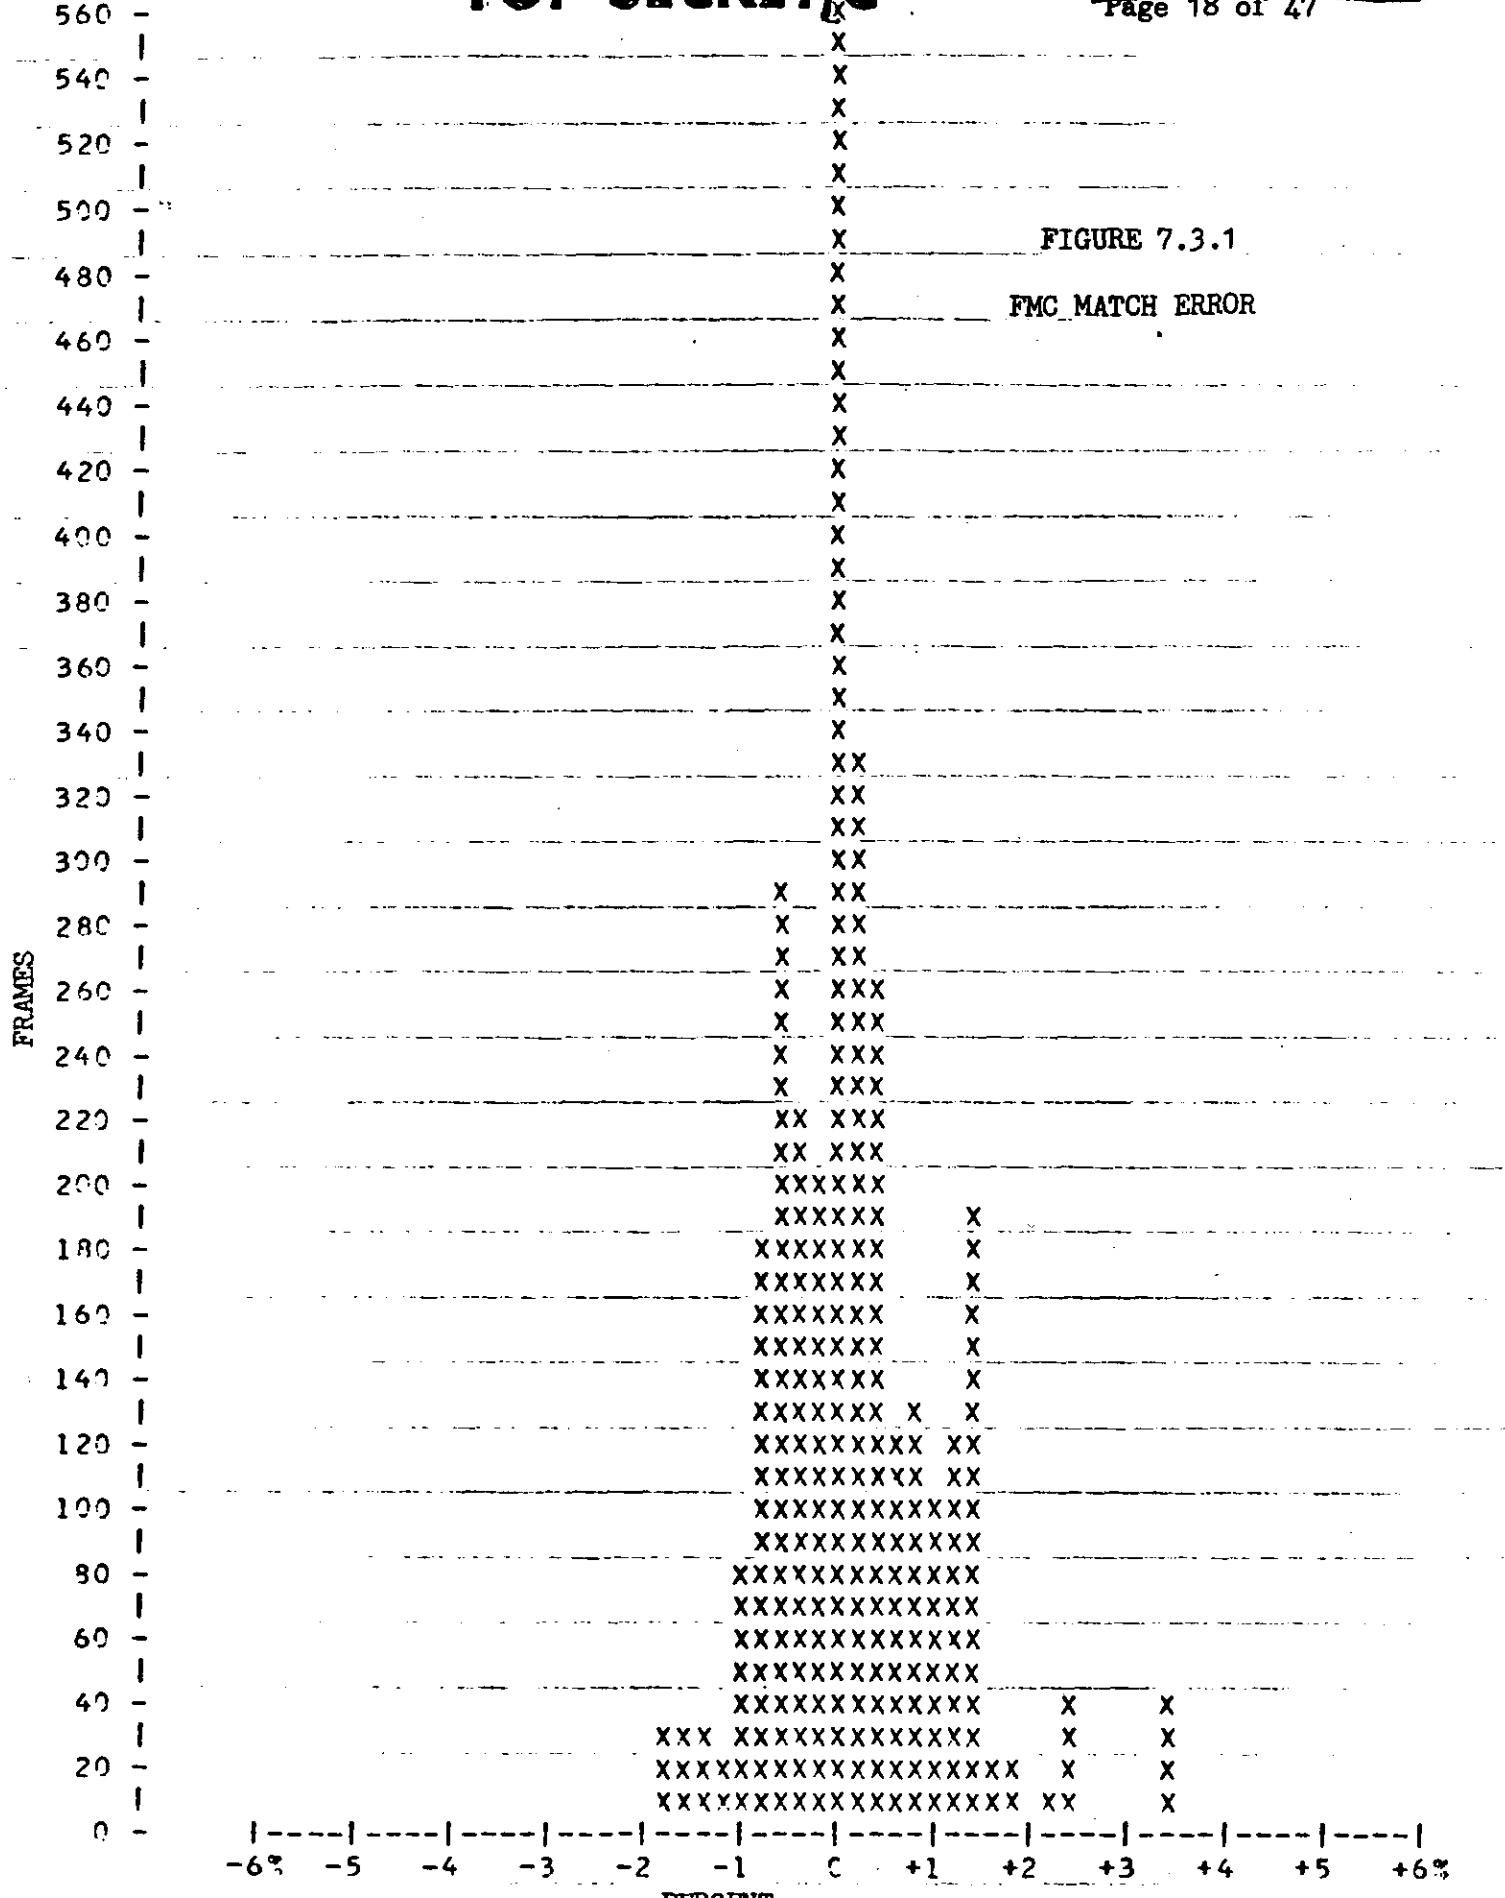
MISSION 1114-1 AFT LOOKING--ORBIT MATCH
MEAN = 0.16 ONE SIGMA = 0.84 TOTAL FRAMES = 2938
2470 FRAMES MATCHED ORBIT +/- 1% REPRESENTS 82.66% OF THE MISSION

The Ramp to Orbit match was satisfactory throughout both missions. During 82.5% of the first mission operations and during 82.1% of the second mission operations, the mis-match error was less than 1.0%.

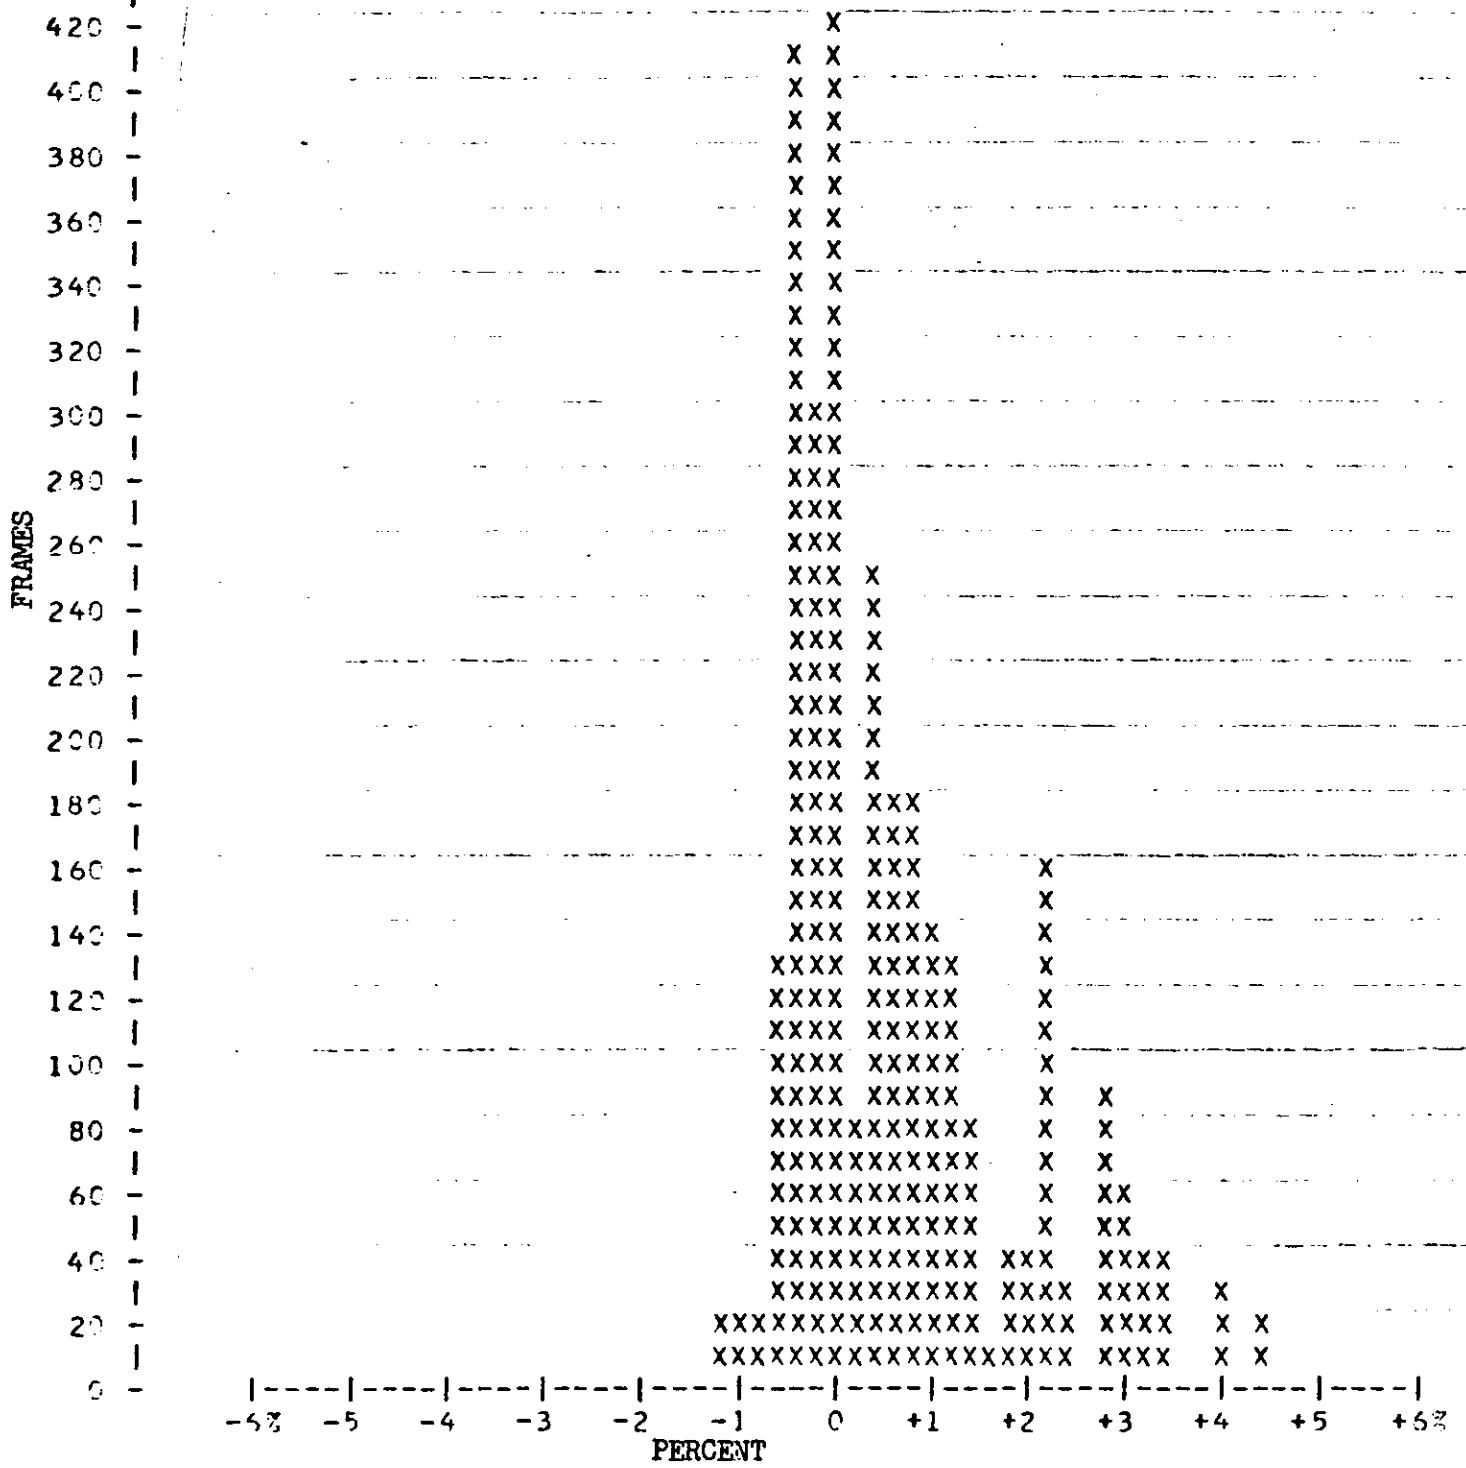
MISSION 1114-2 AFT LOOKING-ORBIT MATCH

MEAN= 0.65 ONE SIGMA= 1.16 TOTAL FRAMES=2918

2123 FRAMES MATCHED ORBIT +/- 1%, REPRESENTS 72.76%, OF THE MISSION

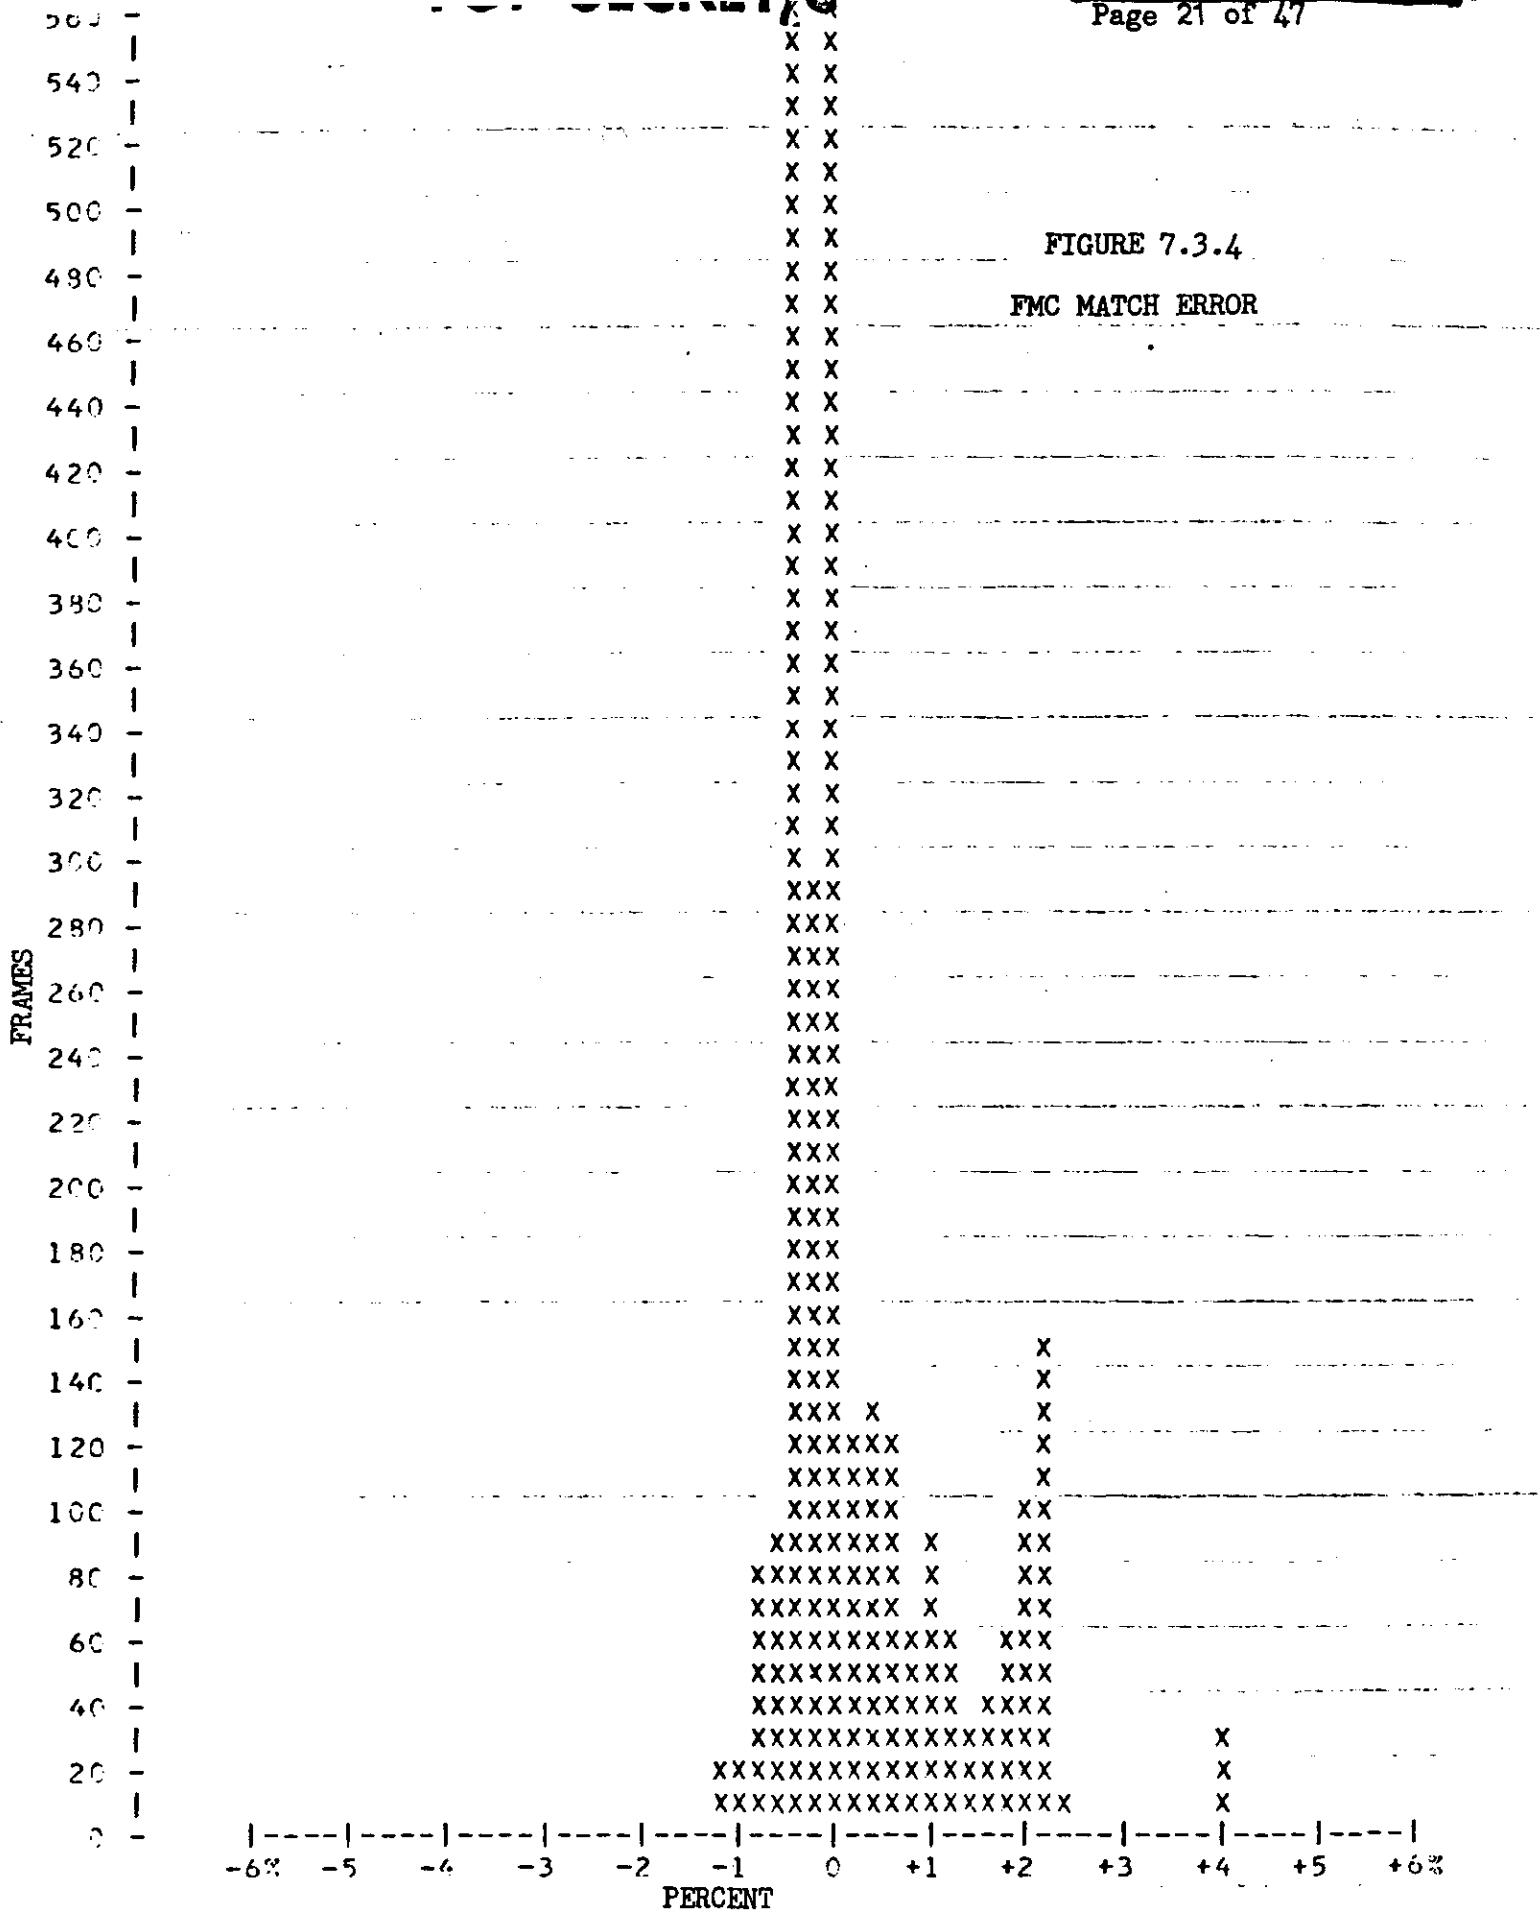
MISSION 1114-2 FWD LOOKING--ORBIT MATCH

MEAN= 0.26 ONE SIGMA= 0.89 TOTAL FRAMES=2902

2394 FRAMES MATCHED ORBIT +/- 1%, REPRESENTS 82.49% OF THE MISSION

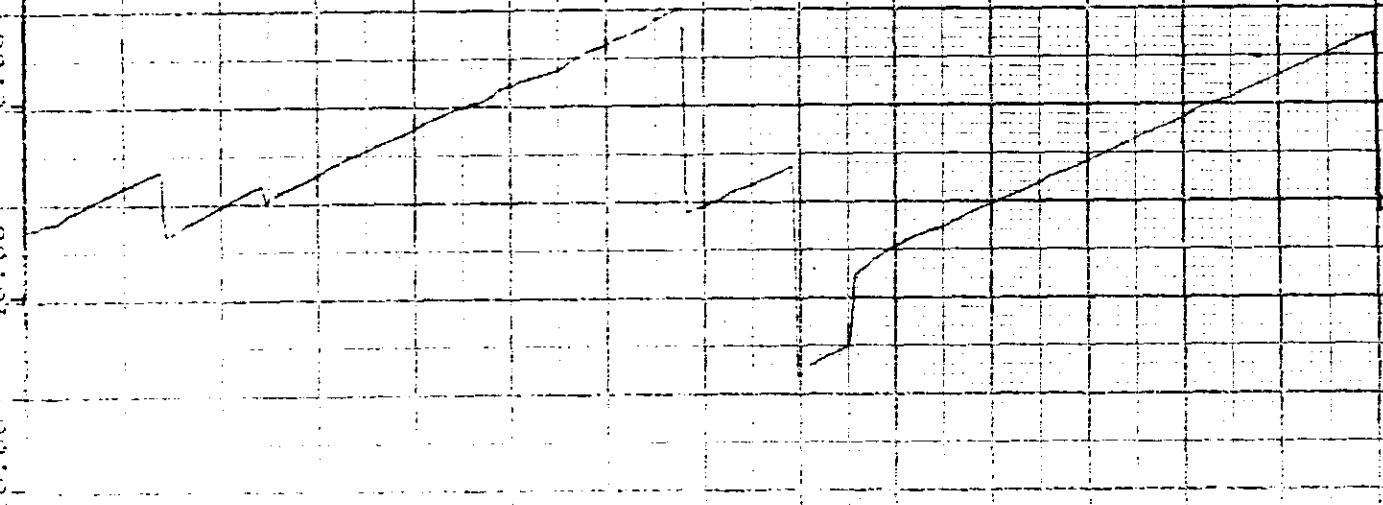
FIGURE 7.6.1

ORBIT HISTORY

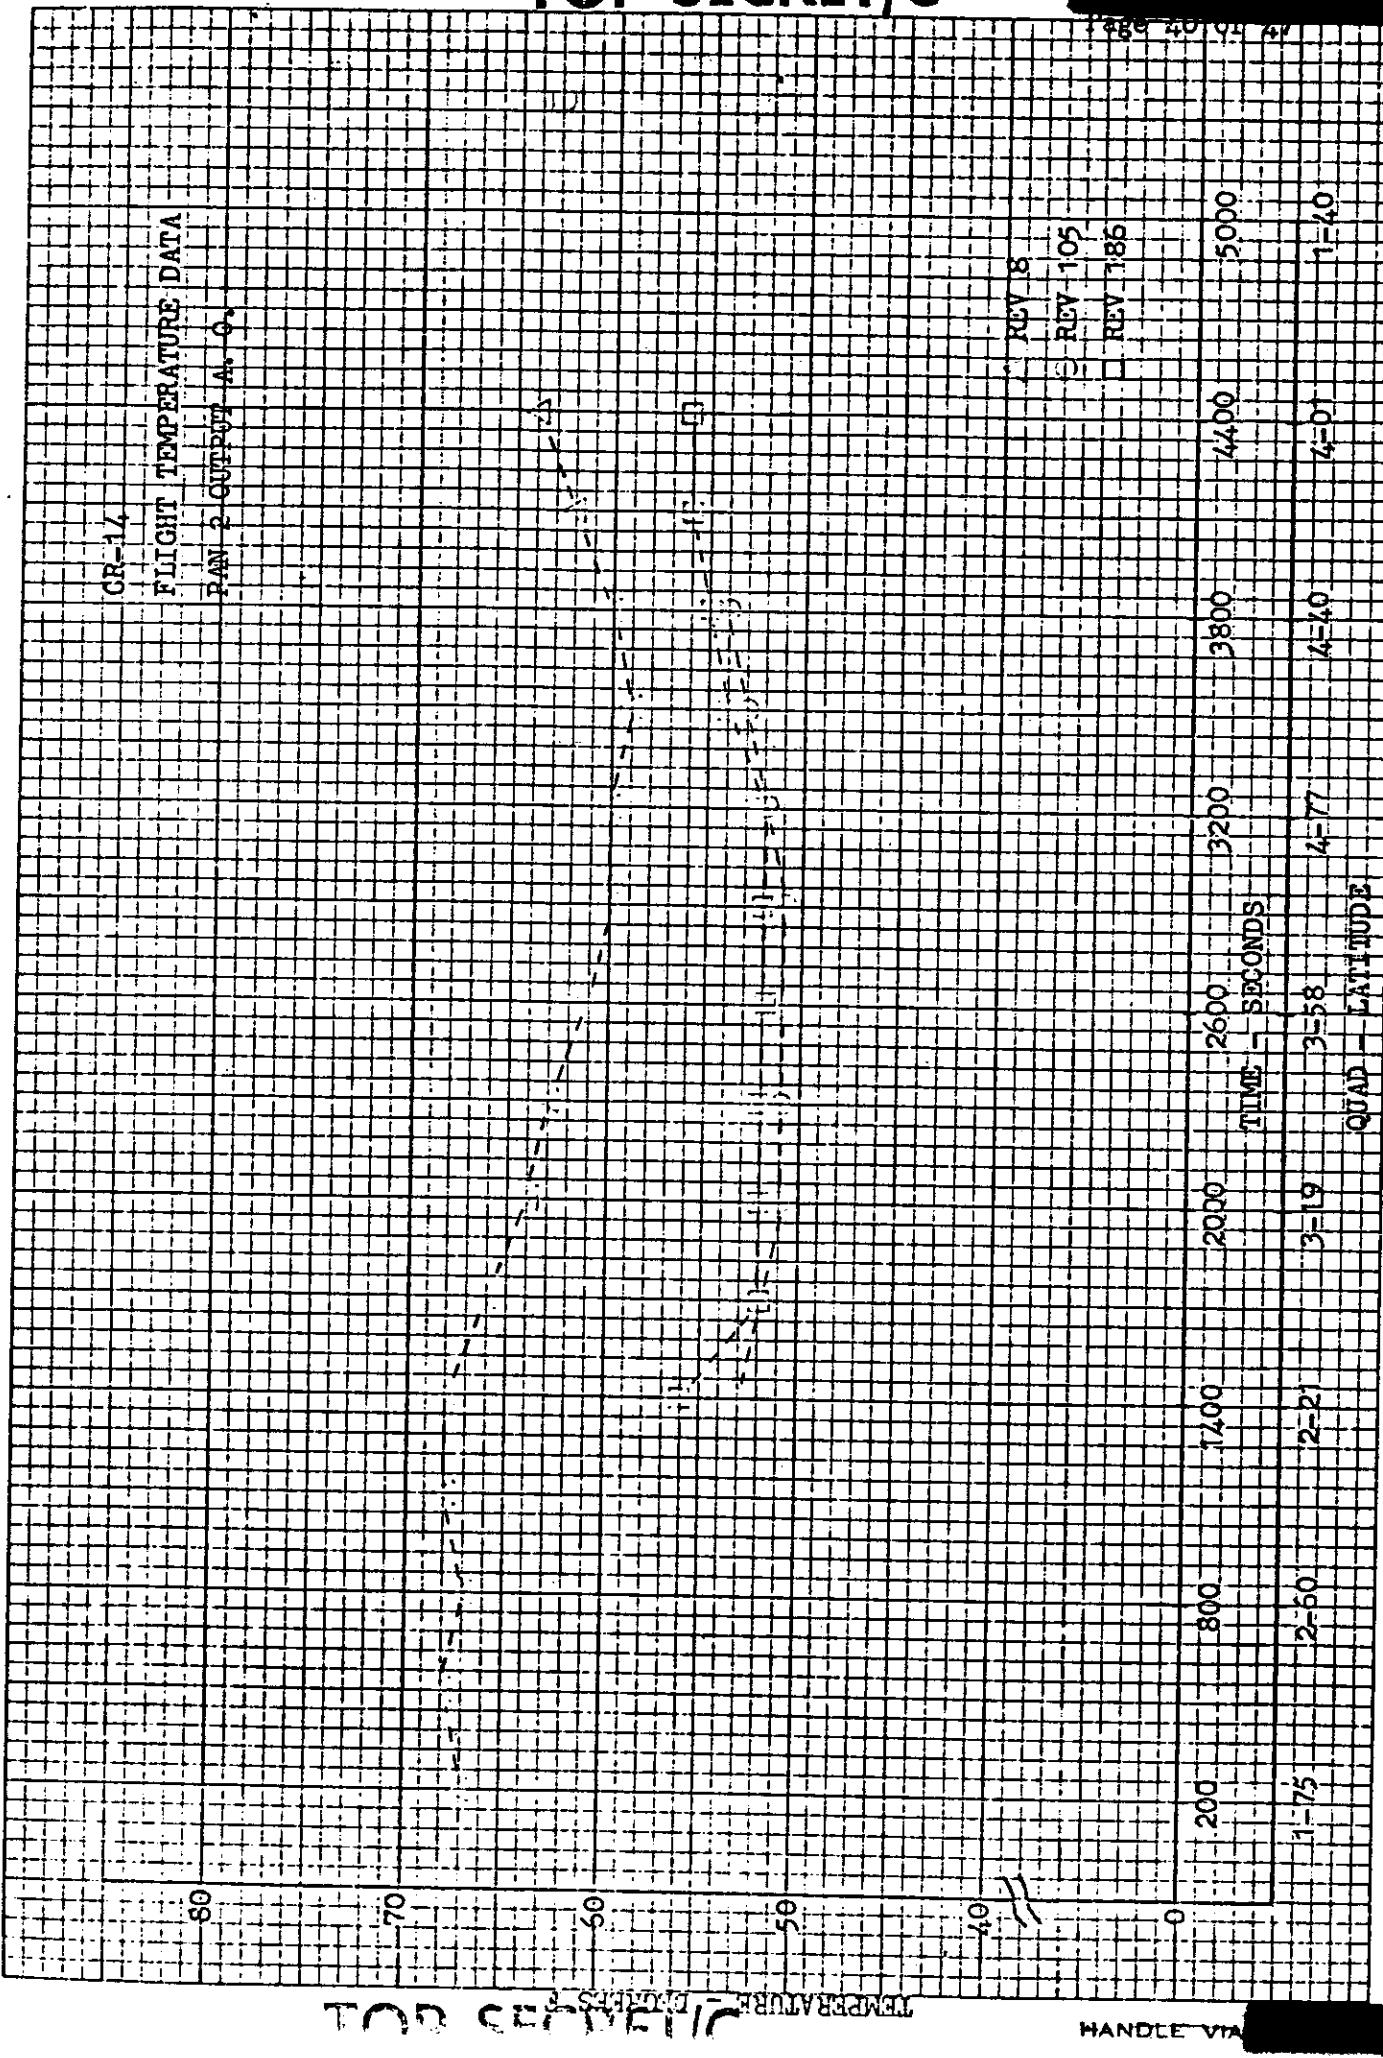
FIGURE 7.8.11

CR-14
FLIGHT TEMPERATURE DATA
PAN 2 FRONT BALL

The on-orbit temperature profiles for Revs. 8, 105, and 186 are included in Figures 7.8.2 thru 7.8.14.

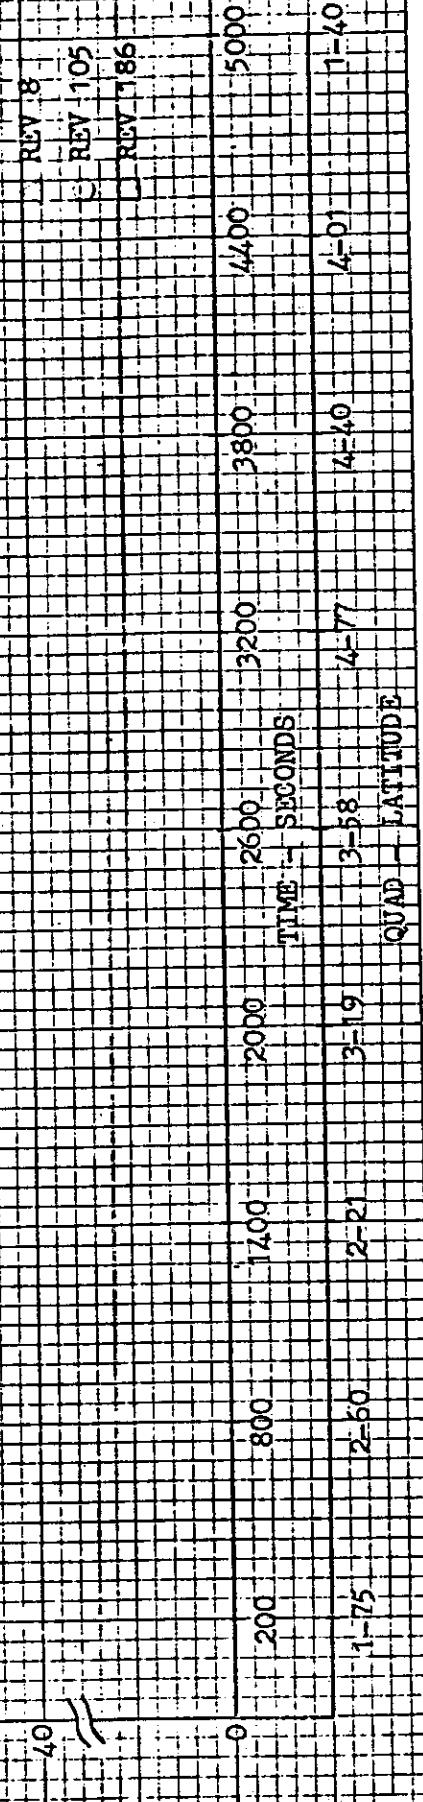
FIGURE 7.8.12

CR-14
FLIGHT TEMPERATURE DATA
PANEL 2 REAR RAIL
