HEXAGON PROGRAM
PRELIMINARY POST FLIGHT REPORT
FOR FLIGHT NO. 9

31 MARCH 1975

This document presents preliminary evaluation results of vehicle and ground system performances during the ninth Program HEXAGON flight. The evaluation is based upon data gathered during operations at the Satellite Test Center (STC), Sunnyvale, California.

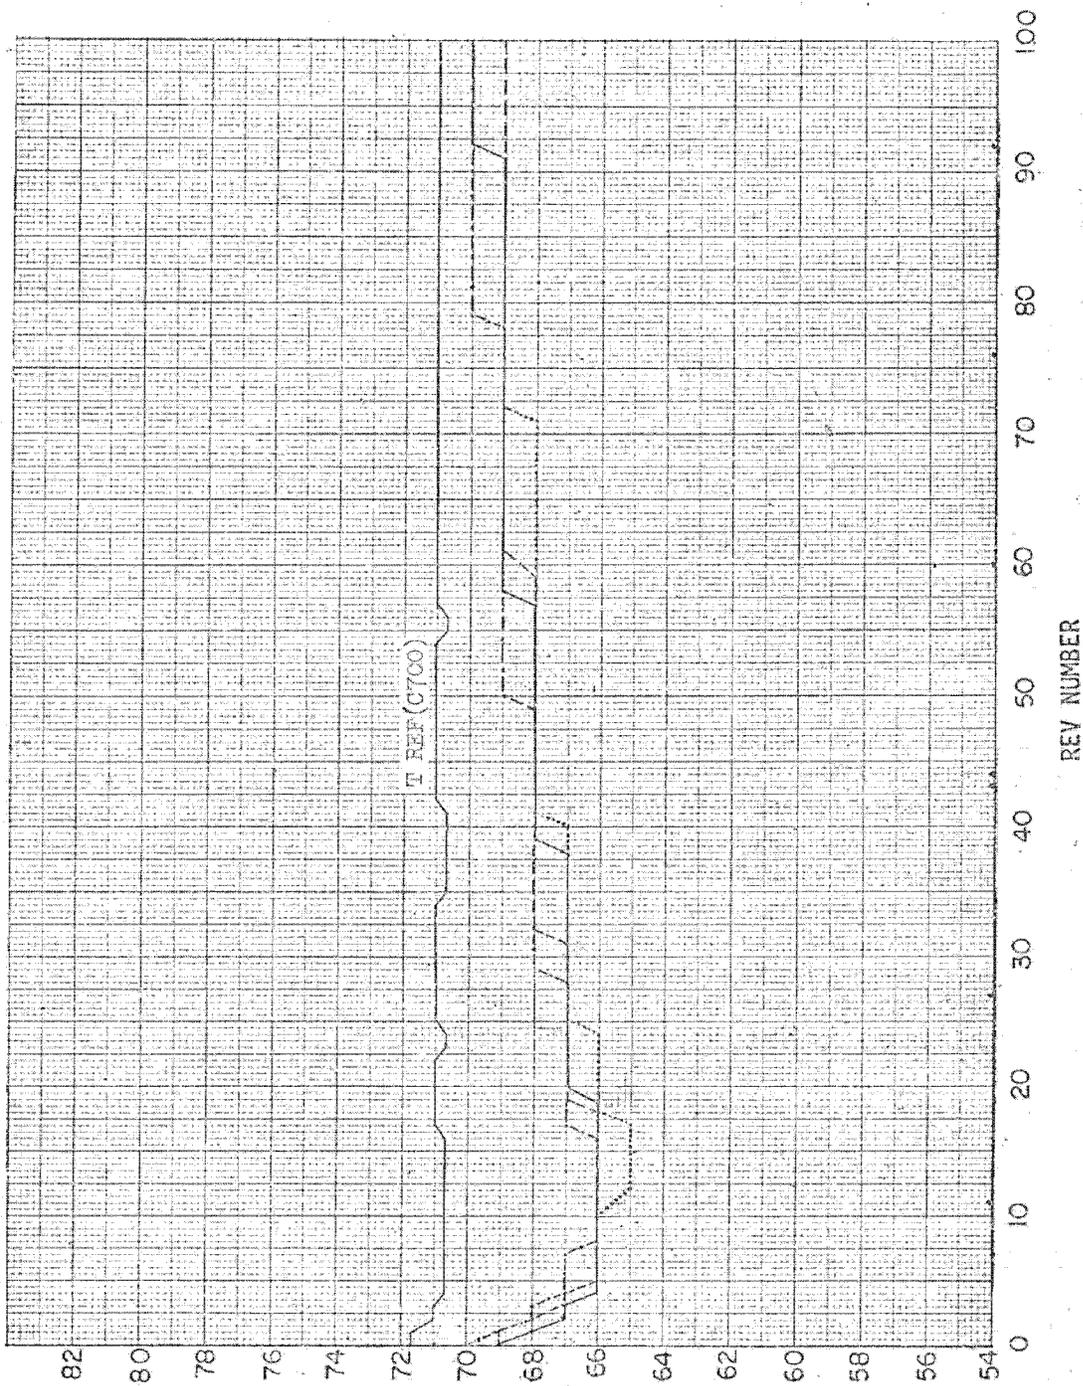
ACTIVE THERMAL CONTROL SYSTEM
RV PAYLOAD CONTAINER & REFERENCE TEMPERATURES

TEMPERATURE ° F

RV1
 RV2 - - - -
 RV3 - - - -
 RV4 - - - -

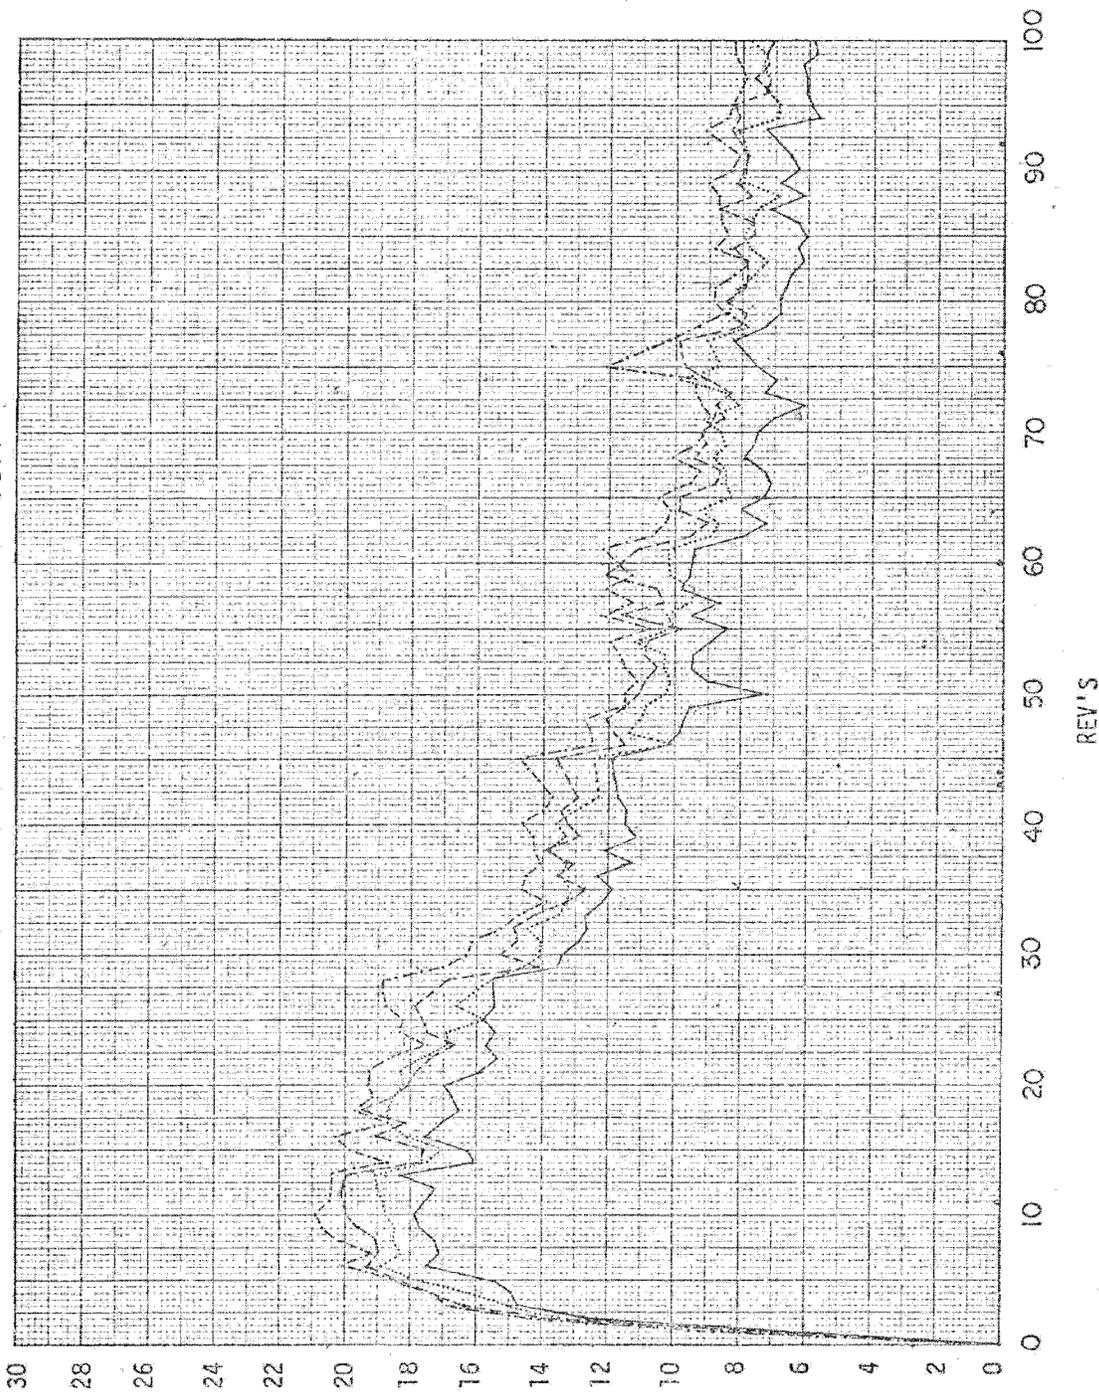
ACTIVE THERMAL CONTROL SYSTEM
RV HEATER POWER CONSUMPTION

AVERAGE HEATER POWER PER RV - WATTS

RV1 - - - - -
 RV2 - - - - -
 RV3 - - - - -
 RV4 - - - - -

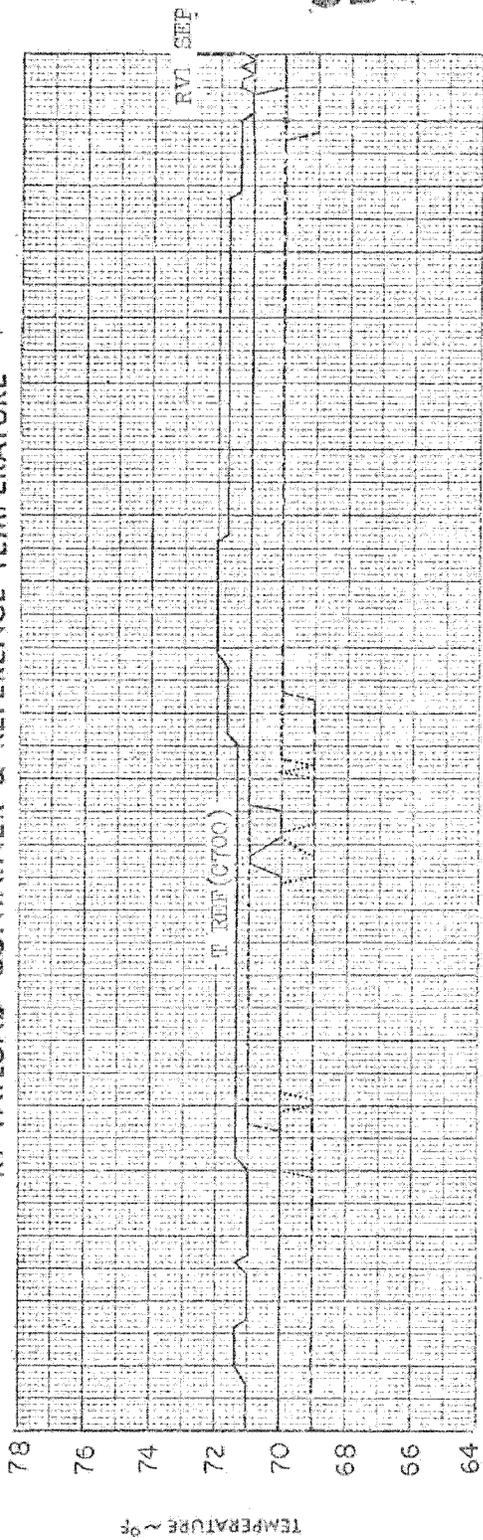
ACTIVE THERMAL CONTROL SYSTEM
RV PAYLOAD CONTAINER & REFERENCE TEMPERATURE

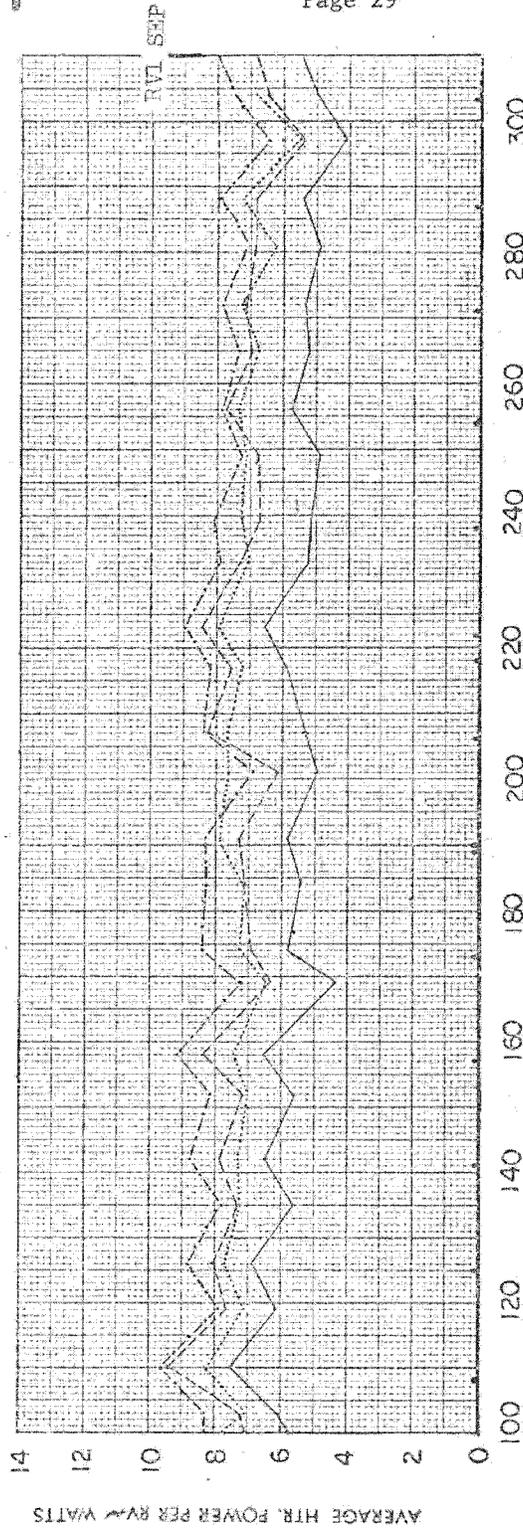
RV HEATER POWER CONSUMPTION

RV1
 RV2 - - - -
 RV3 - - - -
 RV4 ———

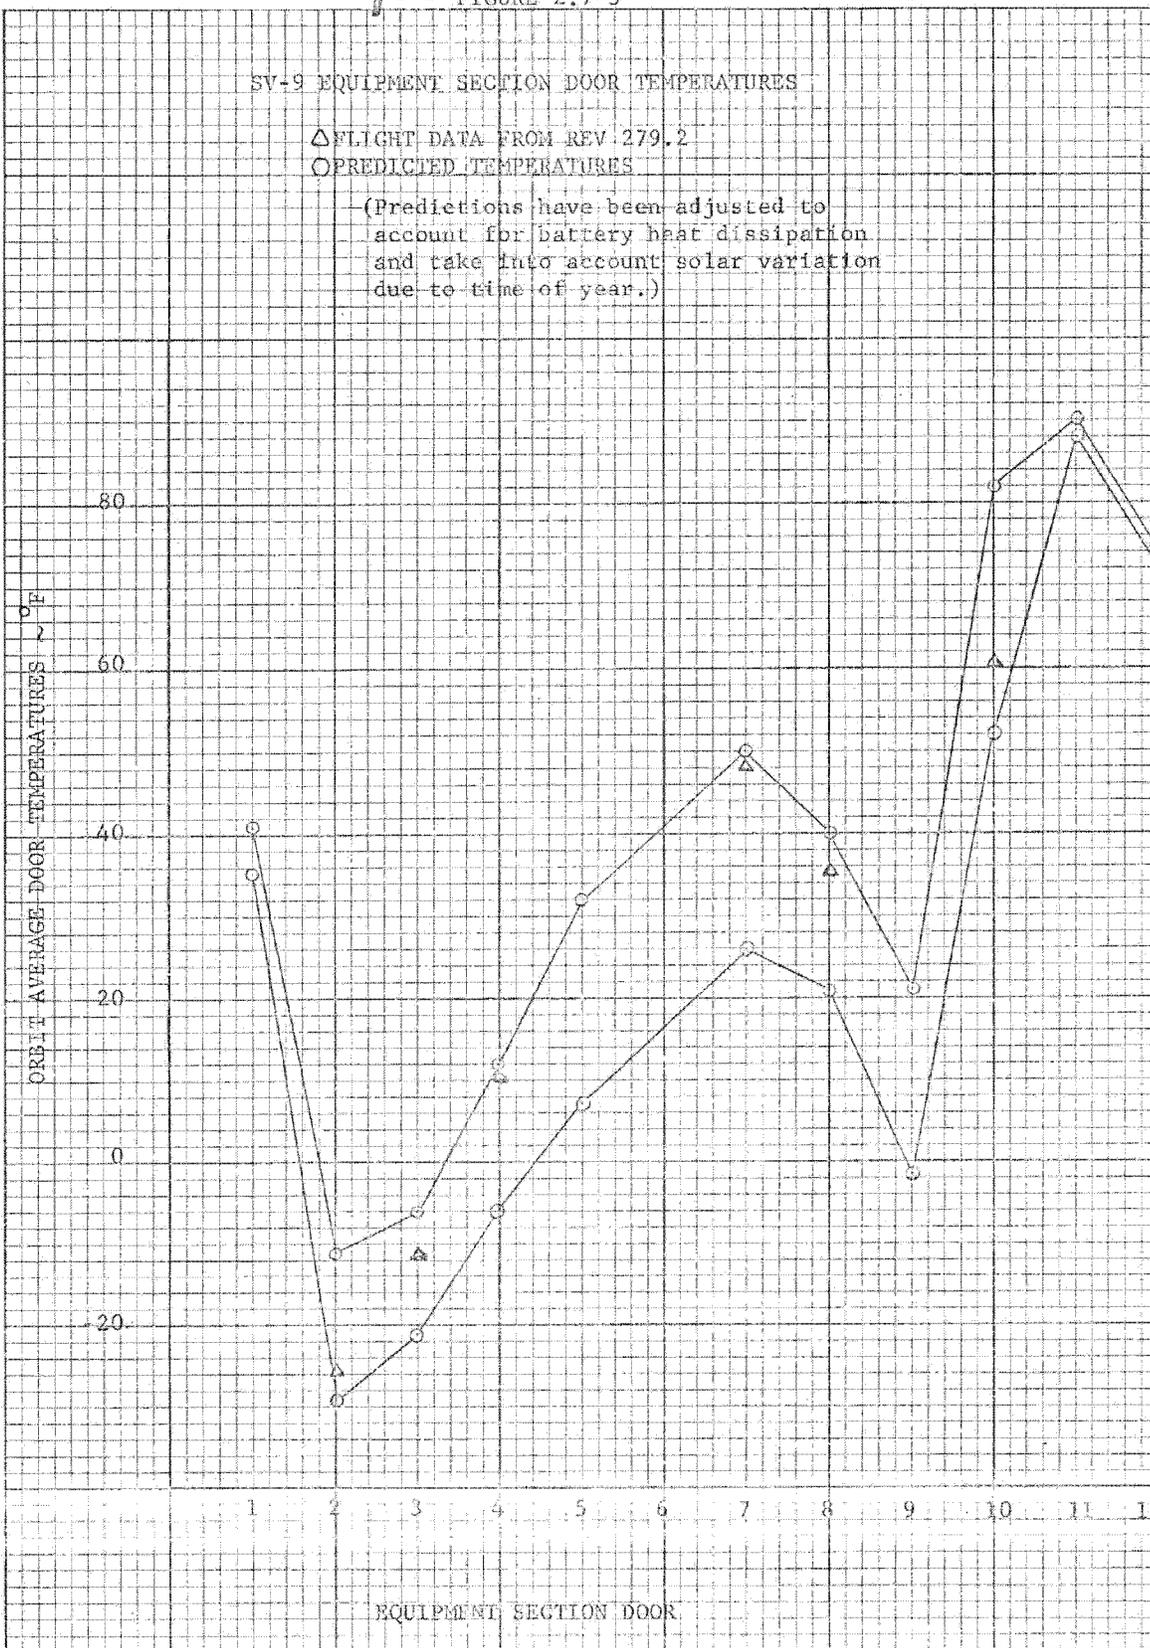
FIGURE 2.1-3

SV-9 EQUIPMENT SECTION DOOR TEMPERATURES

○ PREDICTED TEMPERATURES

(Predictions have been adjusted to account for battery heat dissipation and take into account solar variation due to time of year.)

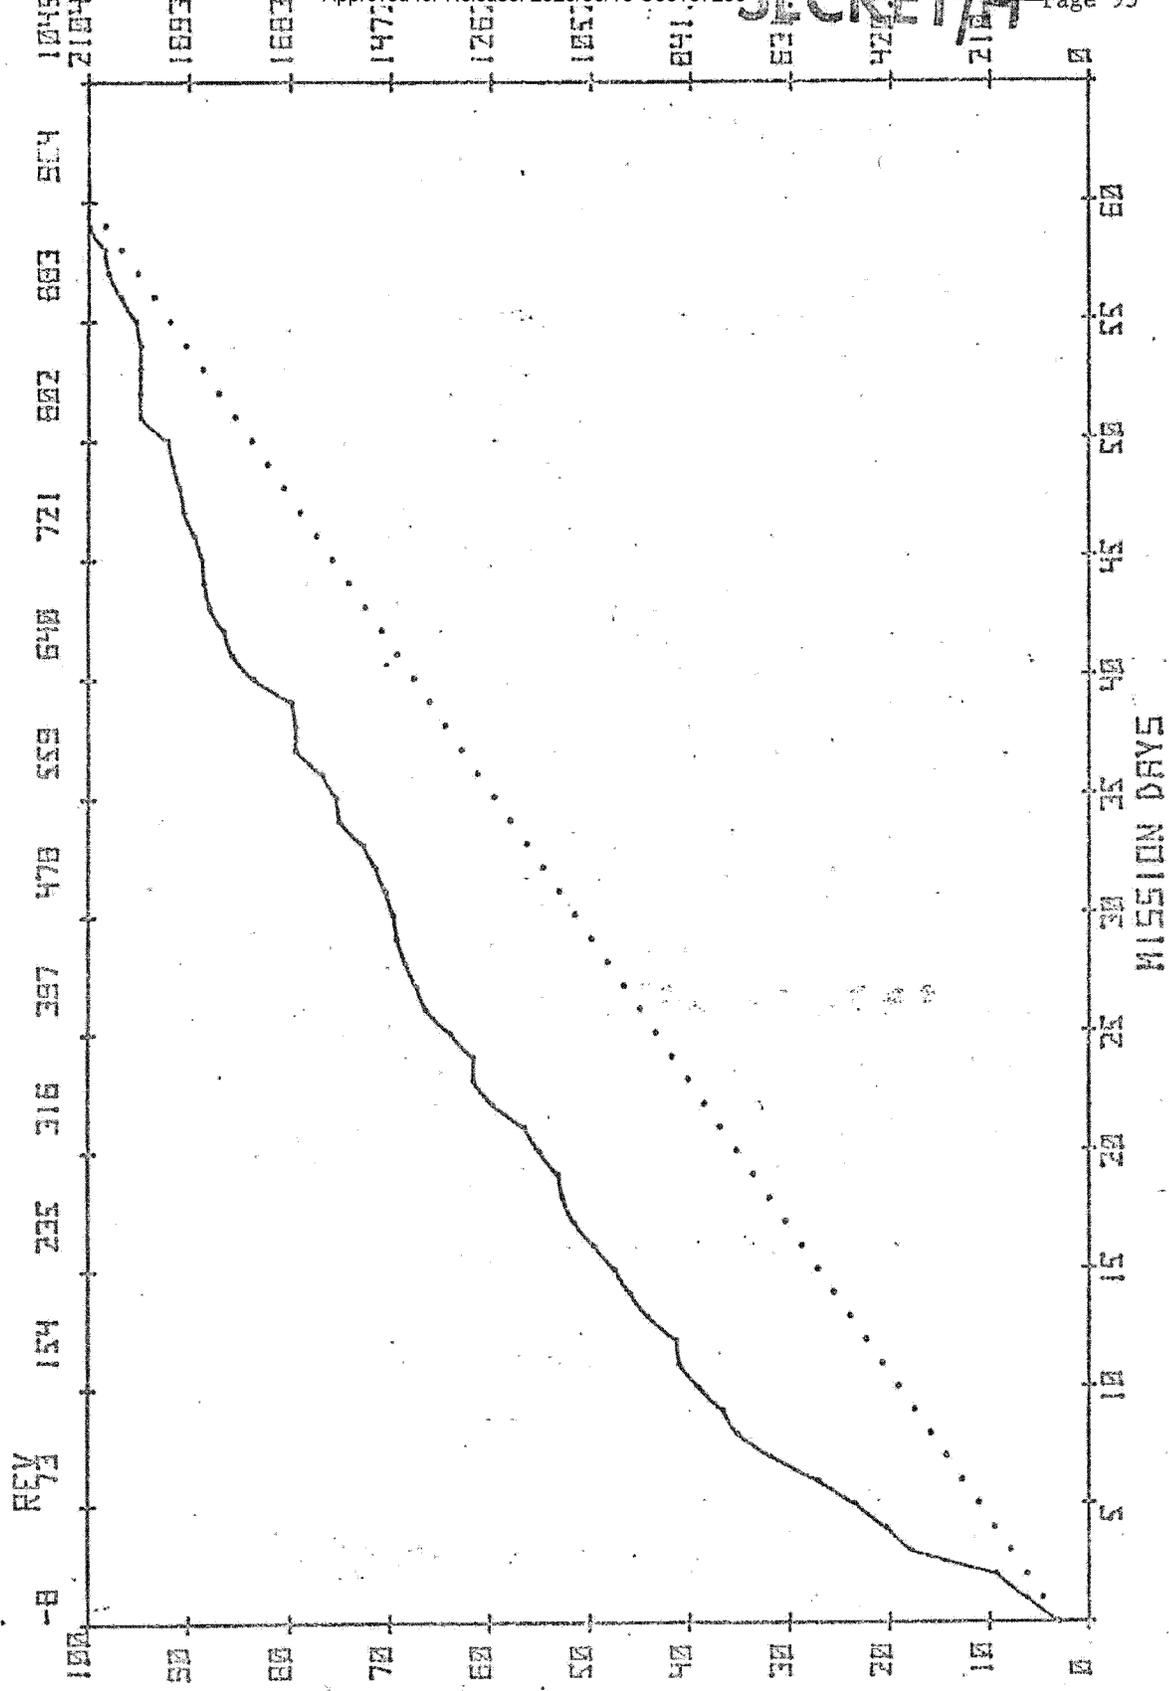
FILM CONSUMPTION SV 9

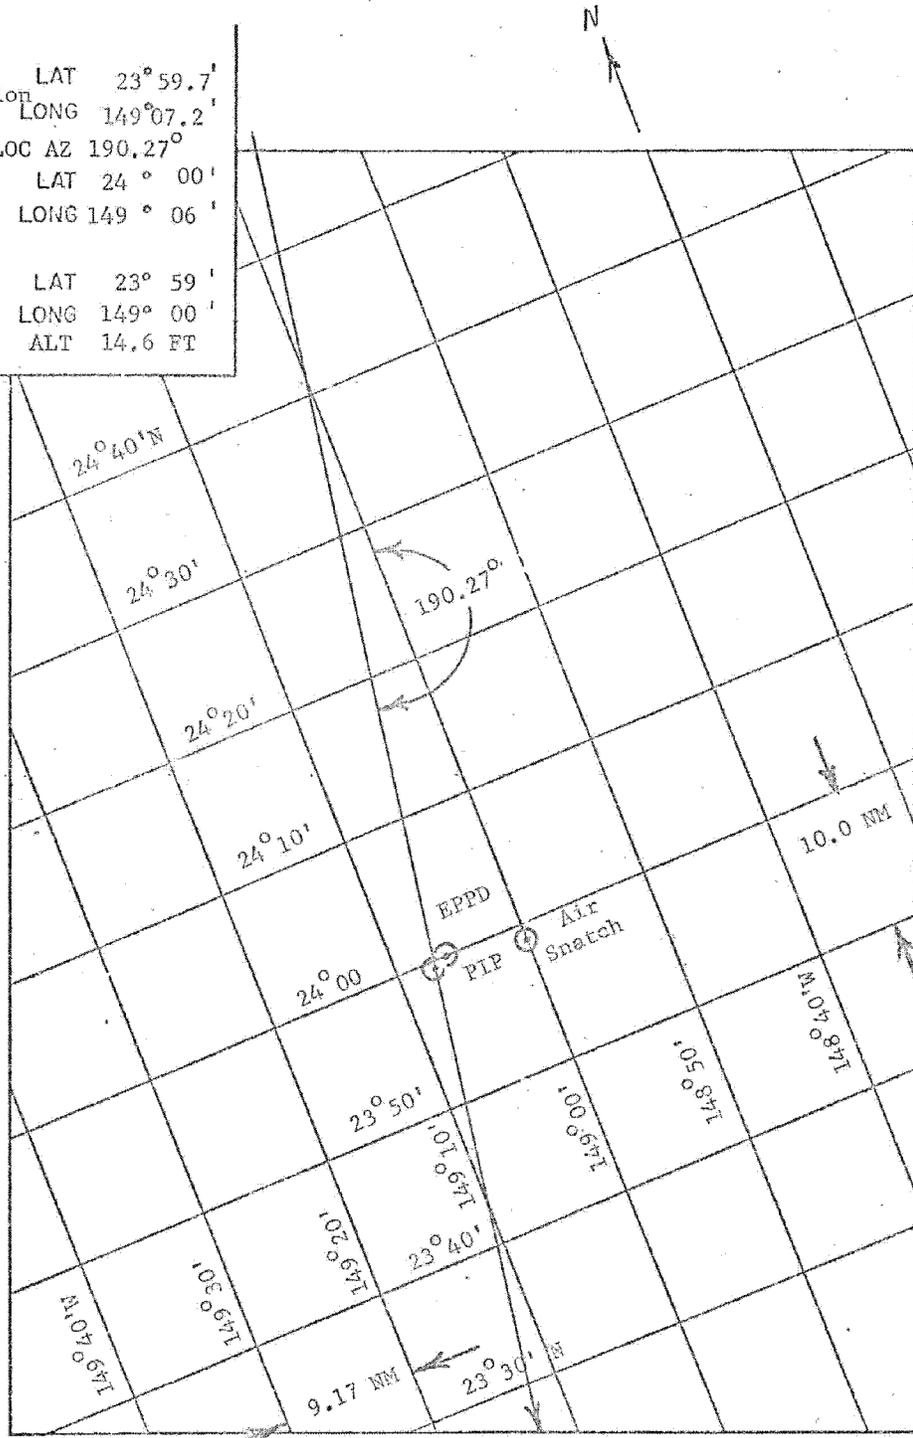
PIP (Evaluation TPOT)	LAT 23° 59.7'
	LONG 149° 07.2'
55K FT	LOC AZ 190.27°
EPPD	LAT 24° 00'
	LONG 149° 06'
AIR SNATCH	LAT 23° 59'
	LONG 149° 00'
	ALT 14.6 FT

CROSSTRACK DISTANCE N. MI.
1.03 NM East

Predicted / Actual Impact Locations

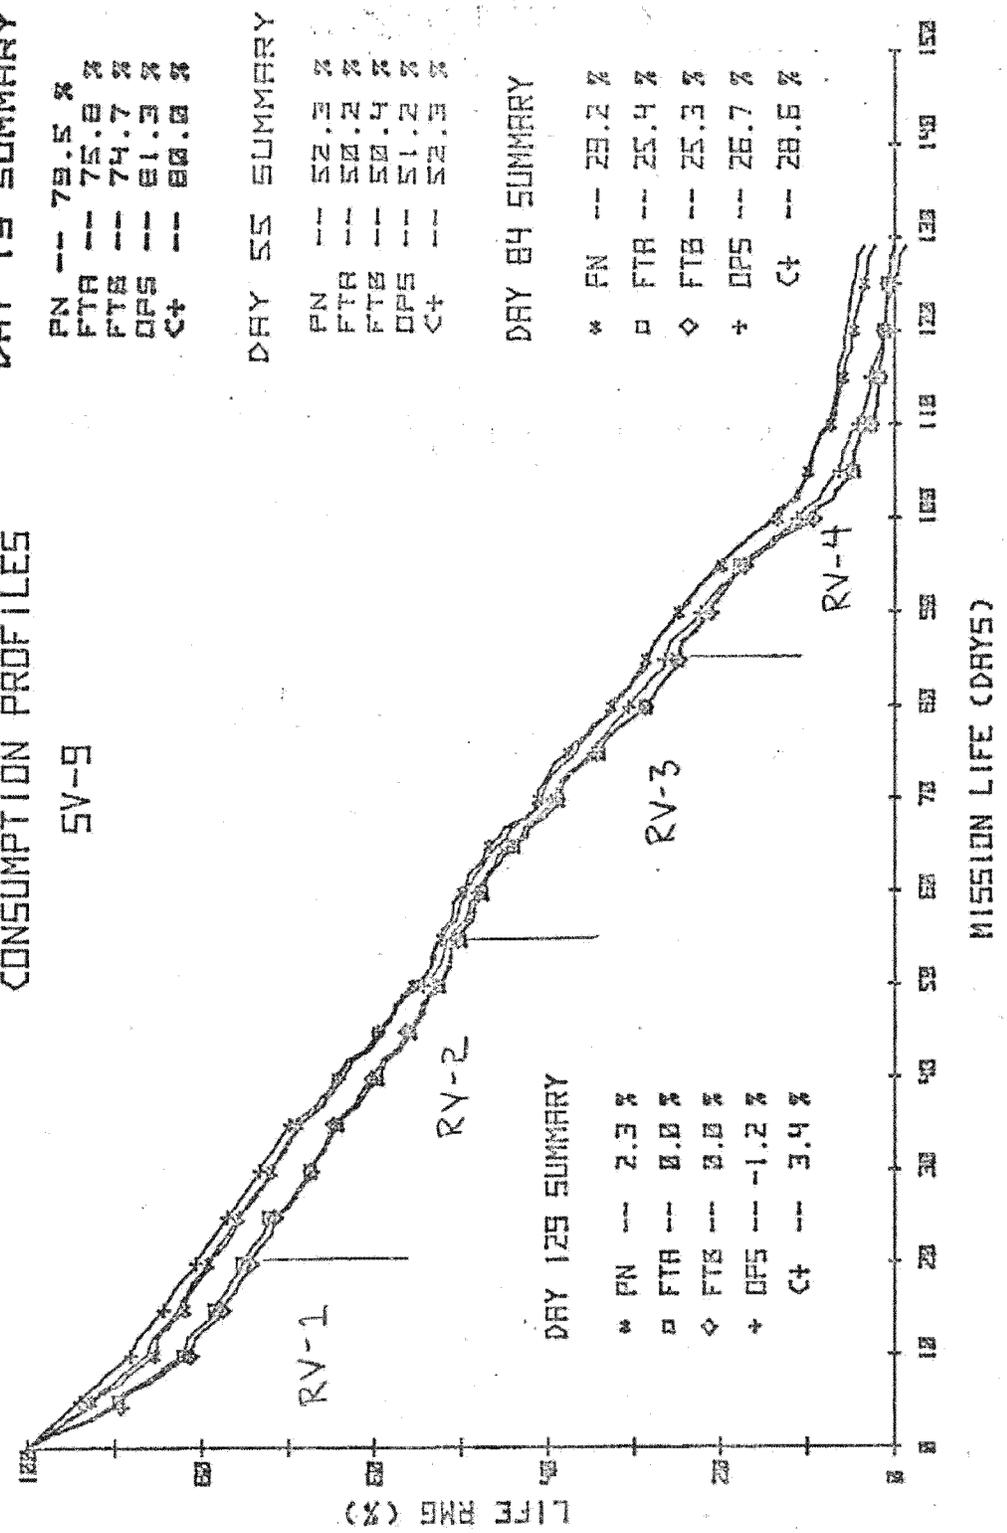
Figure I-1 Consumption Profiles

DAY 129 SUMMARY

* PN	--	2.3 %
□ FTR	--	0.0 %
◇ FTB	--	0.0 %
+ DPS	--	-1.2 %
C+	--	3.4 %

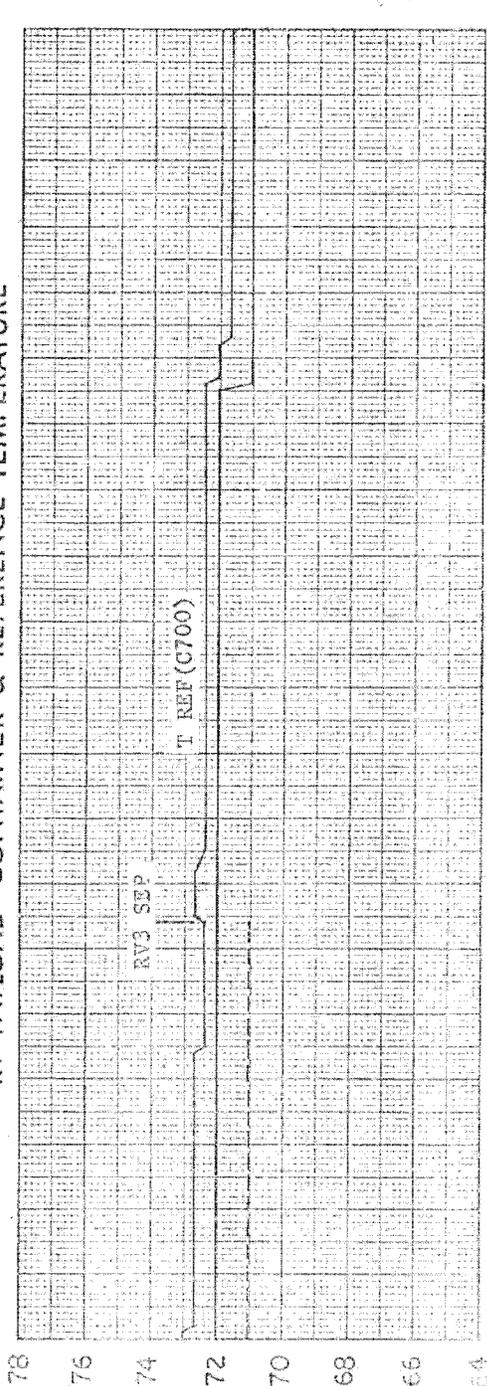
ACTIVE THERMAL CONTROL SYSTEM

RV PAYLOAD CONTAINER & REFERENCE TEMPERATURE

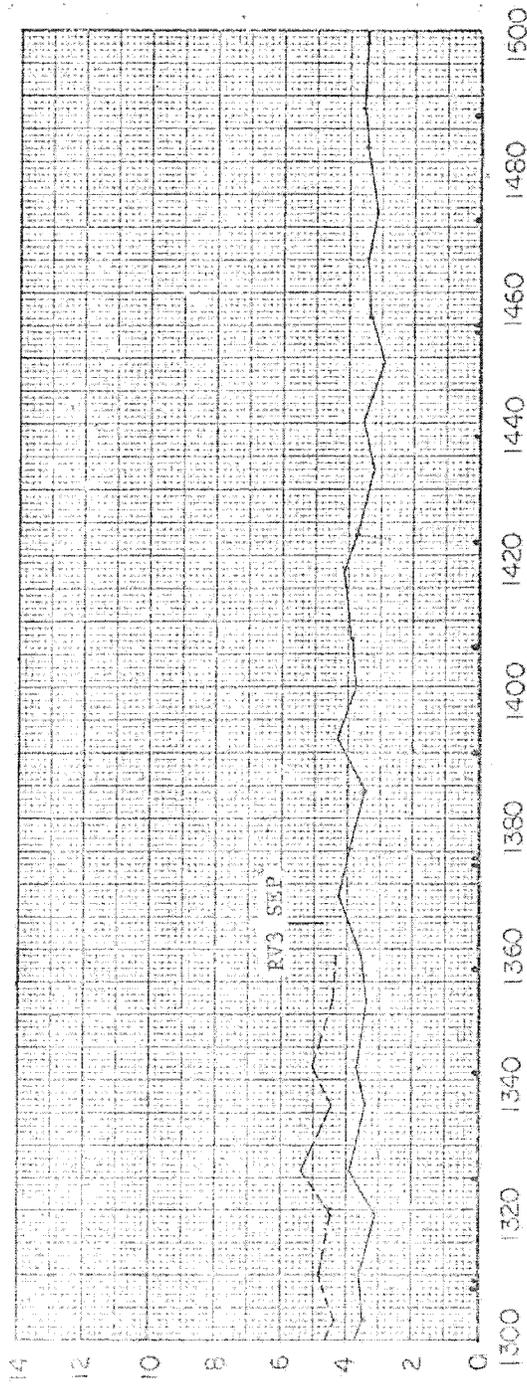
RV HEATER POWER CONSUMPTION

RV1
 RV2
 RV3 - . - .
 RV4 _____

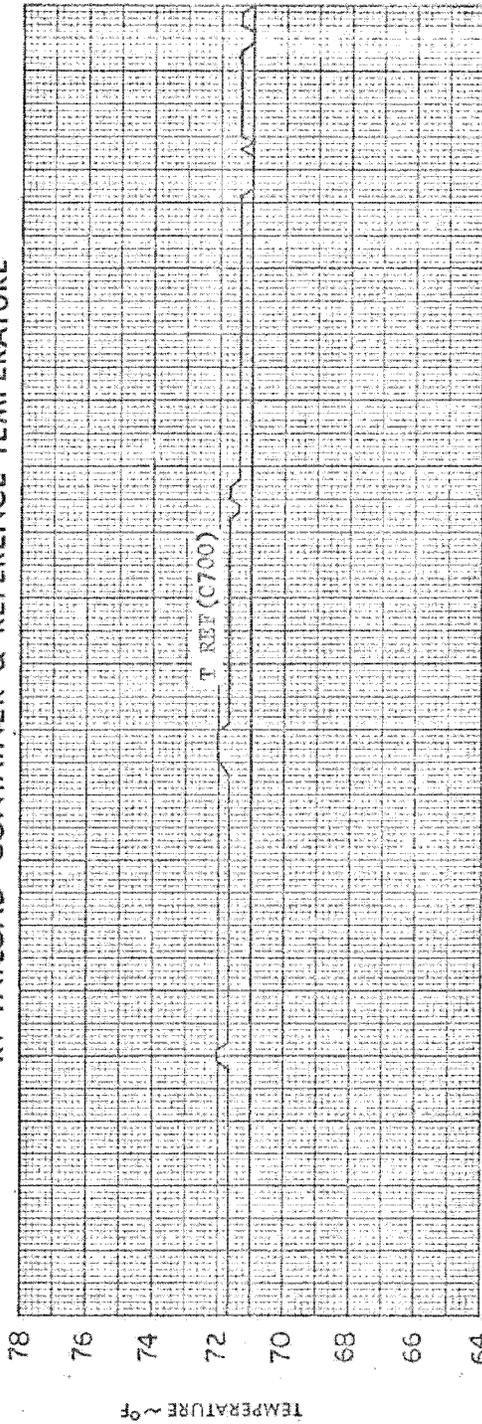
RV PAYLOAD CONTAINER & REFERENCE TEMPERATURE

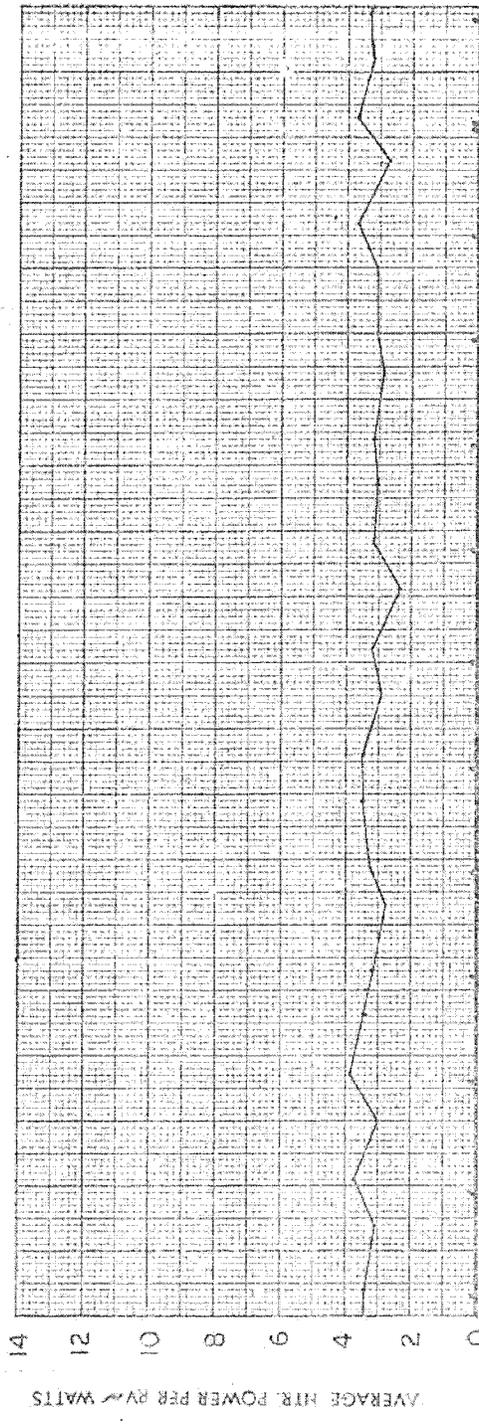
RV HEATER POWER CONSUMPTION

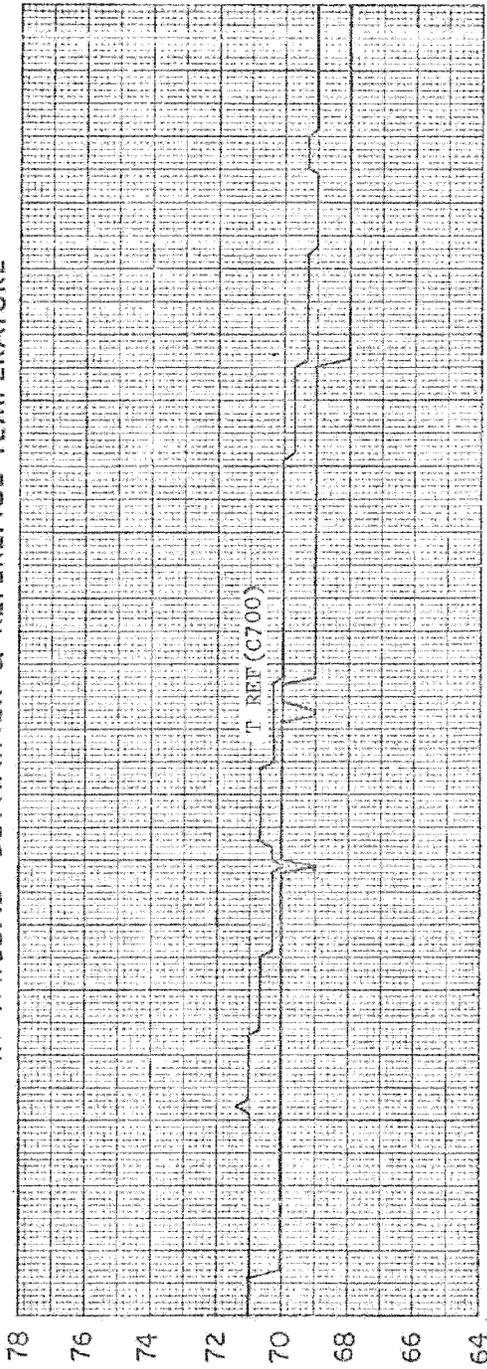
RV PAYLOAD CONTAINER & REFERENCE TEMPERATURE

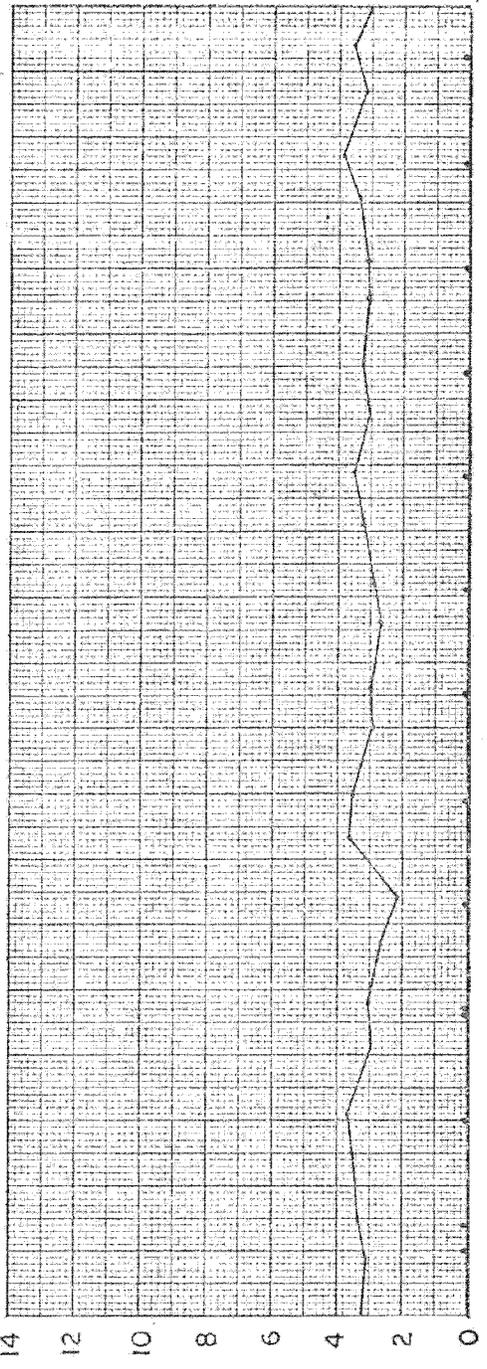
RV HEATER POWER CONSUMPTION

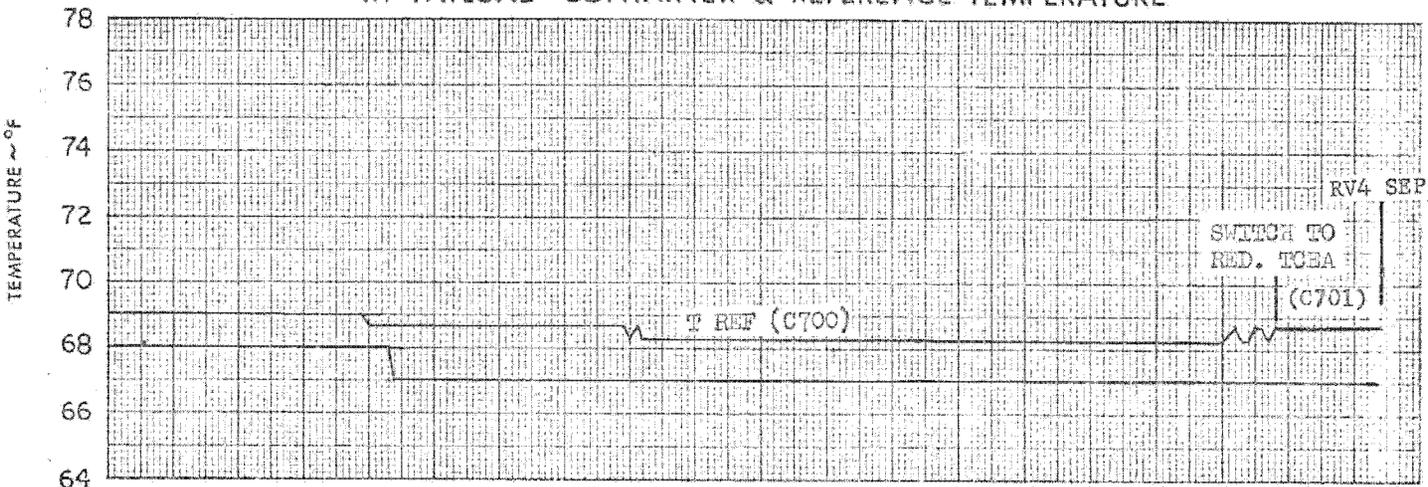
RV PAYLOAD CONTAINER & REFERENCE TEMPERATURE

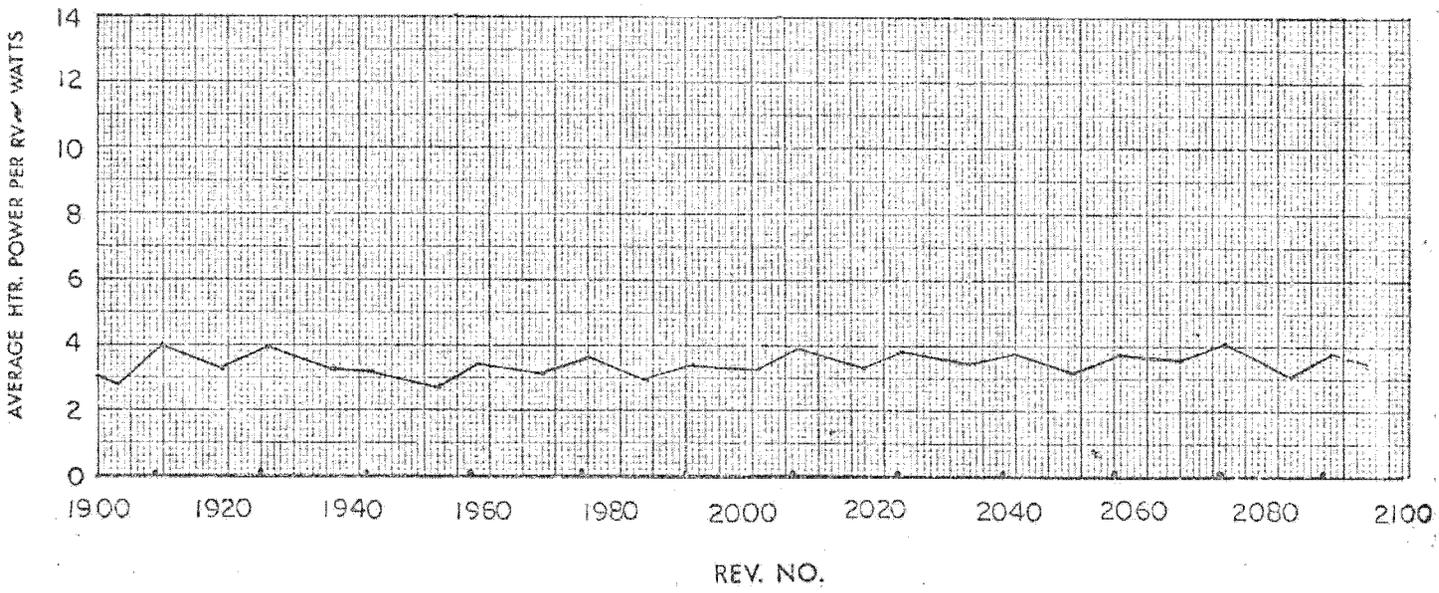
RV HEATER POWER CONSUMPTION
