Subject: TRIP REPORT CONCERNING MISSION 1013 FAILURE (J-15)

TRIP REPORT CONCERNING MISSION 1013
FAILURE (J-15)

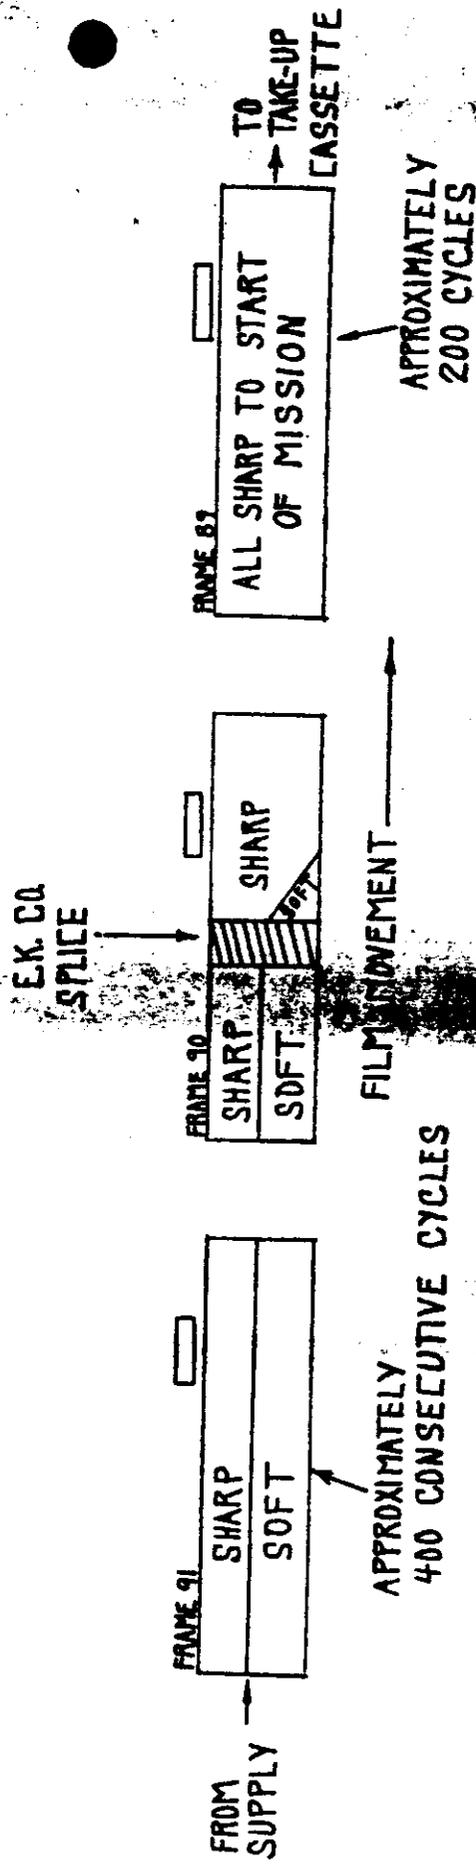
FIGURE NO. 1 : AFT LOOKING CAMERA: PHOTOGRAPHIC DEFINITION VS E.K. CO. SPLICE PASSAGE
PASS 24

Aft camera terrain photography was consistently sharp prior to the time the first Eastman Kodak splice passed thru the platen of instrument 159 during pass 24, frame 90. Beginning with frame 90 and immediately thereafter, aft camera photography became soft with low

definition over 50 to 60% of each format area for approximately 400 consecutive photographs where weather permitted detailed evaluation.

Figure No. 1 shows the general character of photography before, during, and after passage of the first Eastman Kodak splice thru the aft looking camera.

Measurements show that at the time the splice entered the aft camera platen area, the film shifted laterally toward the rail on the timing track side of the format by about 0.012 inches. Subsequent measurements made at random intervals from pass D-24 to D-47 indicate that the film path generally continued to be laterally displaced toward the timing track rail and never fully recovered.

An abnormally large quantity of adhesive appeared to be present at the edges of the Eastman Kodak splice. Additional adhesive appeared to have transferred to the original negative at the edges of the splice. The adhesive was observed on the original negative at Eastman Kodak prior to film handling, splicing, and spooling operations. The adhesive 75 inches ahead of the splice corresponds to one film wrap on the supply spool and is accompanied by static marks that outline the dimensions of the splice. The adhesive 120 inches ahead of the splice partially fills the voids observed in the adhesive layer at the splice.

1. It is recommended that Eastman Kodak be advised of the excessive adhesive associated with some of their splices and the potential impact upon the performance of the J system.
2. It is recommended that Boston be advised of the excessive film lengths and associated soft imagery observed in the platen area of both cameras during photographic scan beginning with pass 51.
